**RECONNAISSANCE LEVEL SURVEY  
of Barns and Agricultural Structures**

Town of Clarence, New York

September 30, 2014

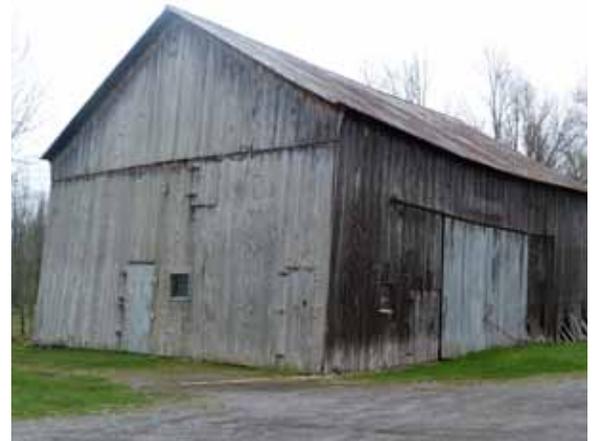
Figure 15. English Barn form

The interior of the English barn is typically divided into three bays, or mows, but could also be five, six or seven bays wide and one or more bays deep. Mortise and tenon framing would run perpendicular to the doors to create a clear-span center bay for threshing and space for livestock and grain storage in the outer bays, separated by framing bents. If additional bays were required, more bents were added. Barns of all types were constructed using mortise-and-tenon framing of heavy timber beams until the mid-20th century.

Central doors led to the threshing floor, which was also called the driveway or runway. Threshing occurred inside the barn, between the central doors. Bundles of wheat were placed on the floor and beaten, releasing the grain from its husk. Using a winnowing basket, wheat was tossed in the air and caught in the basket. Crosswinds sweeping through the barn removed the lighter husk from the barn while the heavier grain remained on the floor to be collected or in the basket.<sup>47</sup>

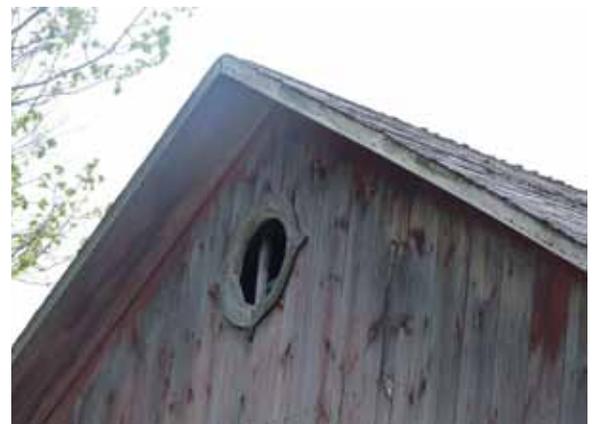
Figure 16. Maker's mark

Other than the central doors, the elevations of the English barn remained without much fenestration. Small man-doors or dutch-style doors for animals were sometimes included depending on the farmer's individual needs. Small openings were incorporated into the construction on the gable end, for small birds and owls to enter for pest control. Small makers' marks (figure 16) were also carved or cut into the wood plank siding, similar to a signature,

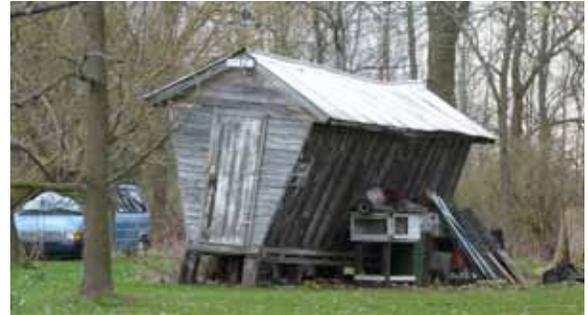
Figure 25. Corn Crib

*Corn Crib* – slatted wooden shed, elevated off the ground to protect the crop from rodents. The open slats allow for air circulation to dry the corn and prevent spoil. The sidewalls always slant outward at the eaves.<sup>51</sup> (Figure 25)

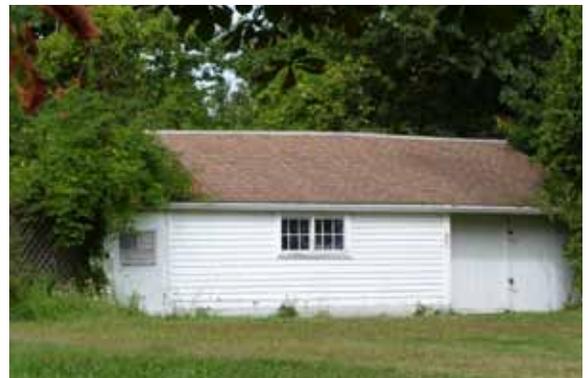
Figure 26. Hog House

*Hog House* – sometimes a shed addition to the primary barn, often a stand-alone wood-framed structure with gabled ends. Single door for access and smaller doors connected to a pig pen and mud pit. (Figure 26)

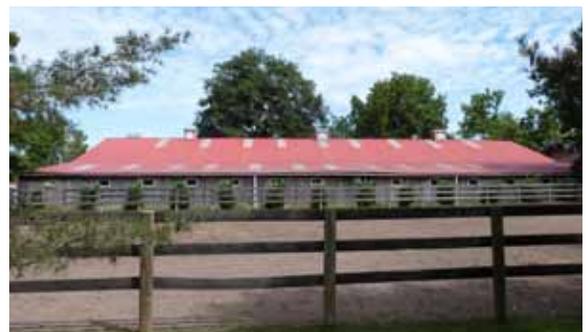
Figure 27. Horse Stables

*Horse Stables* – found on large farms which required the separation of livestock. Horse stables were also located within the primary barn. Wagons were often located adjacent to horses for accessibility ease. These functions were also accommodated with carriage houses, which were meant to match the style and detailing of the farmhouse. (Figure 27)

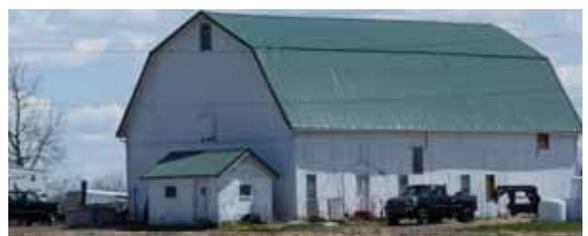
Figure 28. Milk House adjacent to barn

*Milk House* – for the storage of milk and/or milking of cows. Often located near the barn, sometimes connected as a shed structure or gabled-end addition. Usually built with concrete walls and wood framed roof. Contained few windows and deep eaves in order to keep milk cool. (Figure 28)

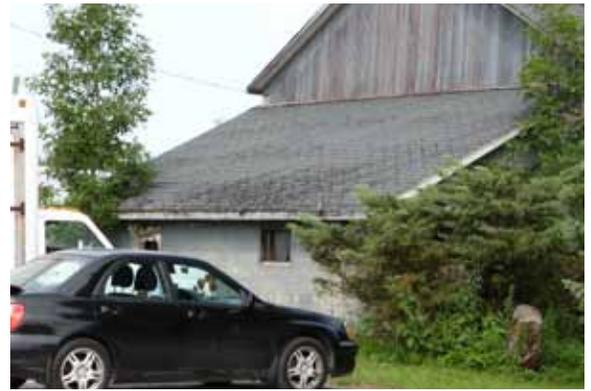
Figure 29. Milk Shed

*Milking Shed* – typically a small, one-story structure, either attached or detached but located nearby the main barn. Often combined with an icehouse for dairy preservation, the milk shed could also process small amounts of milk and cheese.<sup>x</sup> (Figure 29)

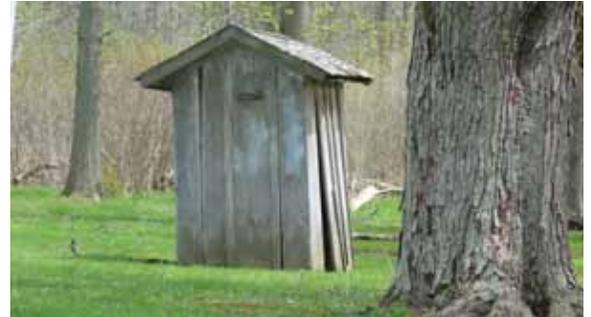
Figure 30. Privy

*Privy* – early bathroom facility for the farmhouse occupants and/or farmhands prior to interior plumbing. Wood framed and smaller in footprint than a smokehouse, the privy would be in close proximity to the farmhouse, but far enough away to prevent seepage. Often contains a single wooden door with no windows. Roof is typically gabled end and wood framed. (Figure 30)

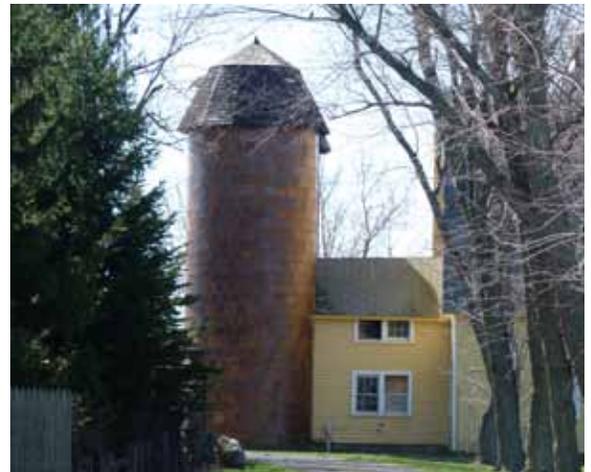
Figure 31. Silo

*Silos* – later addition to many barns. Typically known in its upright form, silos originated as below-grade storage facilities. The first known wooden silo dates to 1873 in Illinois. The circular form was favored over the earlier rectangular silo in the late 1890's. Construction materials include wood, fieldstone, clay tile, metal and slip-form concrete. <sup>41</sup> (Figure 31)

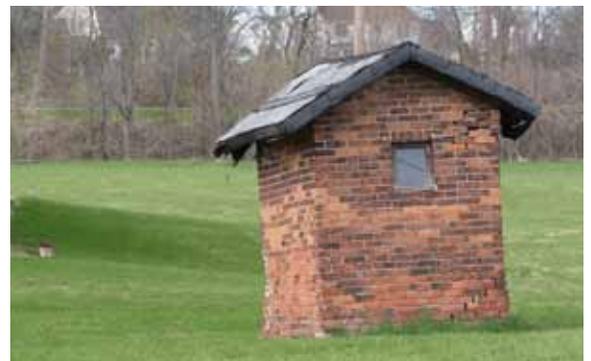
Figure 32. Smokehouse

*Smokehouse* – small masonry, air-tight structure with a trench inside or small addition built on the side to hold a fire and develop smoke for the preservation of meat. Often contain a single wooden door and one small wooden window to view progress. Roof is typically a gable, wood framed. (Figure 32)

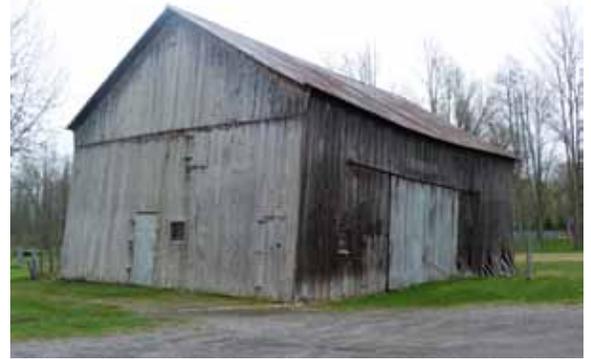
Figure 33. Gable roofed barn.

Gable roofed barns made up more than 75% of the barns surveyed. Gambrel roofed barns were not concentrated in specific areas, but did tend to be part of larger farm complexes set back from the road, whereas gable roofed barns were often situated directly adjacent to roads.

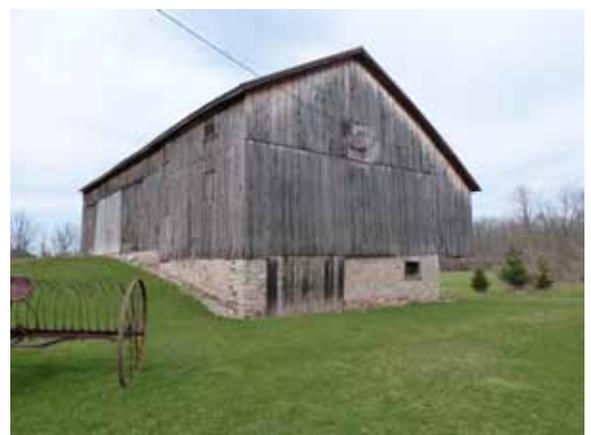
Figure 35. Pennsylvania barn.

Clarence is graced with the presence of four Pennsylvania barns. Colloquially called "Pennsylvania Dutch" barns, the only examples of this barn type in the State of New York are found in this part of Erie County, which makes the small collection of them within Clarence very historically significant, as does their unique construction and functionality. Pennsylvania barns are defined by their "forebay" overhang and typically include an earthen bank on the opposite side. (Figure 35) One of these barns, on the Orchid Ledge farm located at 4830 Thompson Road, is an existing town landmark. The remaining three were included in this survey.

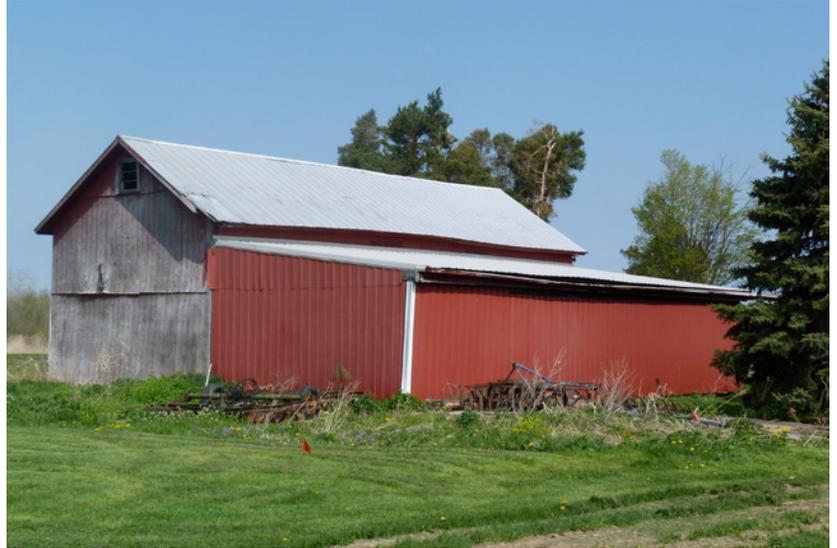
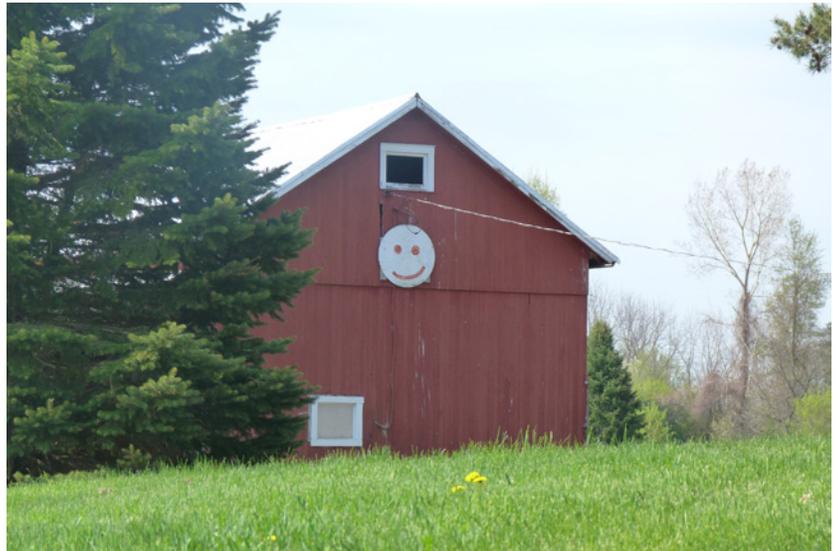
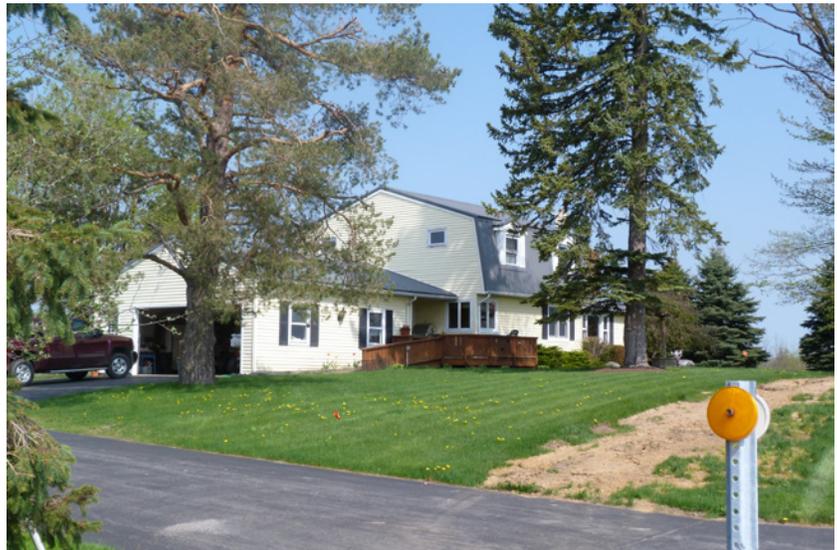
Three-bay gabled English barn with vertical plank siding partially covered with more recent wood siding and metal roof. Large contemporary metal addition covers original entry door and any historic features. Constructed c. 1900.

Property additionally includes c. 1960s vernacular farmhouse and open-sided metal storage shed.

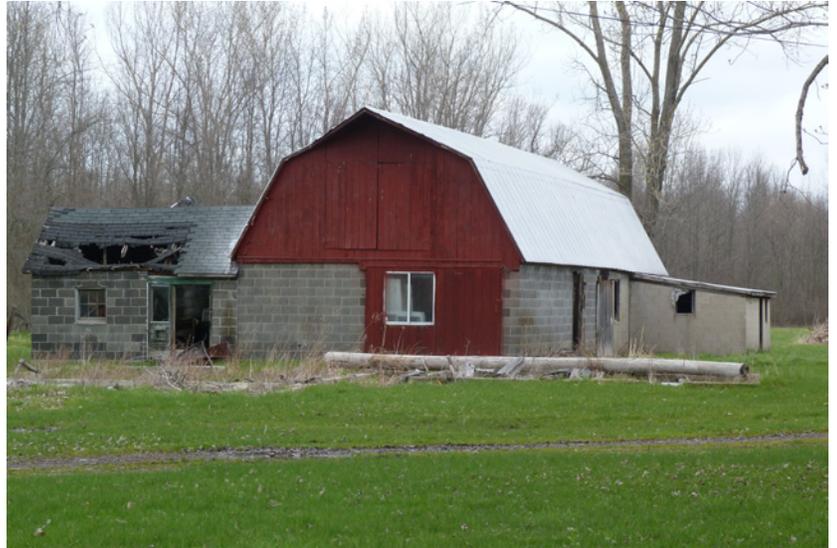
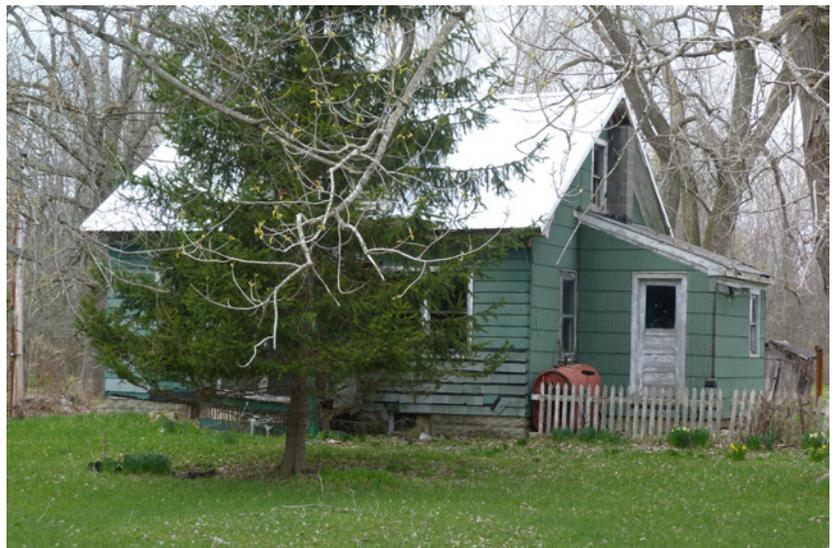
# 10370 Cedar Rd.

Abandoned dairy farm complex including c. 1920s gambrel roof barn with two cinderblock additions and partial cinderblock construction. Cinderblock lean-to was likely a milking room.

Property additionally includes several small plank farm buildings including a chicken coop, all of which are in deteriorated condition. Property also contains two c. 1920s farmhouses and a concrete hitching post.

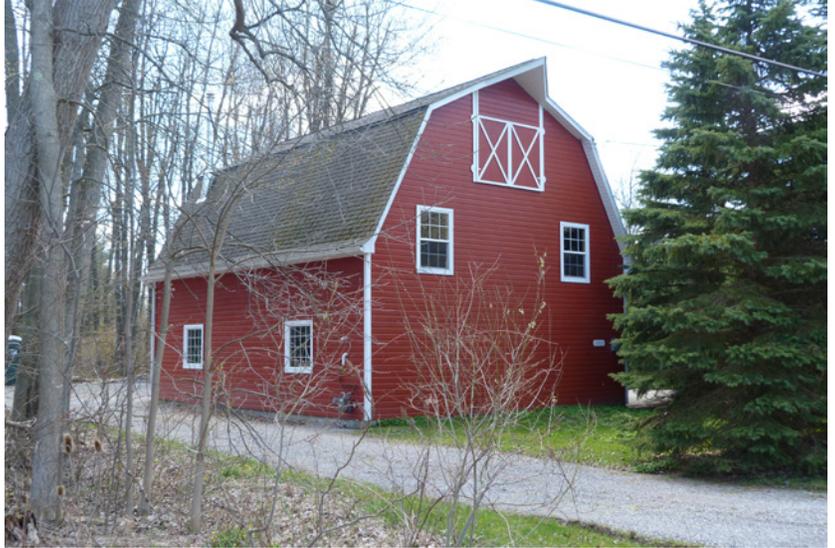
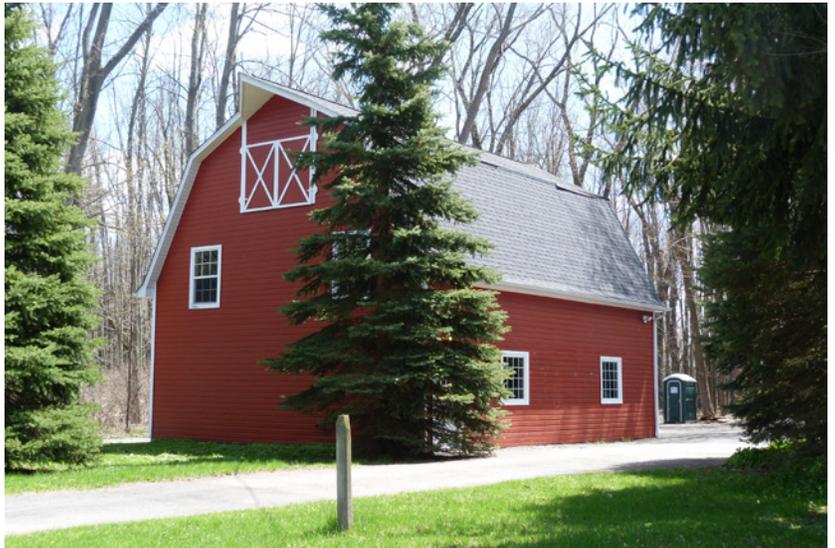
## 8325 County Rd.

Gambrel roof barn with wood siding, hay hood at peak, vinyl windows, and asphalt shingle roof. Former barn that has been converted to a residence. Constructed c. 1900. Barn doors and historic details no longer present.

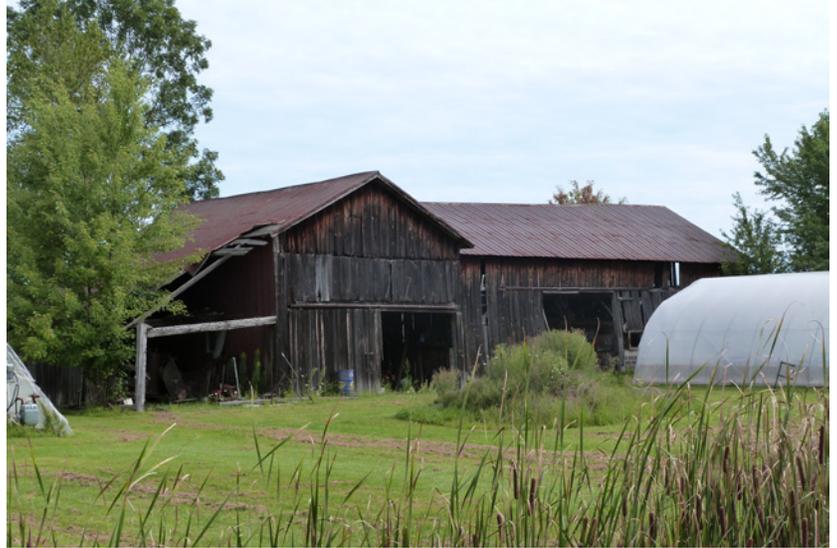
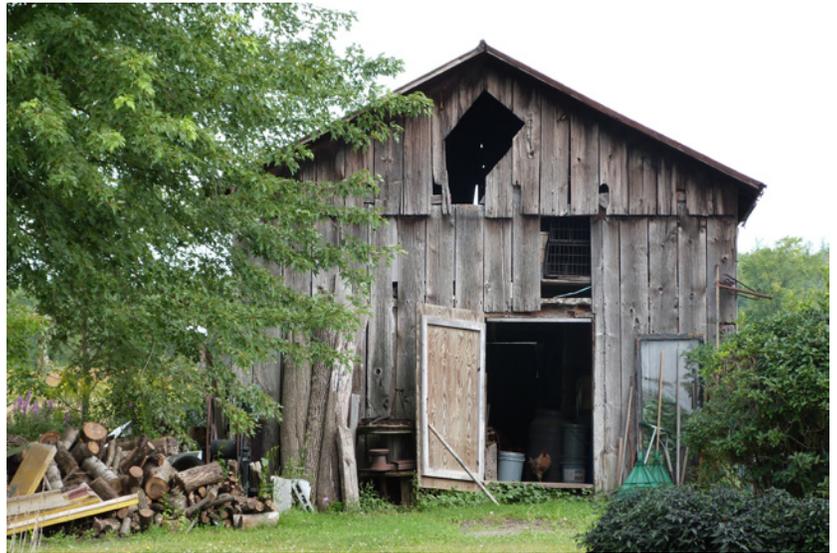
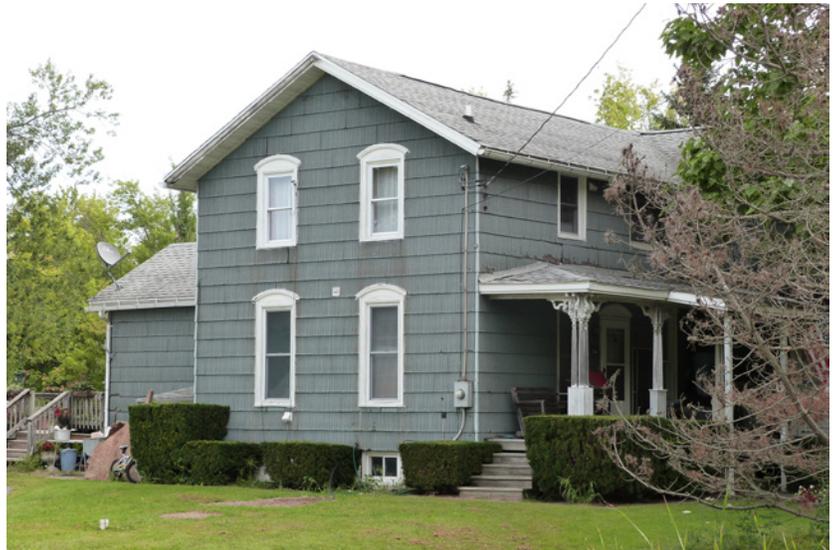
## 8705 County Rd.

Property includes a large cross-gabled barn with vertical plank siding walls and metal roof. Between Aug 2011 (top photo, from Google) and Aug 2014 (middle photo), the barn received a significant renovation that repaired deterioration but covered the original siding with board-and-batten. A diamond-shaped martin hole is present on the end of longer gable wing. The property also includes a chicken coop and a c. 1860s farmhouse that has been sided with asbestos siding. The longer portion of the barn has a stone foundation and likely dates to a similar age as the farmhouse, c. 1860s, whereas the smaller gabled portion has a concrete foundation, which dates it to after 1910.

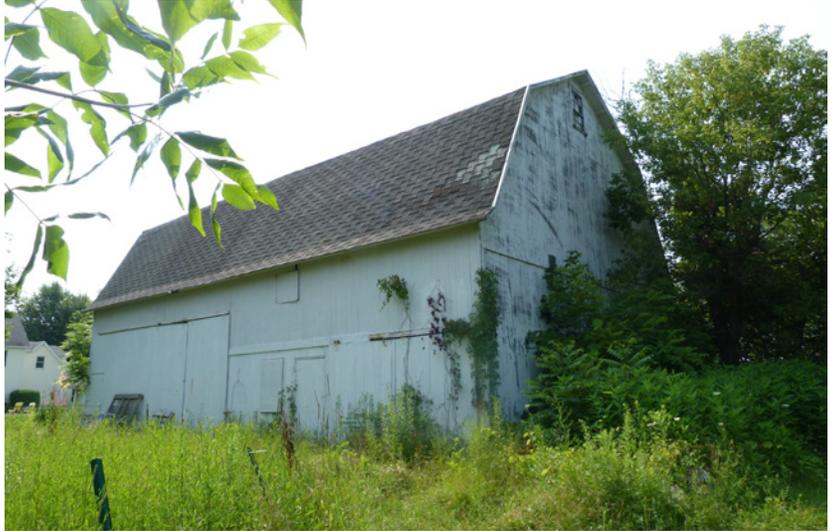
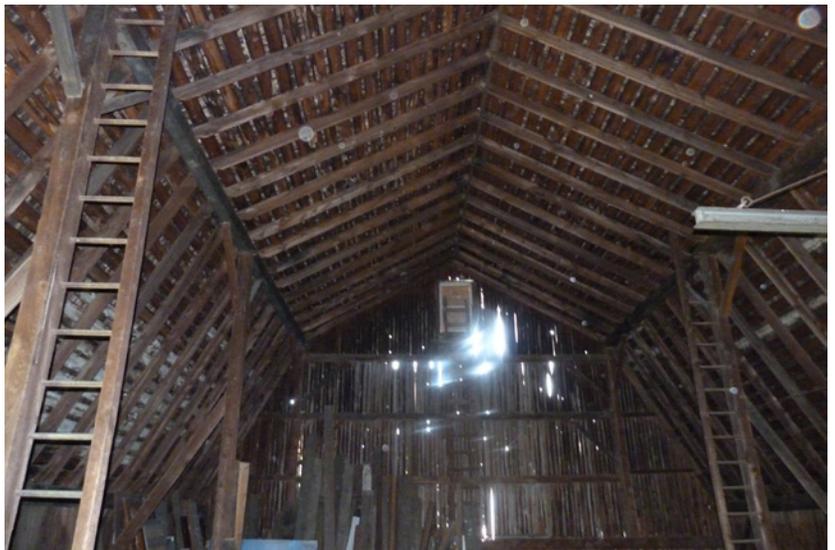
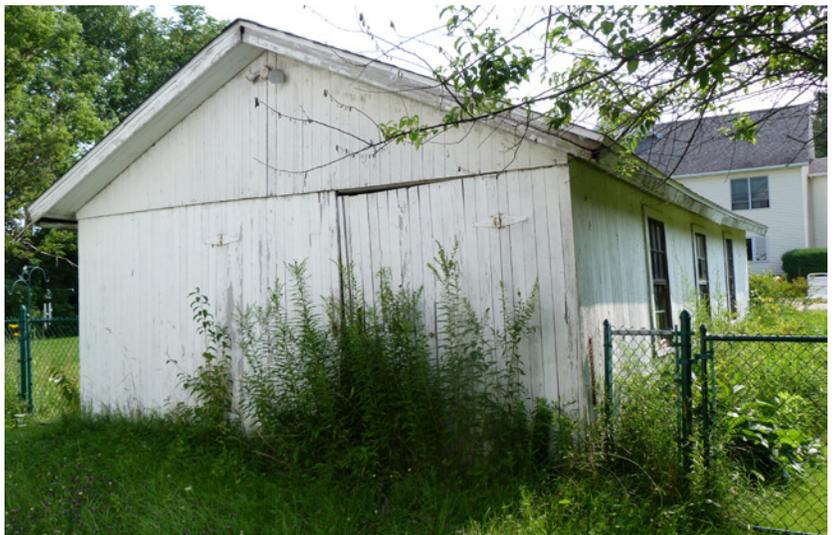
## 7225 Goodrich Rd.

Property includes a wood plank structure with gabled metal roof likely dating from the late 19th/early 20th century that may be a former agricultural structure, either a work shed or chicken coop. No barns are present on property. House dates from after the year 2000. Wood plank structure may be a remnant of an older agricultural operation on the property.

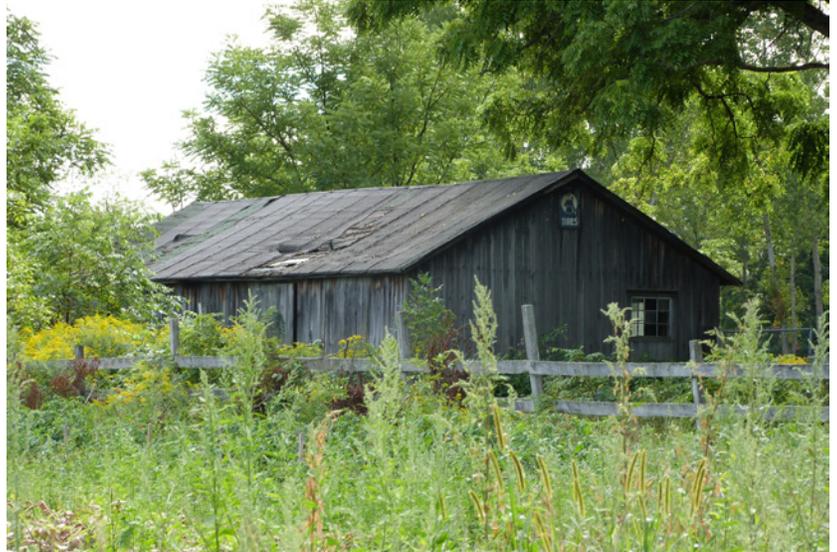
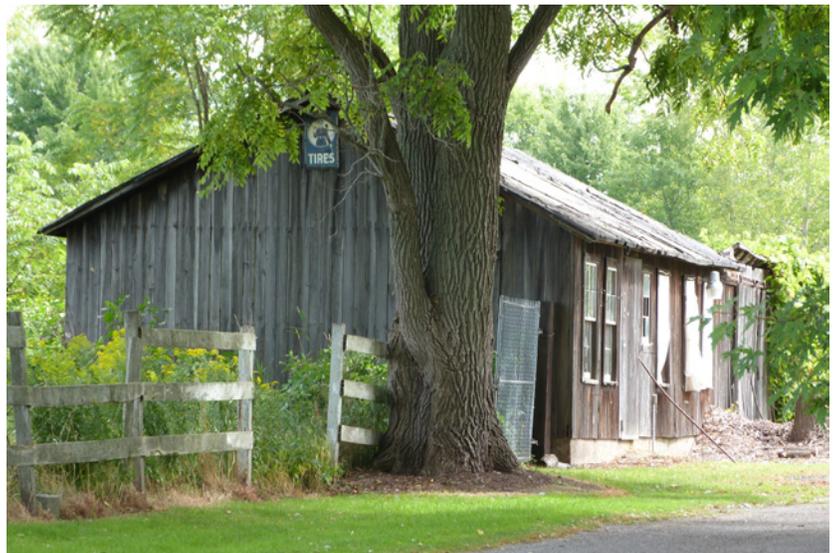
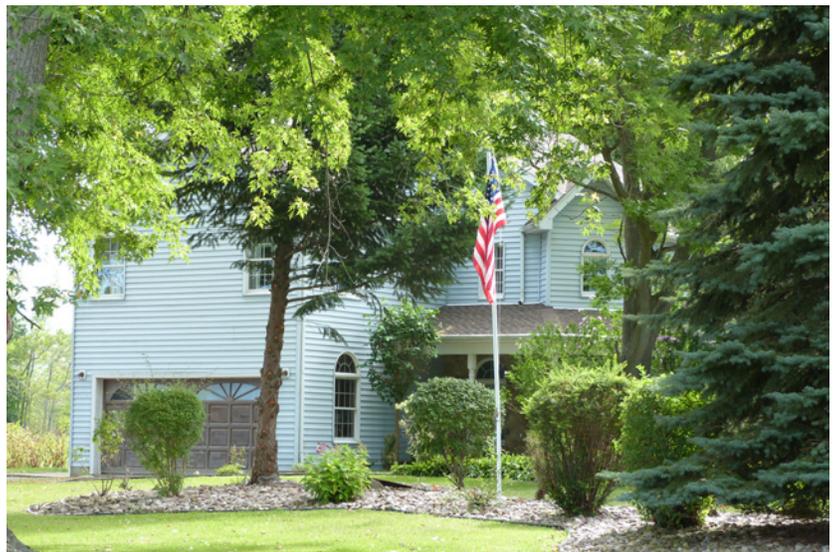
## 7360 Goodrich Rd.

Shed-roofed addition to the side of the main barn is likely an early-to-mid 20th century milking shed, suggesting this was once a dairy farm.

Property is a mid-to-late 19th century former farm complex, but lacks significance due to extensive unsympathetic changes and additions made over time to both the barn and farmhouse.

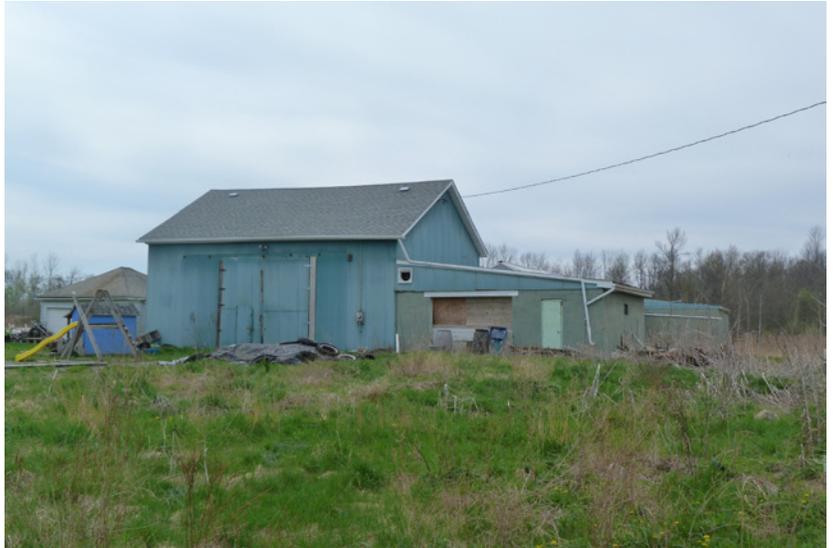
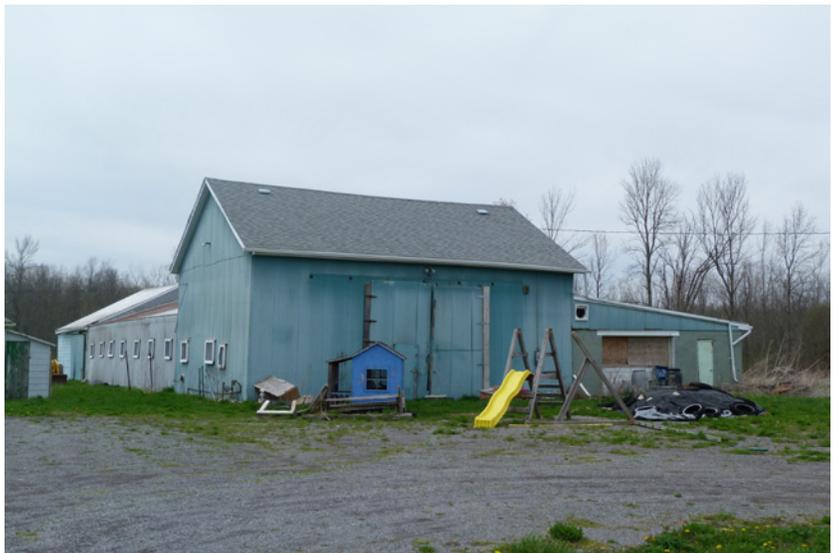
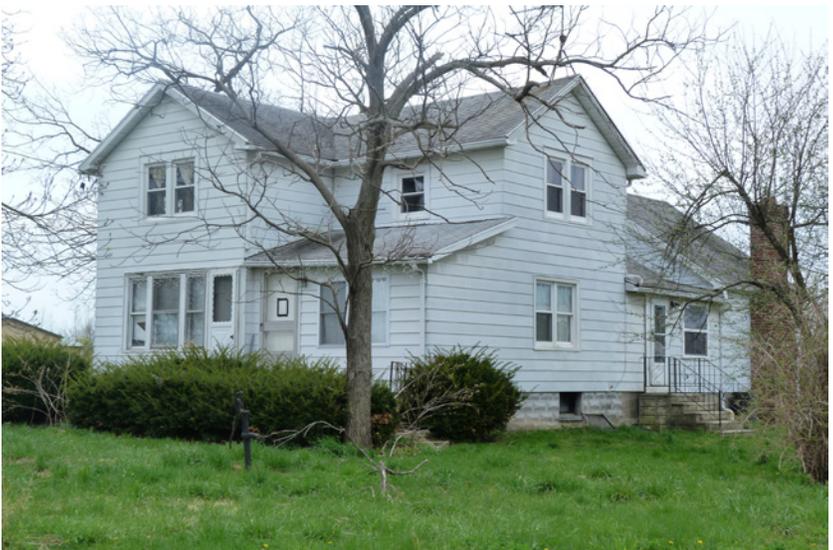
## 7375 Goodrich Rd.

Property includes a three-bay gable roofed English barn with cinderblock shed addition to the side. Barn has an asphalt shingle roof and has been completely sided with plastic. Farmhouse remains on the property, has received a replacement picture window and shingle siding, but is largely intact. Both the farmhouse and the barn appear to date to c. 1860s. Modern greenhouses and c. 1970s retail store building for the active nursery operation on the property are also present and the barn appears to be in continuing use as part of that operation.

Shed-roofed addition to the side of the main barn is likely an early-to-mid 20th century milking shed, suggesting this was once a dairy farm.

Property is a mid-to-late 19th century former farm complex now in use as Szulis Nursery.

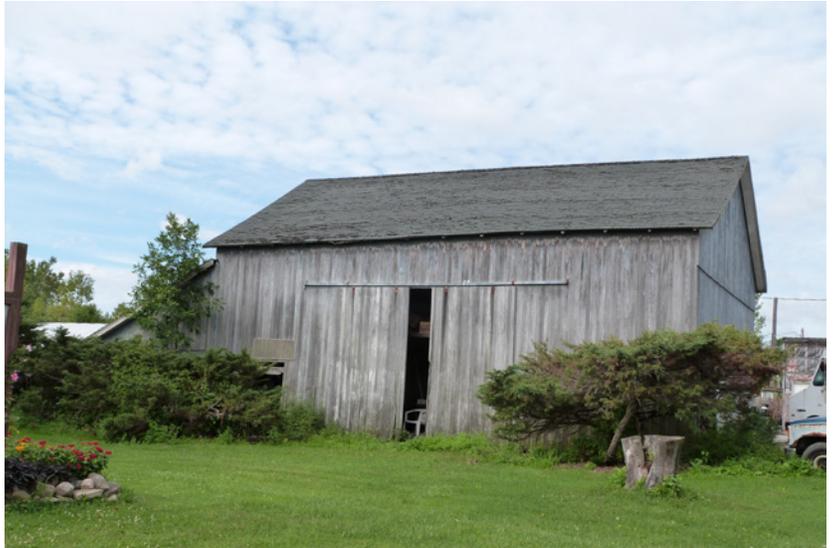
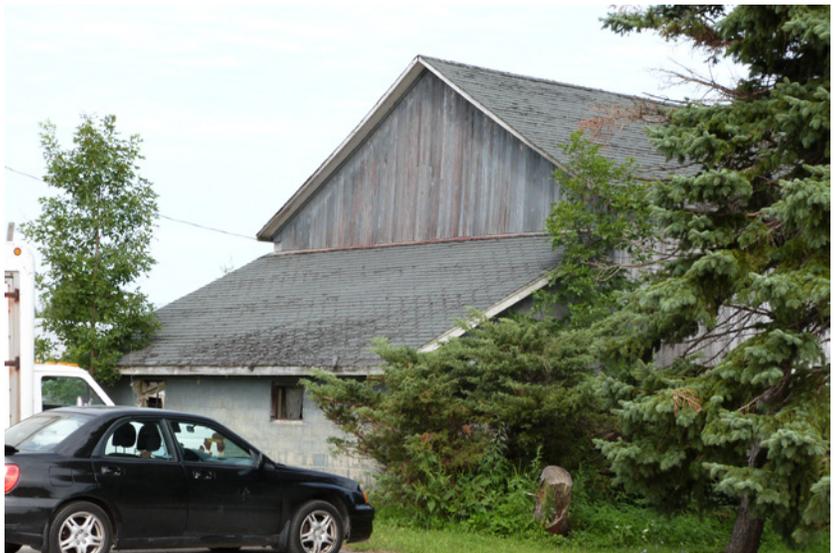
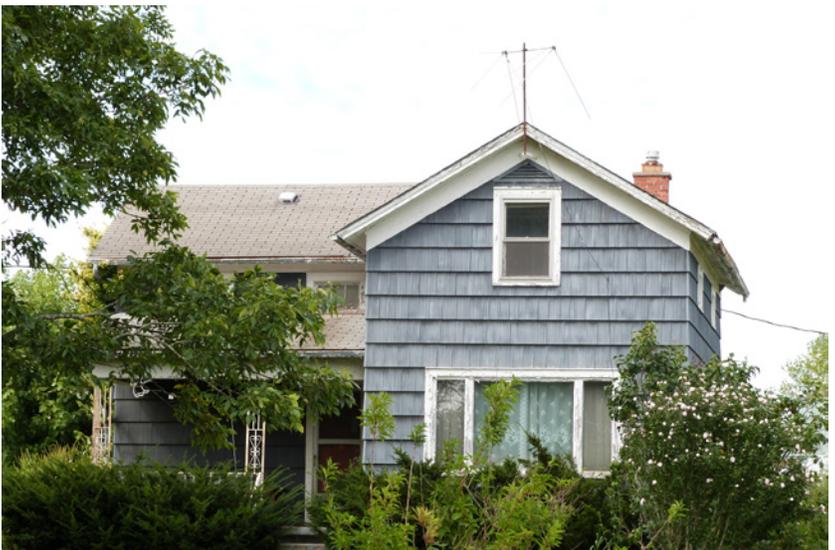
# 7525 Goodrich Rd.

Property includes a collapsed barn, one small gable-roofed building that may be an old agricultural structure, a contemporary gambrel roofed storage shed, and the original farmhouse. The house dates from the 19th century, as judged from its stone foundation, but has been altered multiple times with window changes, additions, and vinyl siding to the point that its original form is barely recognizable.

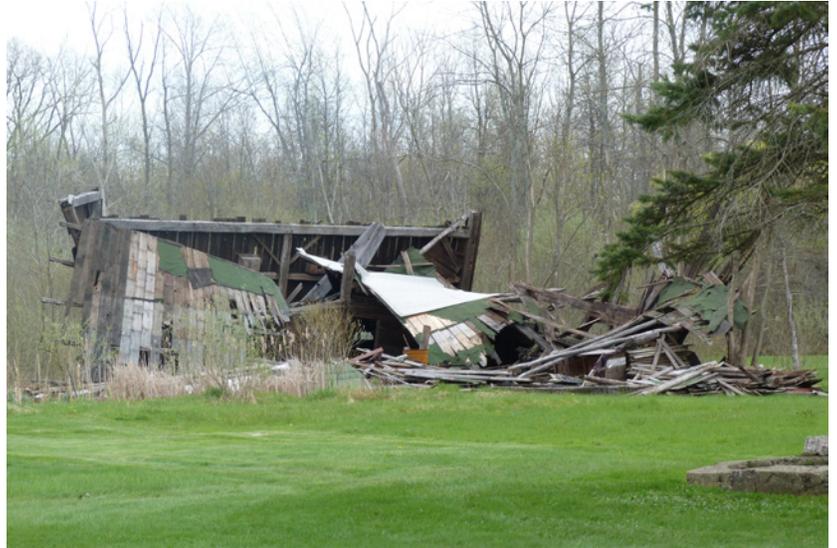
## 7575 Goodrich Rd.

Property includes three-bay gable roofed English barn with board-and-batten wood siding and metal roof and a 1920s American Foursquare farmhouse that is largely intact but has been sided in vinyl. Presence of concrete foundation, use of board-and-batten siding and the unique ventilation grille above the door made out of wood planks (suggesting relatively modern ideas about ventilation/sanitation were being considered in its design) suggests barn was built at the same time as the farmhouse, c. 1920s, though that is late for this barn type. Wood shed-roofed addition was likely originally a milking shed, thus this was once a dairy barn. Modifications have been made to milking shed and side of barn, for storage access.

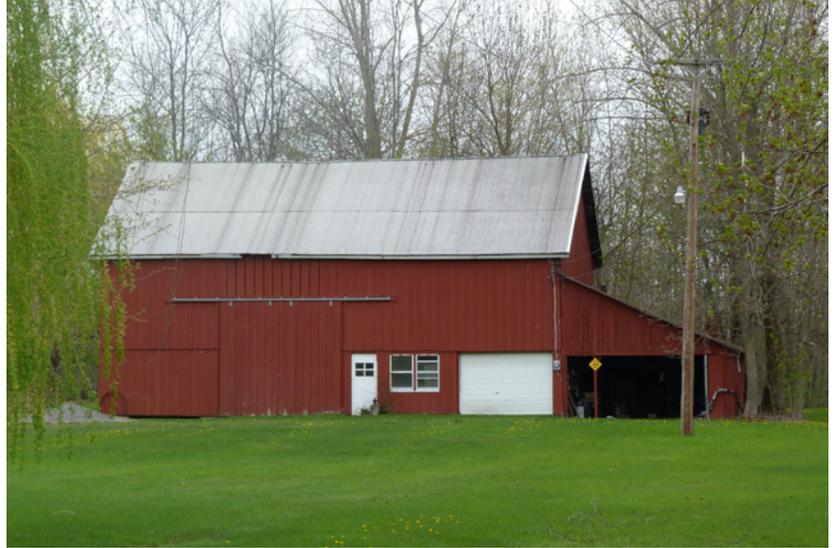
## 7715 Goodrich Rd.

Property includes three-bay English barn with vertical wood plank siding and metal roof and c. 1860s “upright-and-ell” plan farmhouse with asphalt shingle roof. Concrete block chimney and foundation suggests farmhouse underwent a significant renovation in the early 20th century. Barn has original strapwork hardware on man and ventilation doors on gable end and “star” shaped martin hole in the peak of both gable ends. The text of its year of construction, “1879” forms a second martin hole high on the north gable end. Southwest corner of barn is sinking, suggesting damage to its timber frame. Farmhouse burned in mid-2014, but is still standing at the time of this writing.

Property is a modest mid-to-late 19th century farm complex, including largely intact barn and farmhouse.

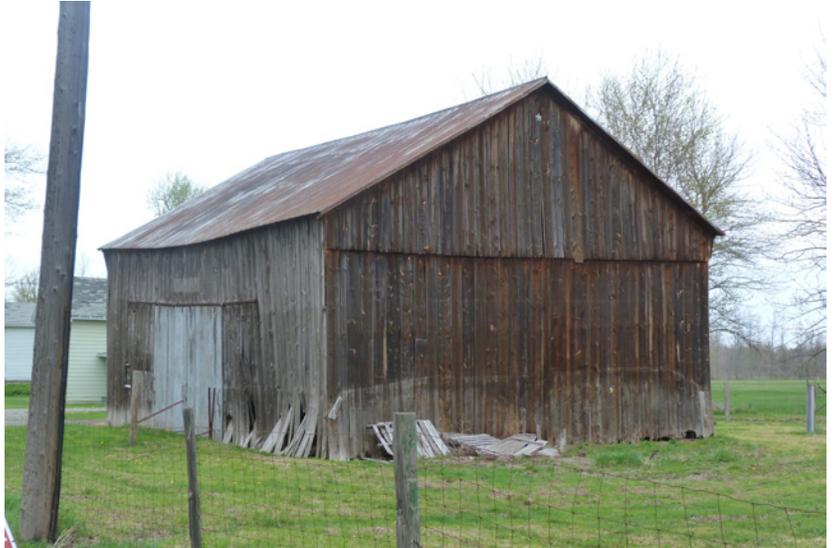
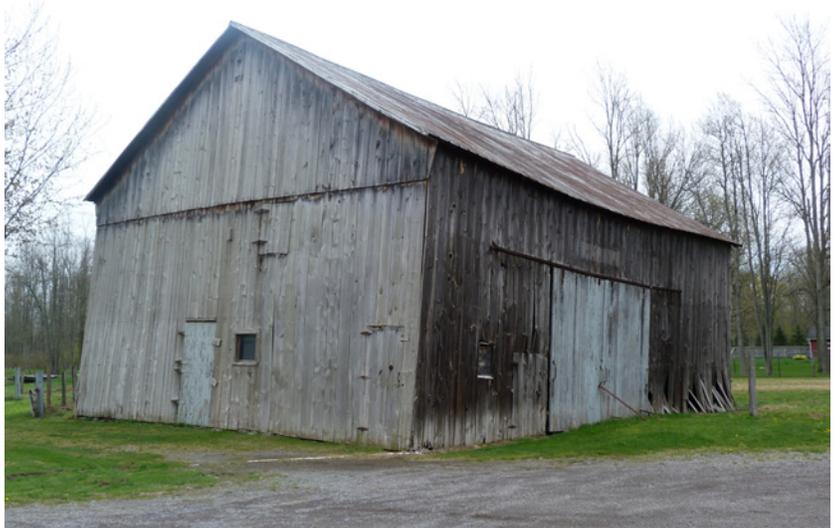
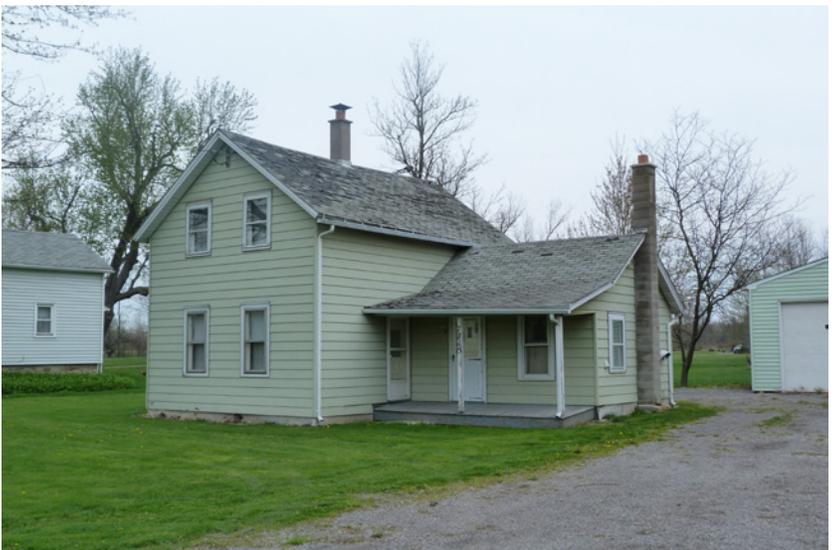
## 7765 Goodrich Rd.

Property includes a three-bay gable roofed English barn with vertical wood plank siding and metal roof, a late 19th or early 20th century farmhouse with additions or alterations, a 1960s ranch house, a small wood garage, and a pole barn. The English barn has been partially sided with board-and-batten siding on its west and south walls and some windows and garage doors have been added. The south gable peak has a “star”-shaped martin hole and cutout text with its date of construction “1883” below. Original strapwork hinges are visible on the doors on the north facade.

Property is a modest mid-to-late 19th century farm complex. The age note on the gable and the presence of a martin hole are details that suggest further study may be warranted.

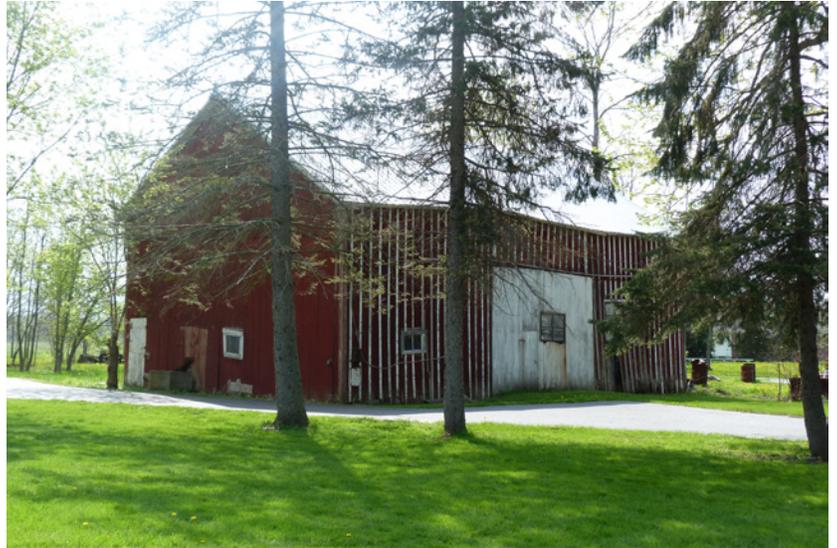
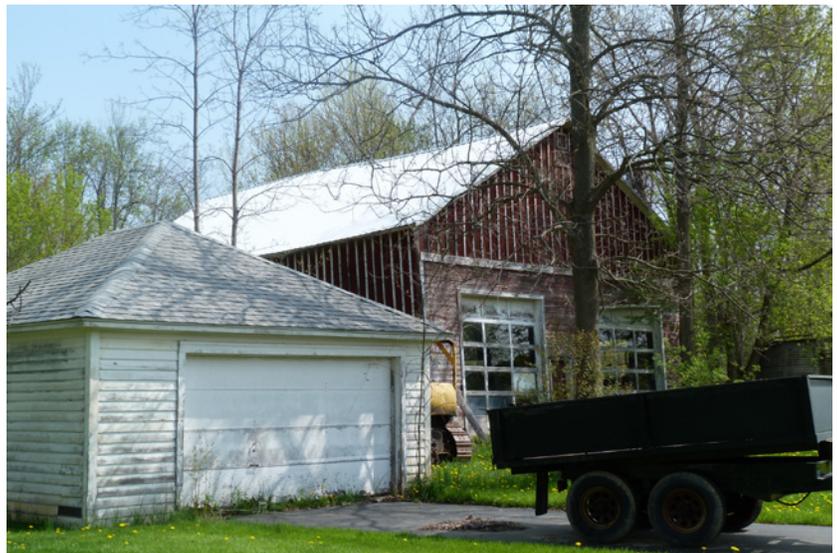
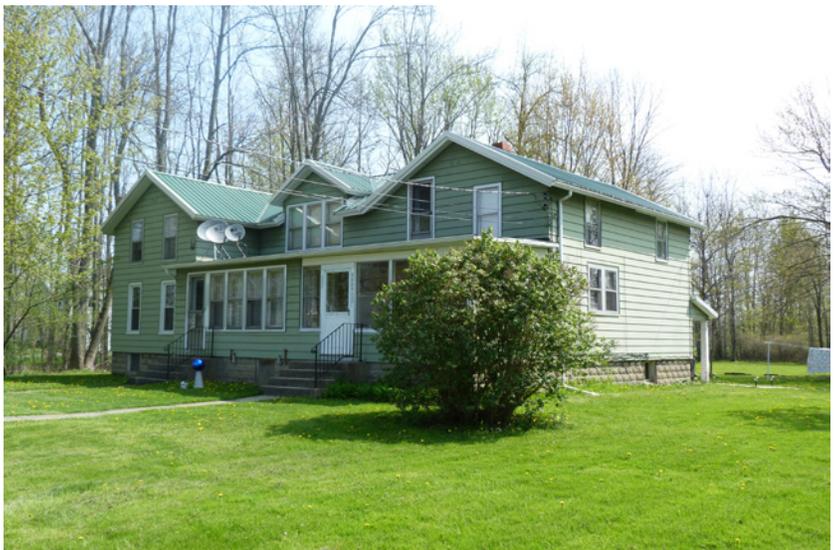
## 8050 Goodrich Rd.

Property includes a large c. 1890 three-bay English barn with vertical wood plank siding, a metal roof, and c. 1870s vernacular farmhouse. The large infilled opening on the barn gable end suggests hay was originally loaded from wagons at this location using a hay trolley at rafter level. The white edge painting on the doors is unusual and is a historic feature on some barns, but whether it is significant on this barn is not known. Two other small gable-roof structures are present on the property, which may be former agricultural structures.

Property is a late 19th century farm complex with largely intact barn and farmhouse.

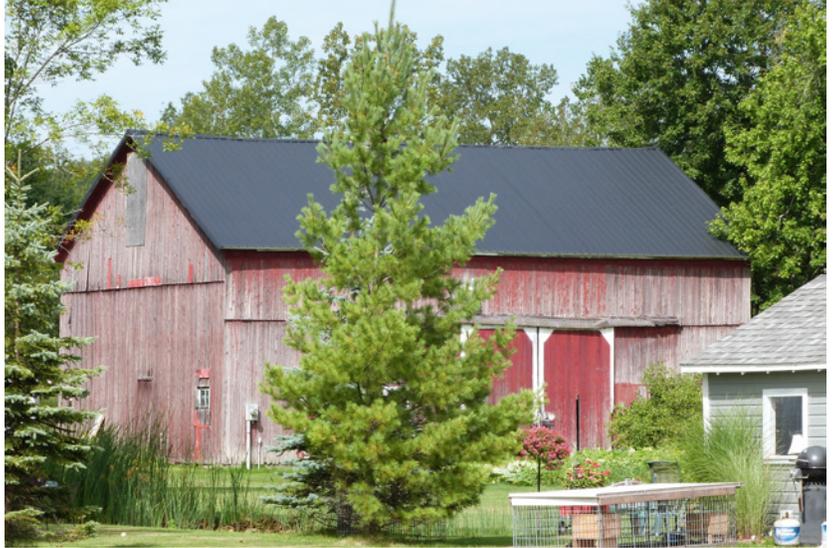
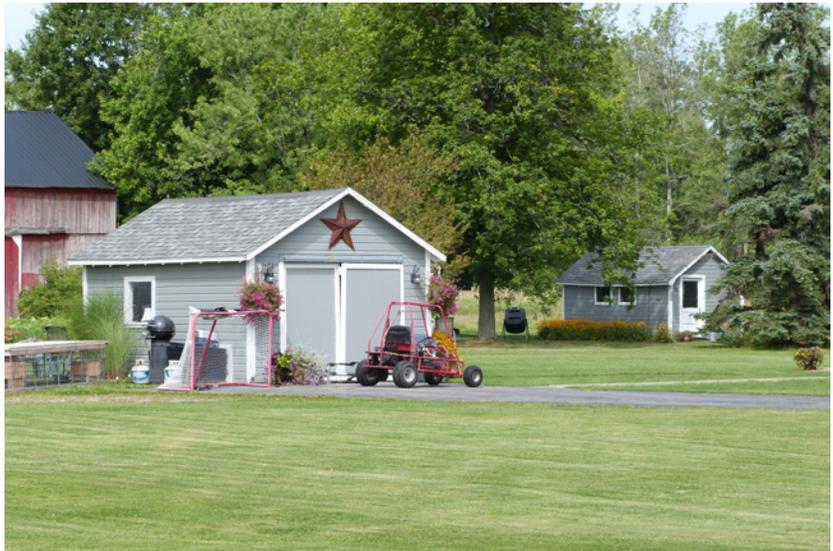
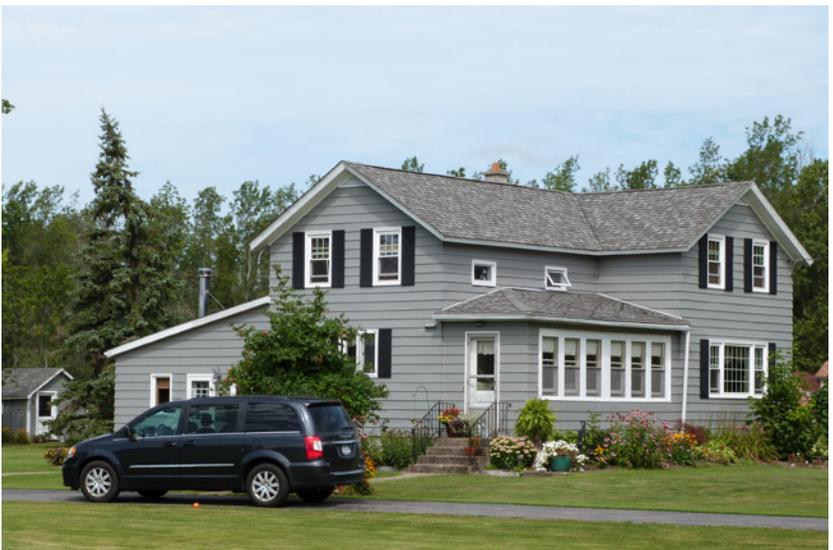
# 8185 Goodrich Rd.

Property includes a large late 19th century 3-bay English barn with attached wood milking shed. Several additional agricultural buildings are present including a privy. The farmhouse is no longer standing. Foundations of other structures on the site suggest the loss of additional related structures.

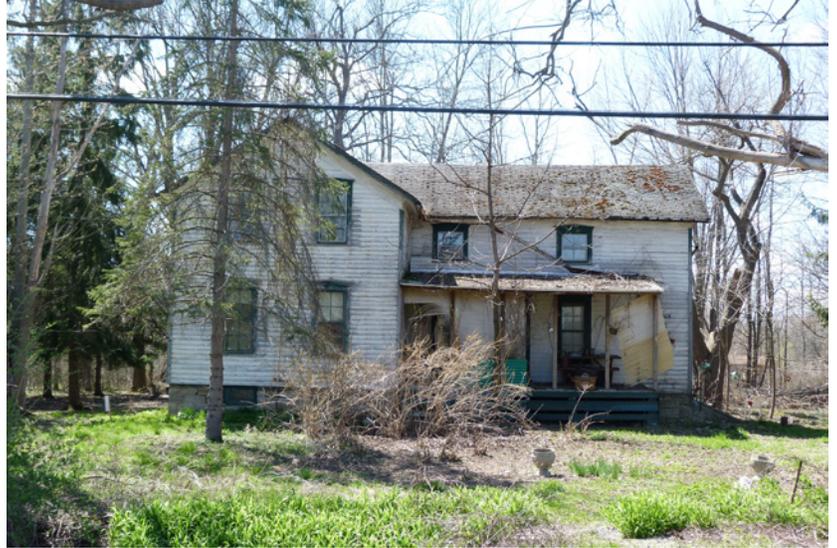
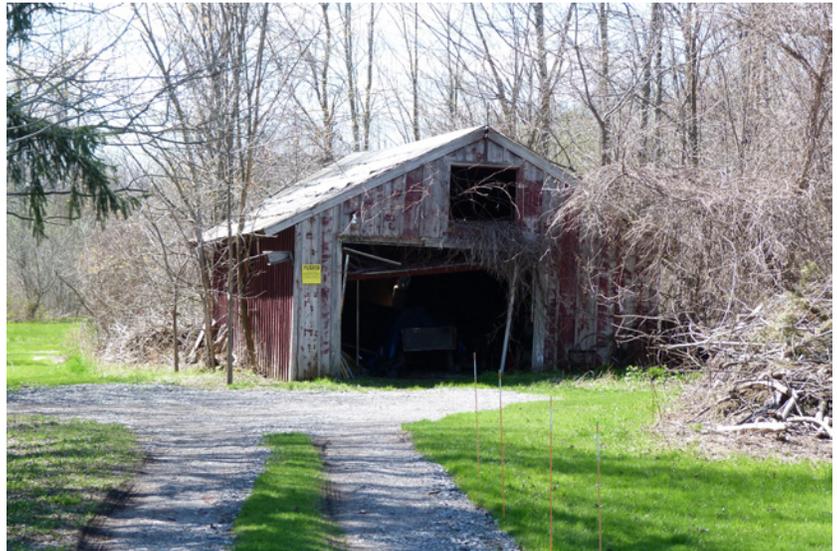
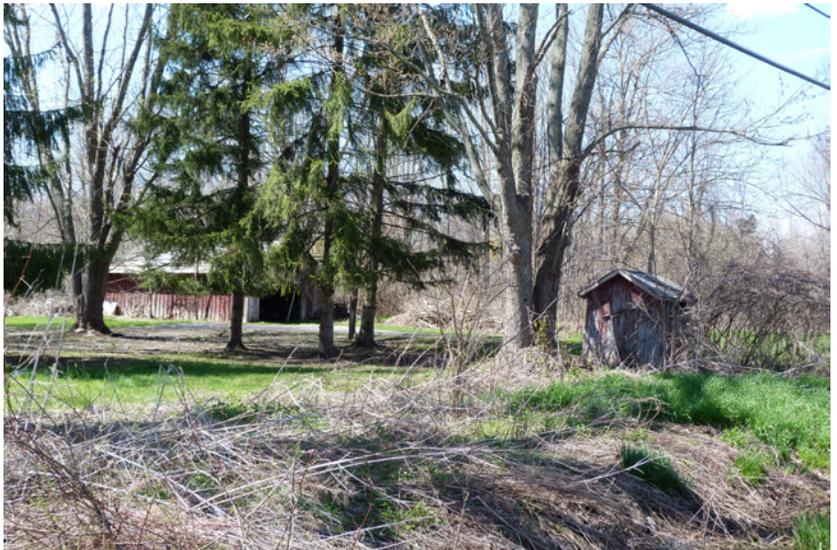
## 8235 Goodrich Rd.

Property includes a c. 1915 gable roofed English barn which has had its barn door replaced by a garage door, new windows installed in the front, and has been partially covered with board-and-batten siding. Adjacent house was constructed in the 1960s or 70s.
