**RECONNAISSANCE LEVEL SURVEY  
of Barns and Agricultural Structures**

Town of Clarence, New York

September 30, 2014

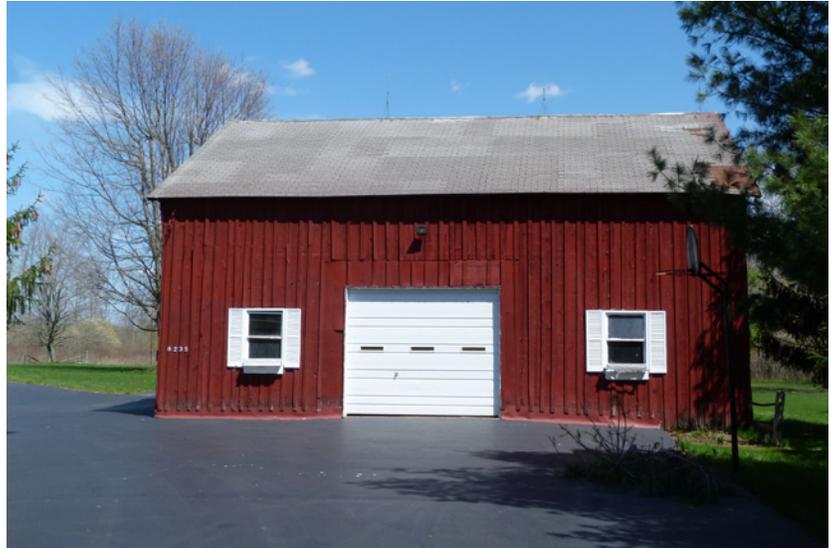
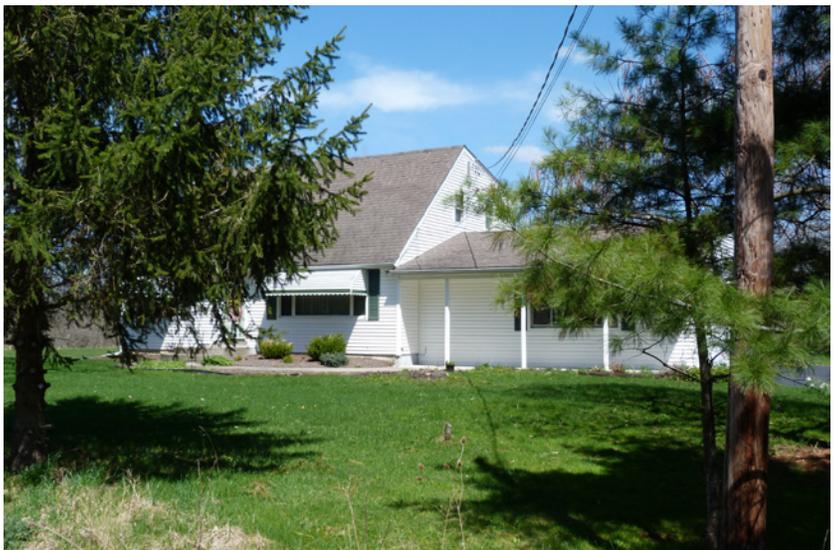
## 8310 Goodrich Rd.

Property includes a c. 1890 gable roofed English barn with vertical plank wood walls and metal roof. A smaller gable roofed addition is present on the north end of the barn. The barn has had its barn door and track removed and several garage doors and windows added.

Property contains several additional former agricultural structures including a corn crib, chicken coop, and privy. The c. 1890 farmhouse remains on the property and has been sided in vinyl but retains its wood windows.

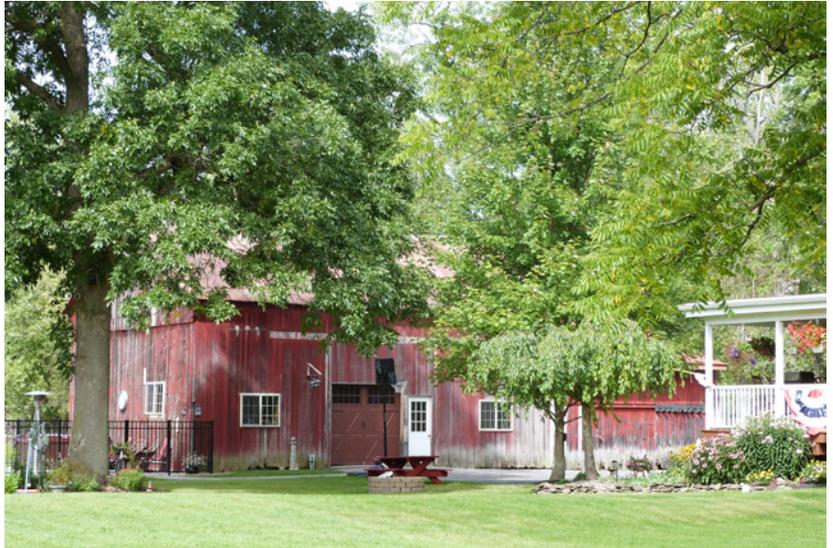
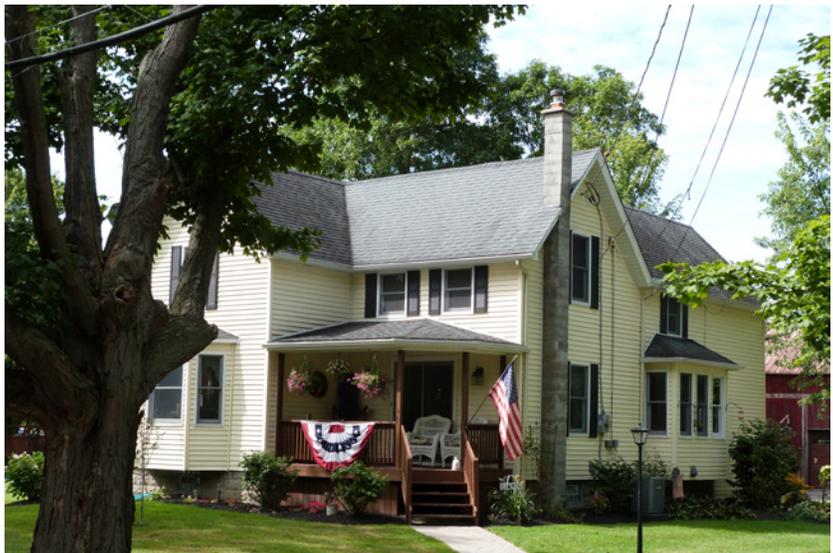
## 8440 Goodrich Rd.

Property includes a c. 1870s farmhouse and a three-bay English barn of similar age with a low pitched gable roof and horizontal plank siding. The sagging of the roof in the middle of the structural bays suggests late 19th-century heavy timber construction, so the barn was likely constructed at the same time as the farmhouse. The barn has been sided in plywood and a rolled roof has been installed. A plywood shed addition has been added to the end. An additional gable roofed structure sits in front of the barn, likely an a former agricultural structure, but its purpose is not known.

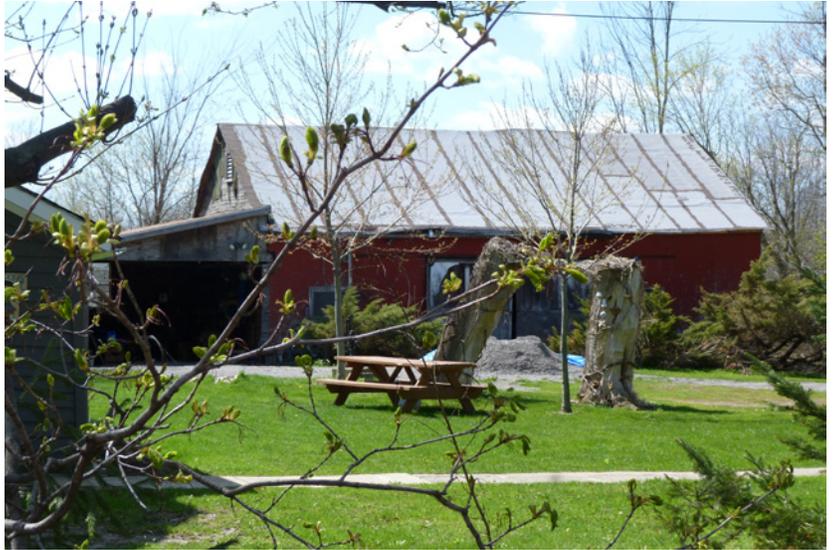
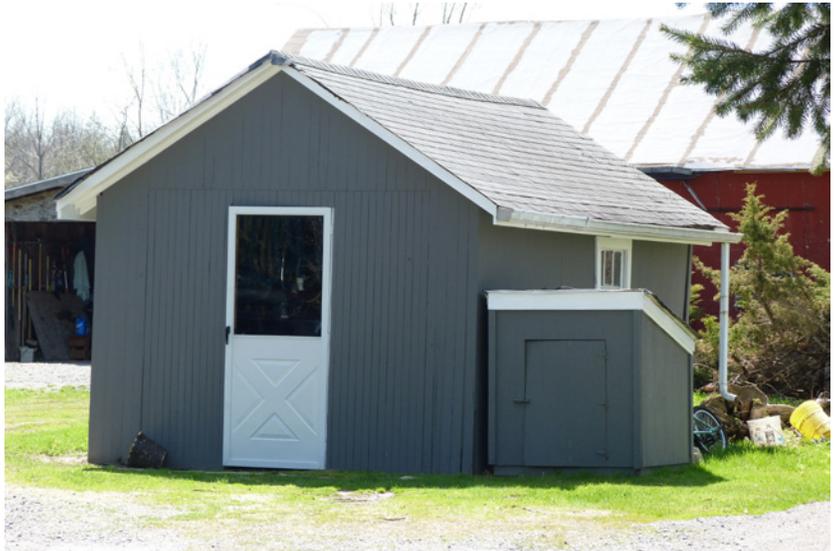
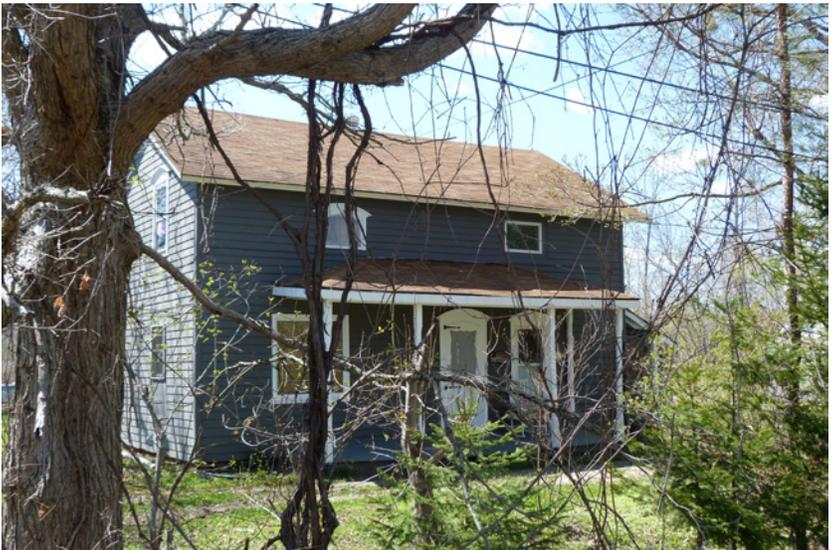
## 8660 Greiner Rd.

Property includes a c. 1950s Georgian-revival style home and a gambrel roofed storage building with brick and concrete block walls with wood infill on the upper portions of the gambrel ends and contemporary door. There is no indication that the gambrel roofed structure was adapted from an earlier barn.

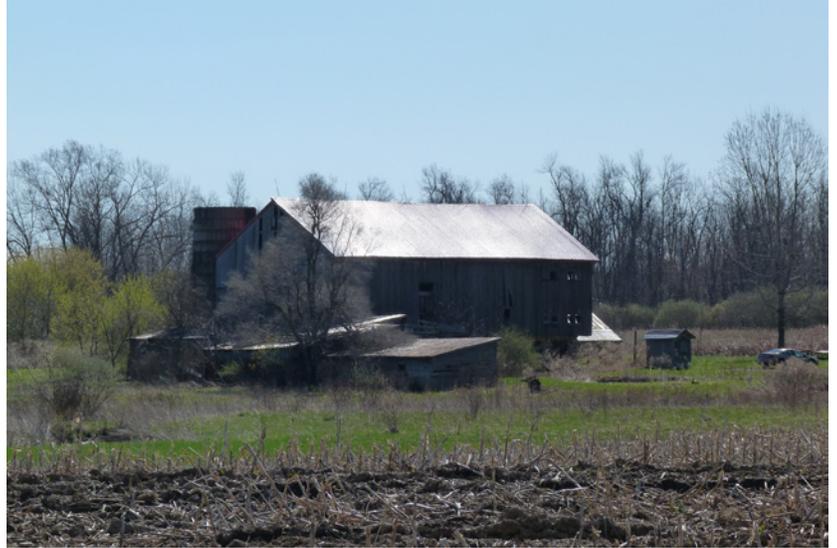
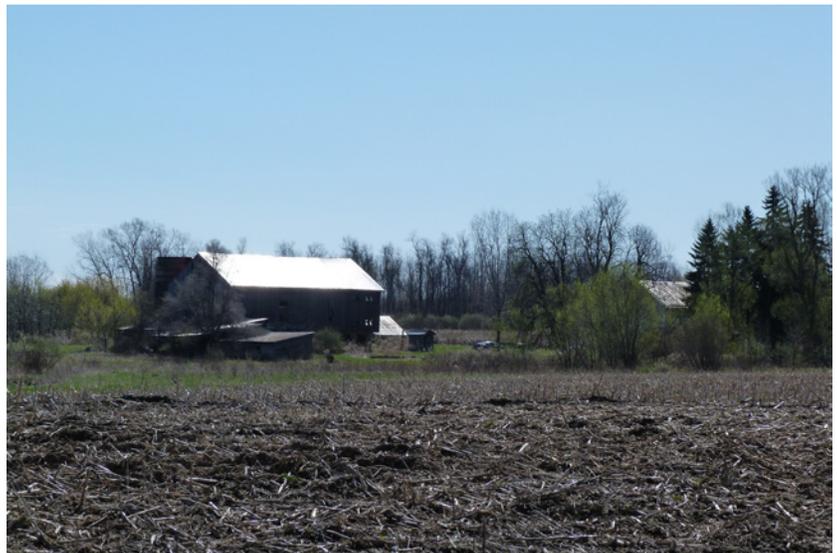
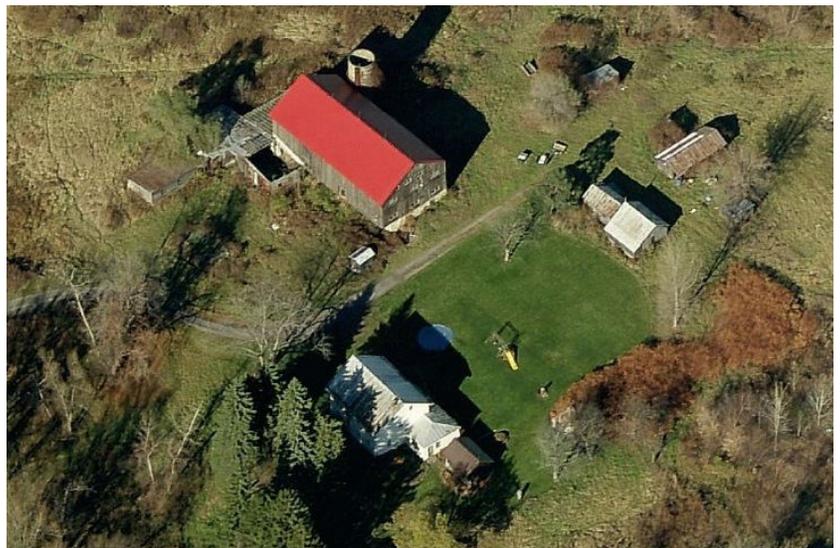
Structures on this property are set far back from Greiner Road and not easily visible from the public right-of-way. Photographs were taken from the nearest public right-of-way and supplemented with aerial imagery. This property is very significant from a historical perspective, as discussed below, but property access will be necessary in order to fully determine the level of integrity present.

Property is the Bishop Lapp Farm. John C. Lapp was a Mennonite preacher who came to Clarence in 1828 as part of the first wave of German-speaking immigrants after the War of 1812. This property includes one of the only four standing Pennsylvania Barns in Clarence. It also appears to contain a concrete block silo, chicken coop, farmhouse with massing suggesting 19th century construction, and other unidentified agricultural buildings.

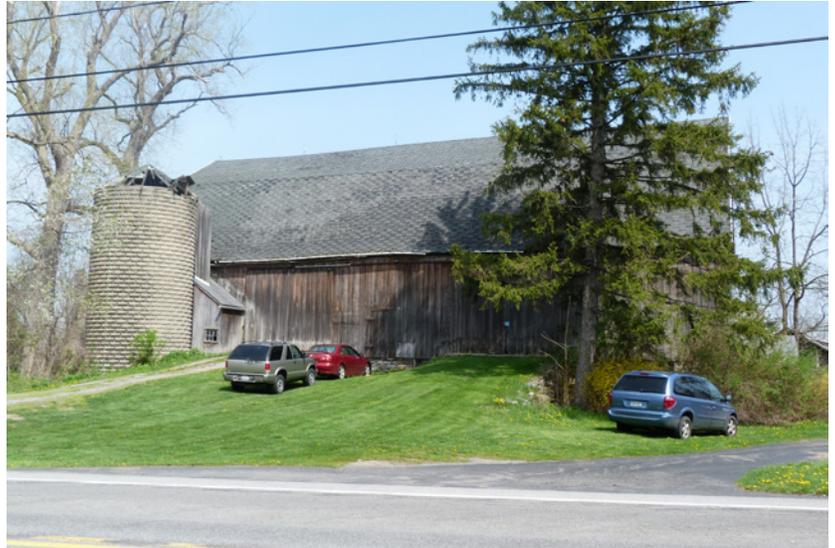
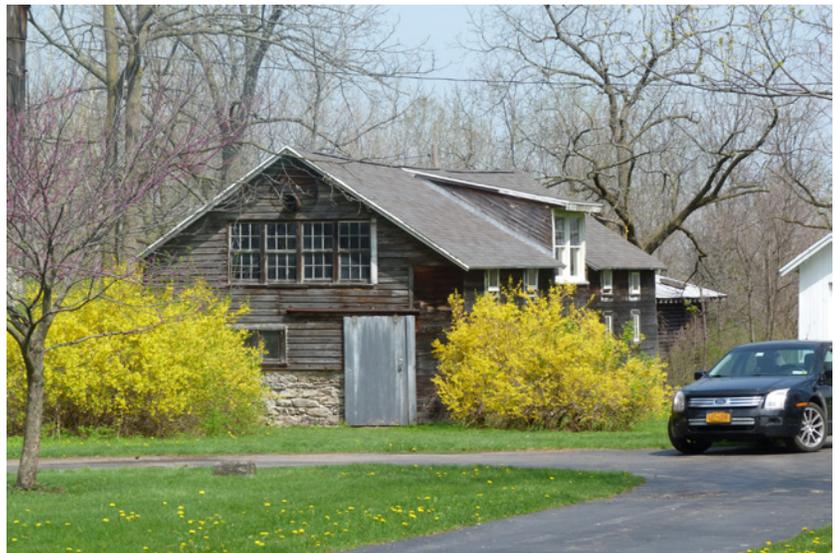
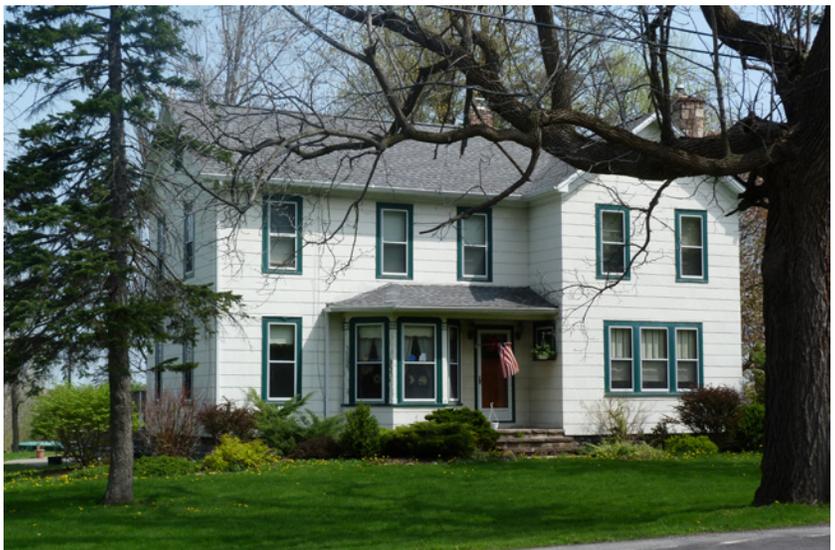
## 9700 Greiner Rd.

Property is the former Forest View Dairy Farm. The farm was founded and constructed by Paul Hoehmann around 1895 and specialized in dairy production but also had fruit orchards on its 141 acres. Durham, Holstein, and Jersey breeds of cattle were raised.

The property includes a very intact farm complex. The centerpiece is a gambrel roofed basement barn. The cattle were raised in the basement level, as evidenced by the concrete milk house that attaches at this level and the “bank” (grass ramp) leading up to the second level allowed hay to be brought into the barn directly on wagons. The silo, given its concrete block construction which would not have been available in the 1890s, is likely slightly newer than the barn. The silo roof is partially missing.

Descriptions of the barn note that it had several dairy related structures including a creamery, which was the likely function of the building shown in the center photograph. Note the stone foundation dating this building to early in the farm’s operation.

The property also contains a modest Queen Anne-style farmhouse, which has been sided in asbestos shingles. The first floor bay window appears in historic photographs. Adjacent to the farmhouse stands a contemporary frame garage.

The property has high historical significance and integrity, and is a rare example of a bank barn in the town of Clarence.

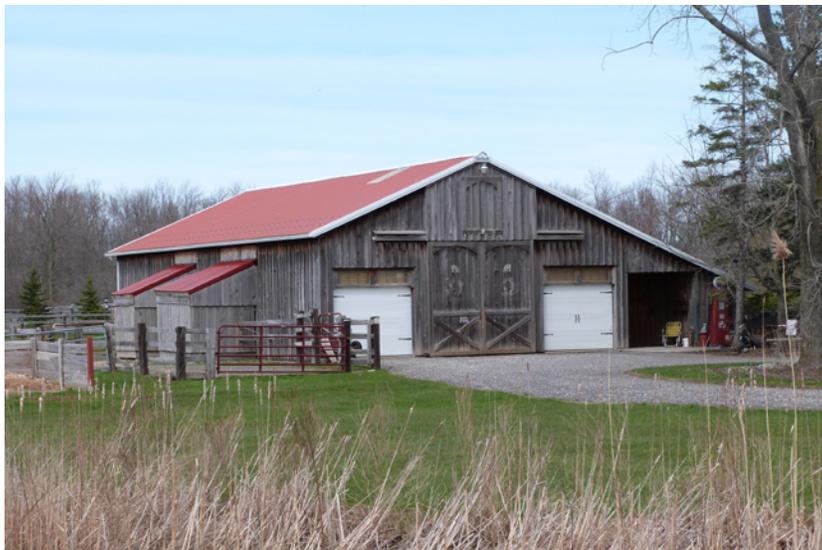
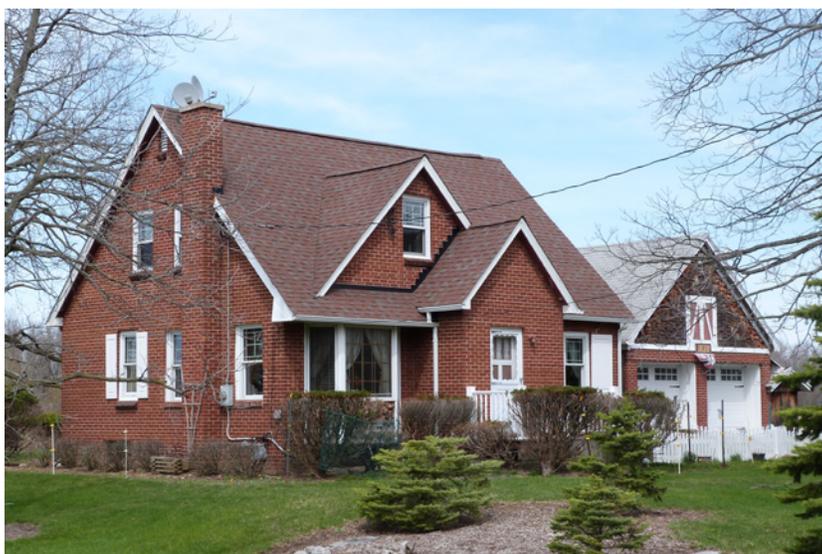
## 10370 Greiner Rd.

This property is a horse farm with 1949 home and contemporary pole barn with applied wood veneer and imitation barn doors on its exterior. The barn has a sign at its peak that reads "Stockade", which is a contemporary brand of pole barn.

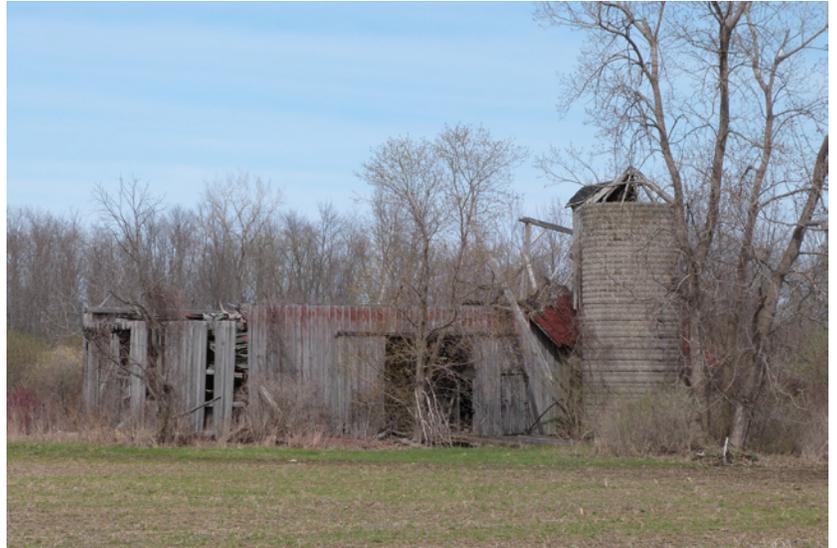
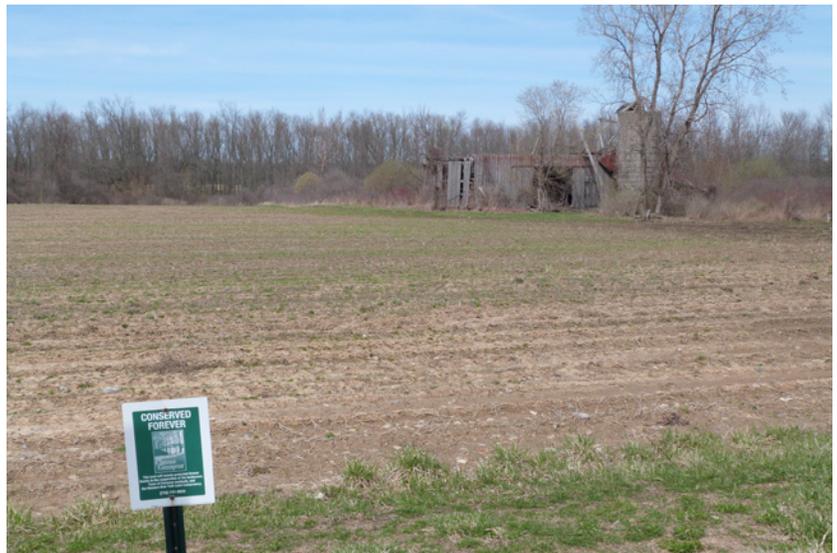
# 10460 Greiner Rd.

Property is owned by the Town of Clarence as part of the Greenprint land conservation program. Remnants of a barn and concrete block silo are present but largely collapsed.

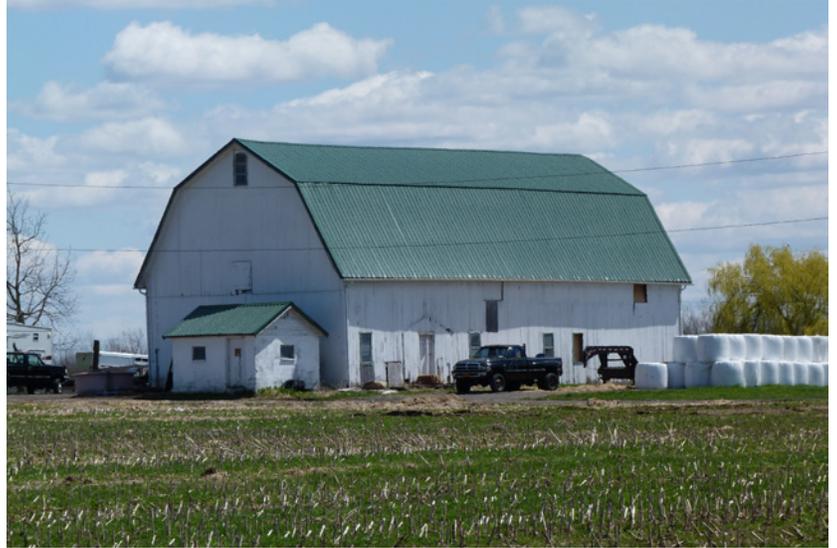
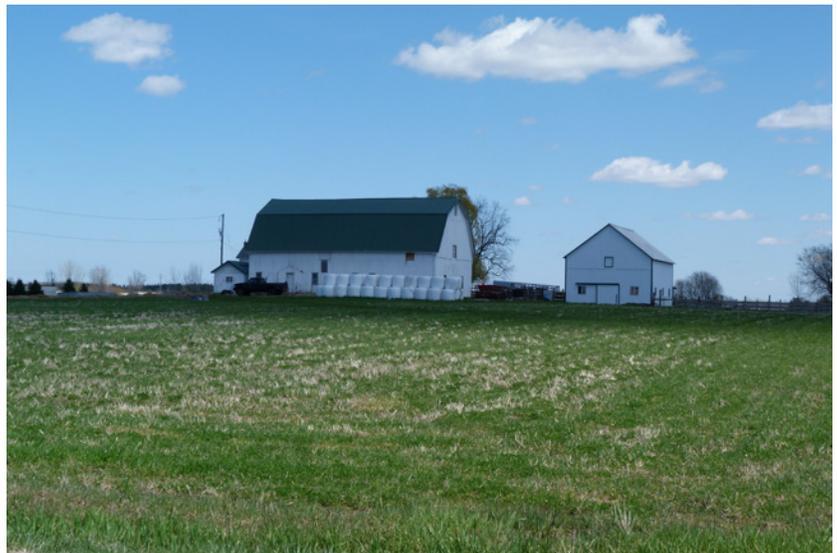
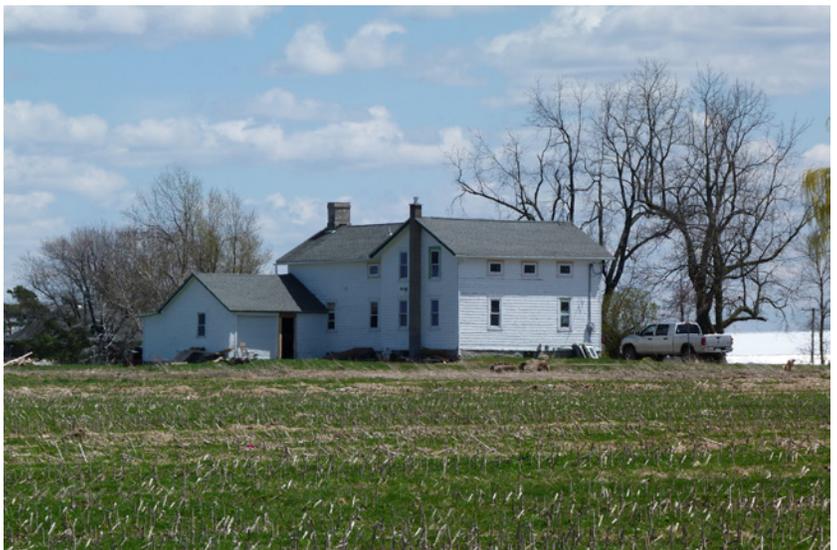
## 6725 Heise Rd.

Property is a former dairy farm complex, containing gambrel roofed barn, farmhouse, and contemporary pole barn. Additionally, a concrete milk house is present, nearly windowless and carefully set on the north side of the larger barn to keep it in shadow to keep the milk cool. The farmhouse appears to date from c. 1870 but the barn is significantly newer, likely c. 1910 or so. Note the ghost of an addition that has been removed from the side of the barn. Farmhouse has its original wood siding and window trim.

Property is a relatively intact farm complex retaining all of its principal buildings.

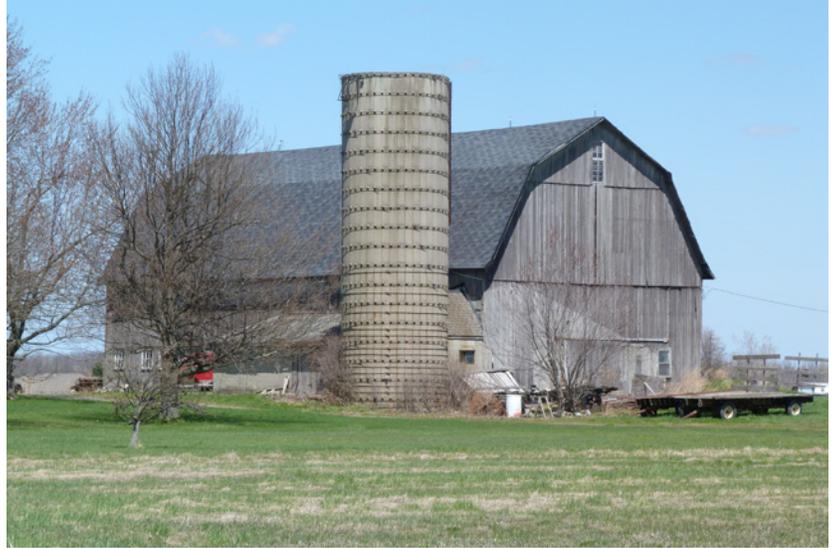
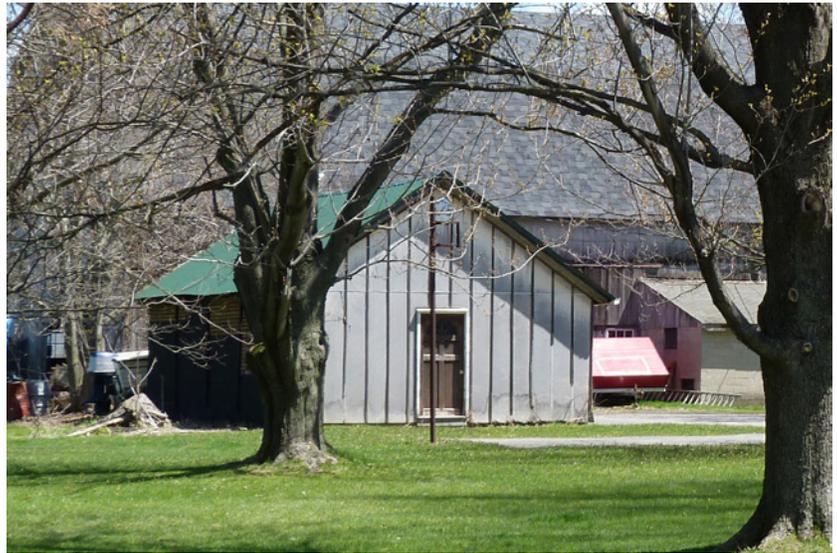
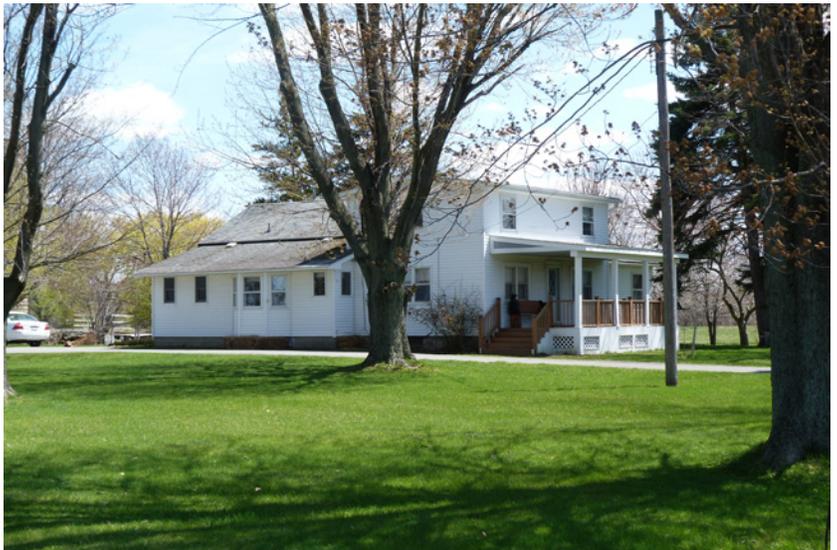
## 6995 Heise Rd.

Property is a former dairy farm complex. The centerpiece is a c. 1900 gambrel roof barn with wood windows and a concrete silo attached to the barn through a concrete block link. The property also contains a farmhouse that appears to likely be the original one on the property dating from the late 19th or early 20th century, based on its stone foundation, but has been modified so extensively as to be unrecognizable, and has been sided in vinyl. The photo in center is a former corn crib that has received extensive siding.

Property is a relatively intact farm complex retaining all of its principal buildings. However, extensive additions and modifications to the farmhouse and presence of non-historic siding on two of the structures diminishes the integrity of the property.

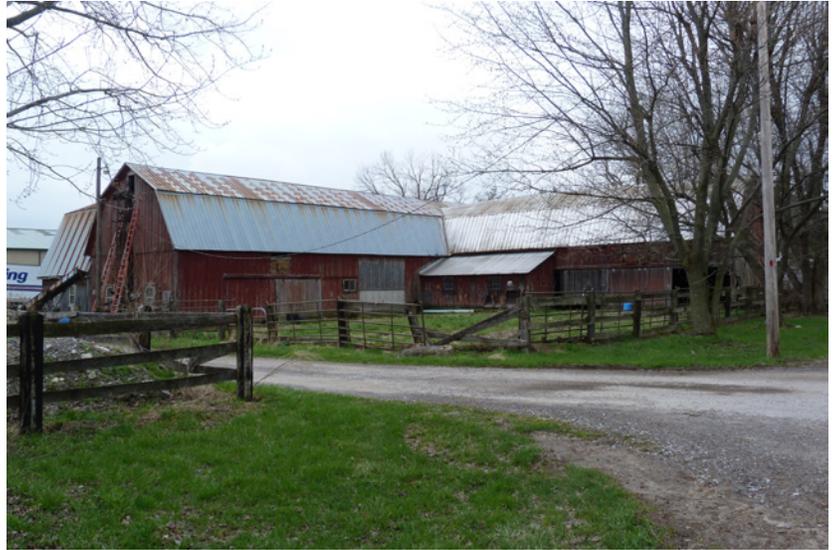
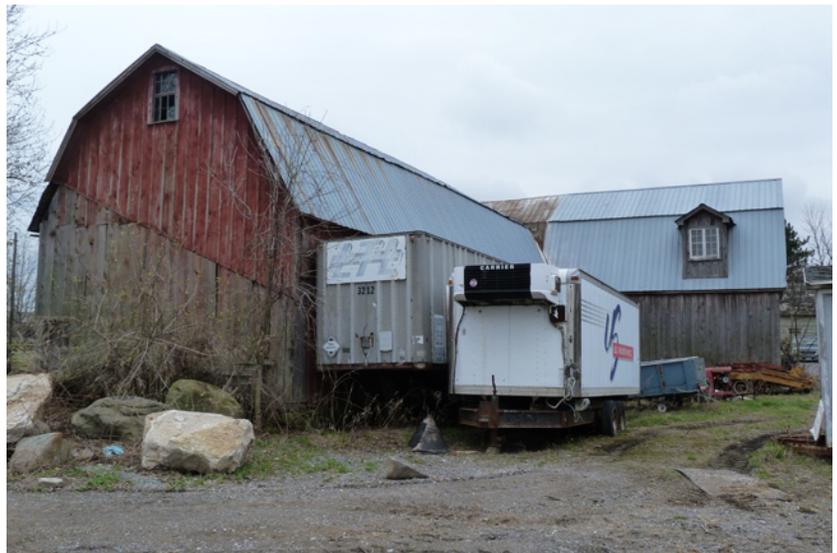
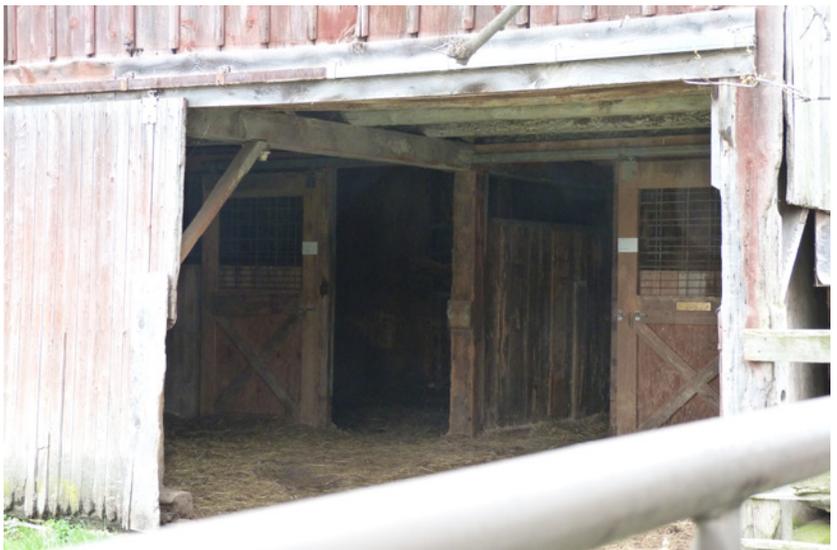
## 10807 Hunts Corners Rd.

Property is the former Maple Row Stock Farm and is currently a horse farm. The centerpiece is a c. 1900 heavy timber cross-gambrelled roof basement barn with wood windows. Barn has board-and-batten wood siding over vertical plank and metal roofs. Shed roofed structure at the knuckle of the two wings, perhaps a milking shed, appears to date to the original construction and also has wood windows. Two gambrel roofed additions have been added to the main barn at a more recent date. A ghost of a shed-roofed addition is evident at the end of one of the wing. Portions of former openings have been infilled with wood or concrete.

The property also contains a c. 1960s ranch-style farmhouse and a contemporary metal pole barn.

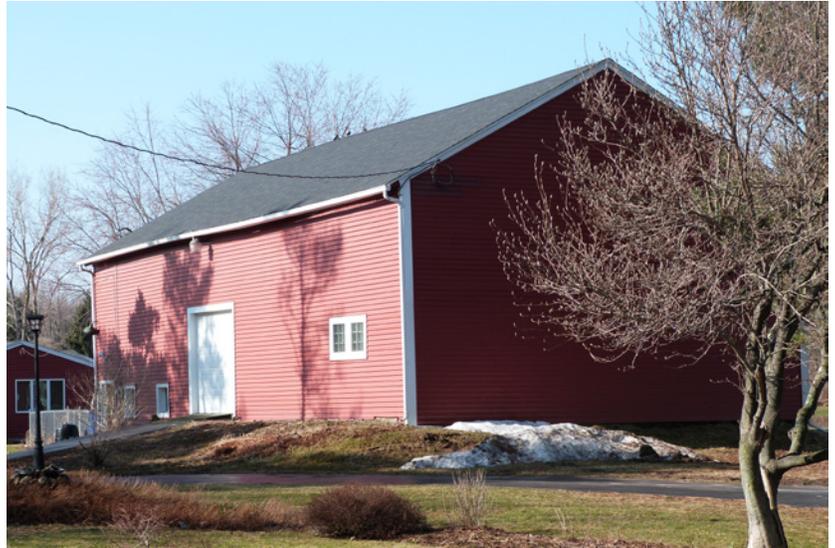
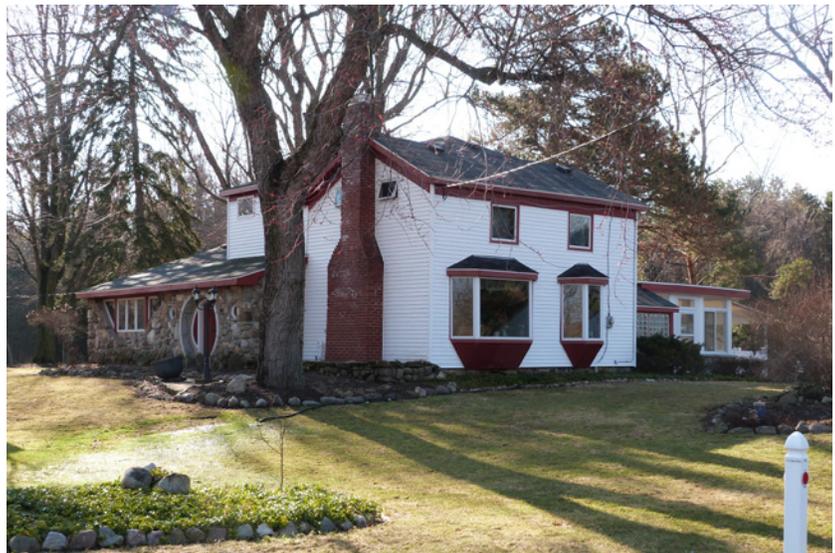
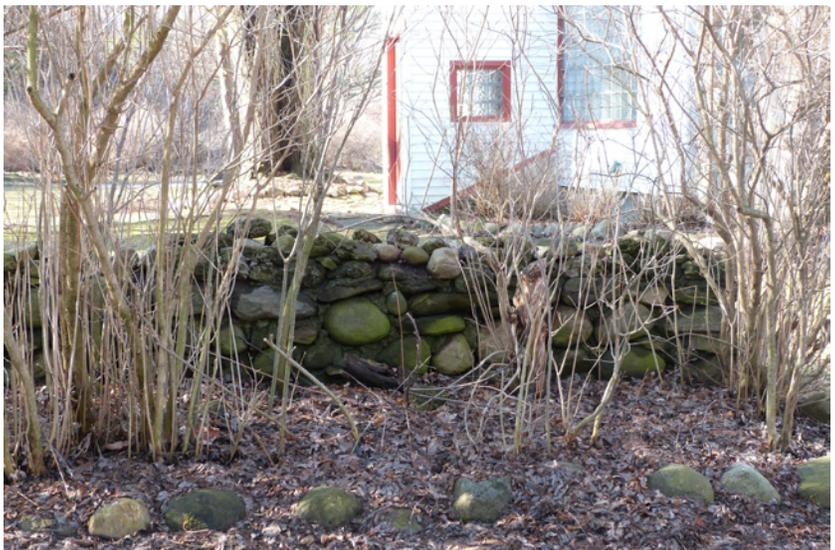
# 10915 Jones Rd.

The three-bay English barn has a stone foundation and has a modest bank leading to the garage door, which would have been the historic location of the barn door. A door to a slightly lower level is visible to the left of the bank, but this does not appear to be a “true” basement barn. A similar modest bank used to be present on the opposite side of the barn, but has been removed and the door infilled. The barn’s wood siding has been replaced and its windows infilled with glass block.

Based on its massing and stone foundation, the farmhouse appears to date to c. 1870, but has been vinyl sided and has received several major additions including a very exuberant 1960s entryway. The property also includes a 1960s two-car garage and a small contemporary storage shed at the rear. The remnants of a mortared stone wall constructed of round river rocks is visible along the street, a feature that was once common adjacent to old farms in Clarence.

The stone wall and unique split-level configuration of the barn are unique elements of this property.

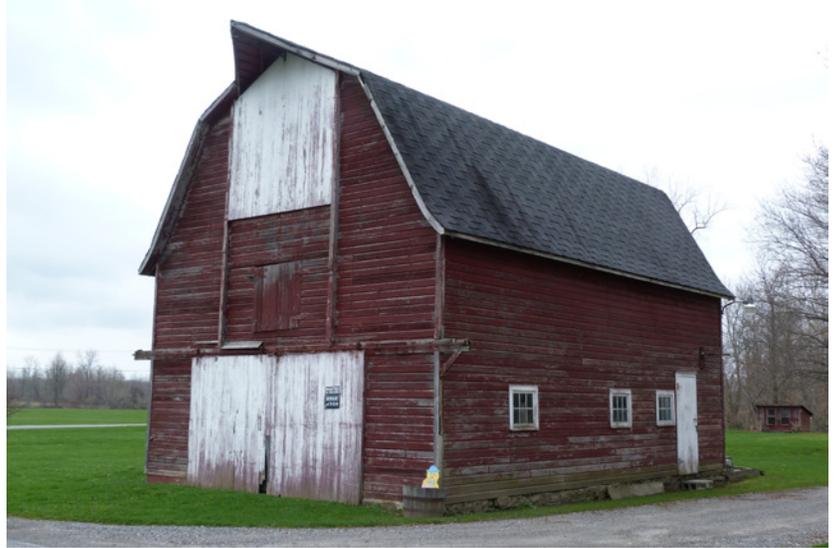
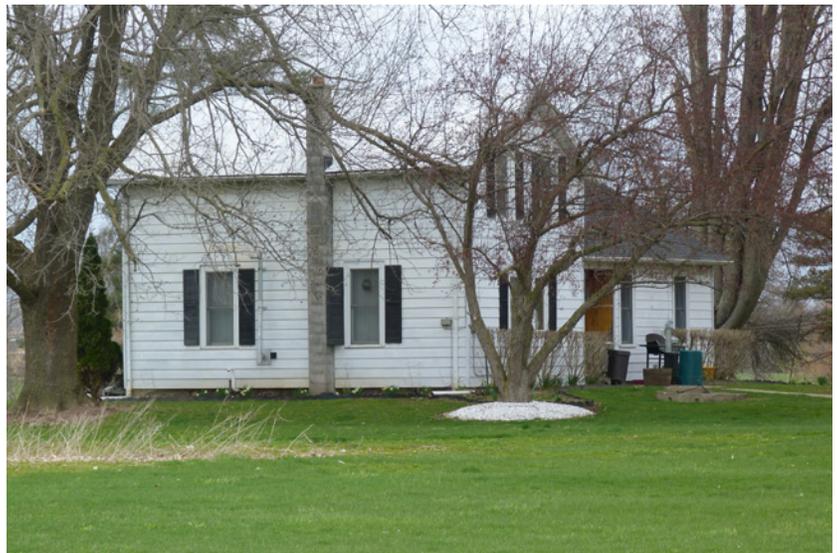
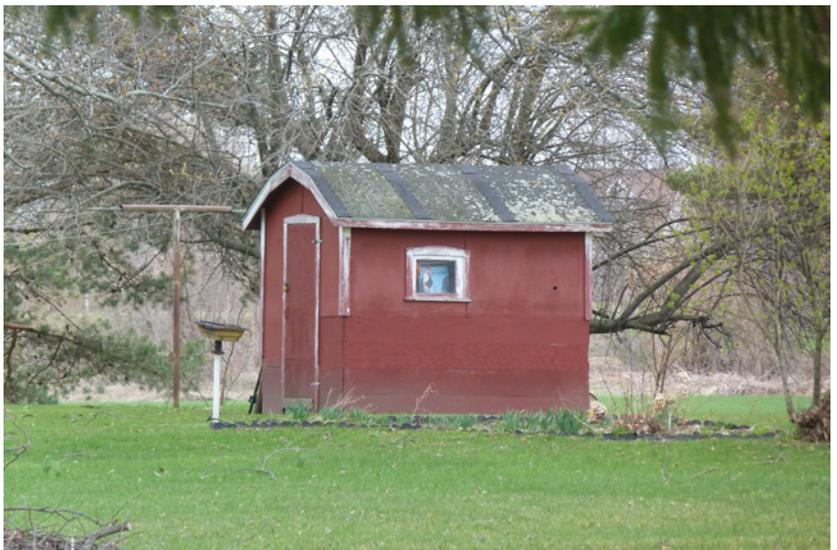
## 10870 Kelkenberg Rd.

Property is a modest early 20th century farm complex. The centerpiece is a small but very intact c. 1915 gambrel roofed basement barn featuring a hay hood over the front entry. Original wood windows and strapwork hinges remain. A chicken coop and small gambrel-roofed farm building of unknown purpose are also present. The farmhouse dates from the late 19th or early 20th centuries and has been aluminum sided. The one-story addition to the farmhouse may be a later addition.

Despite its small size, this farm complex retains all its principal buildings. The barn is a rare small-scale example of a basement barn in Clarence.

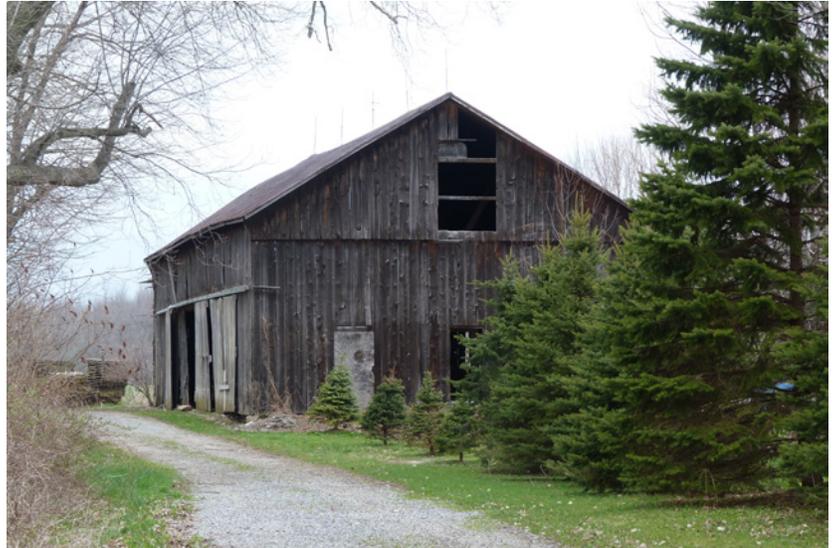
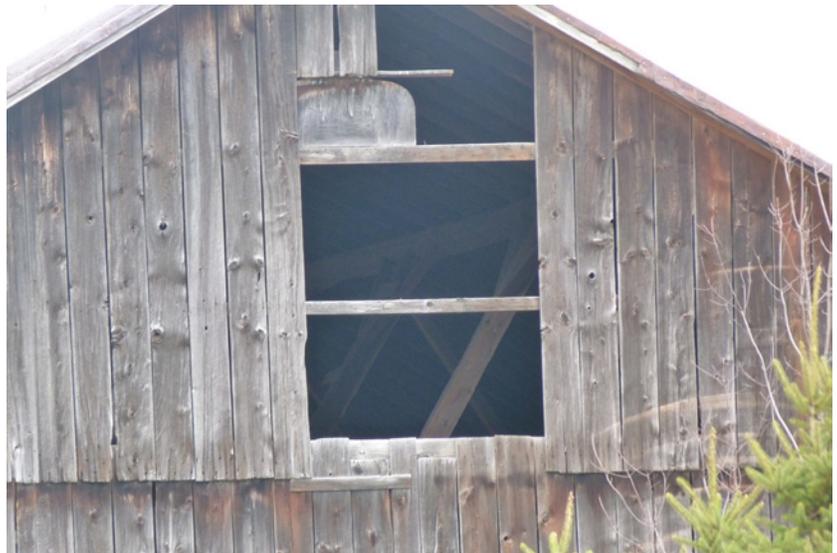
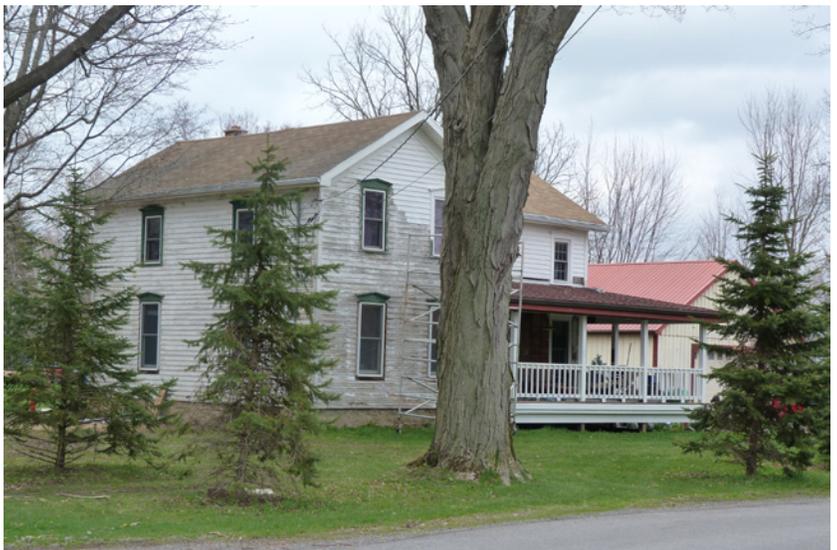
# 10920 Kelkenberg Rd.

The property is believed to have originally been built and inhabited by a branch of the Kelkenberg family, historically a very prominent farming family in Clarence and the family that the street is named after.

This farm complex has significance based both on its high integrity and historical association.

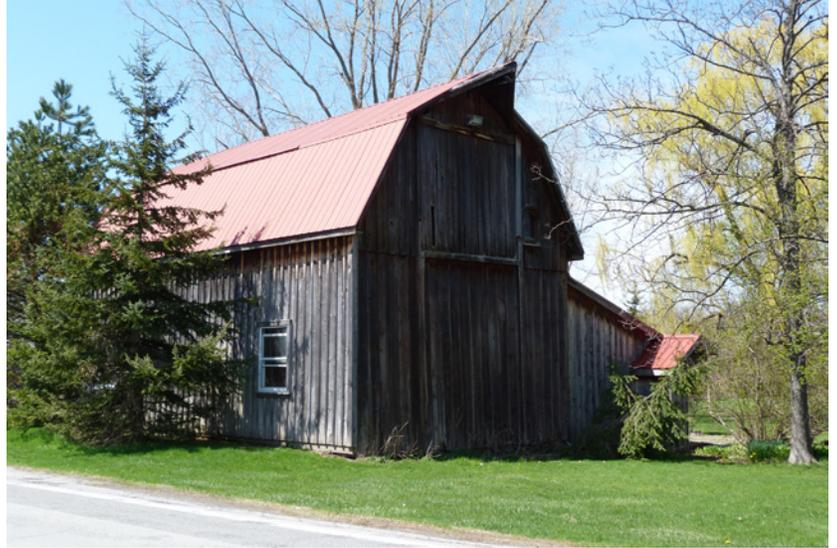
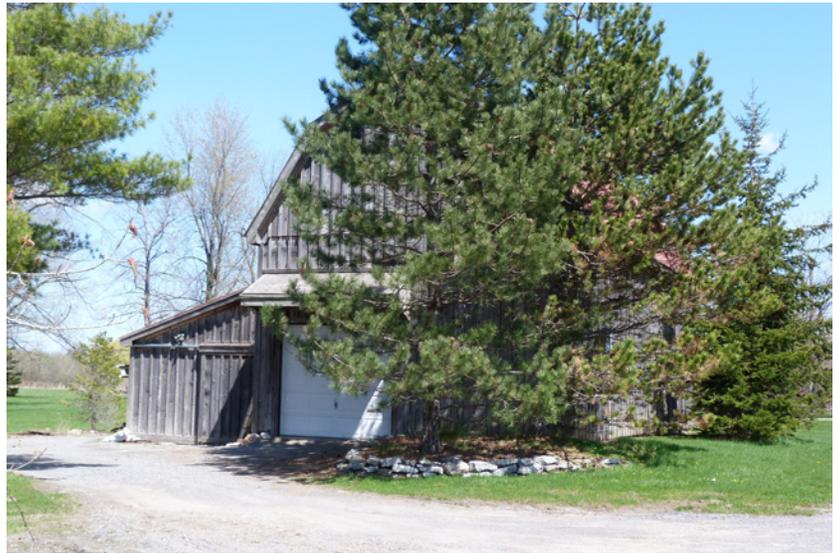
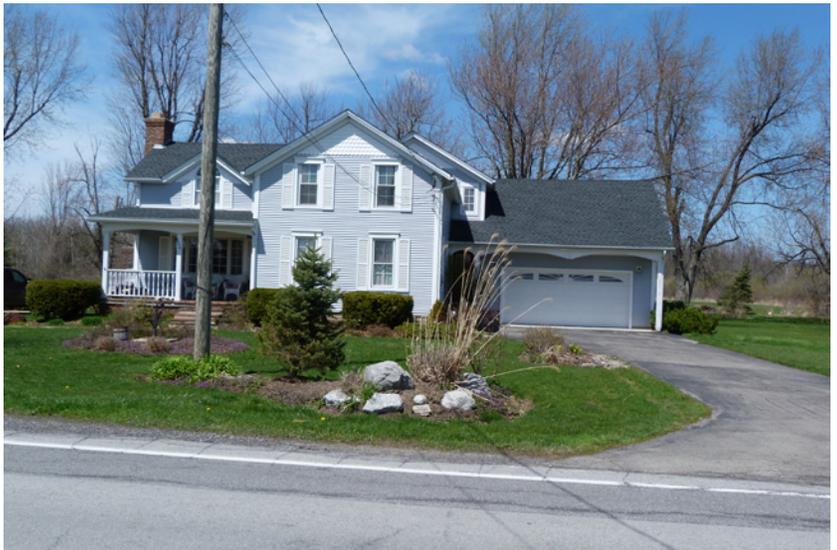
## 9854 Keller Rd.

Property includes a small gambrel roofed barn and a house. The barn is likely quite old, but has received board-and-batten siding, new windows and garage doors have been added, and an addition appears to have been constructed on the rear. Due to its many changes, the barn is difficult to date, but appears to be c. 1900. The two historical details remaining are the presence of the hay hood above the hay loft door and a small arched wood window next to the hay loft door.

The associated house appears to be recently constructed, c. 2000 or later. The central portion of the massing is somewhat reminiscent of older farmhouses in Clarence, but even the foundation has been sided such that it is impossible to tell for sure. If it is the original farmhouse, it has been altered beyond recognition.

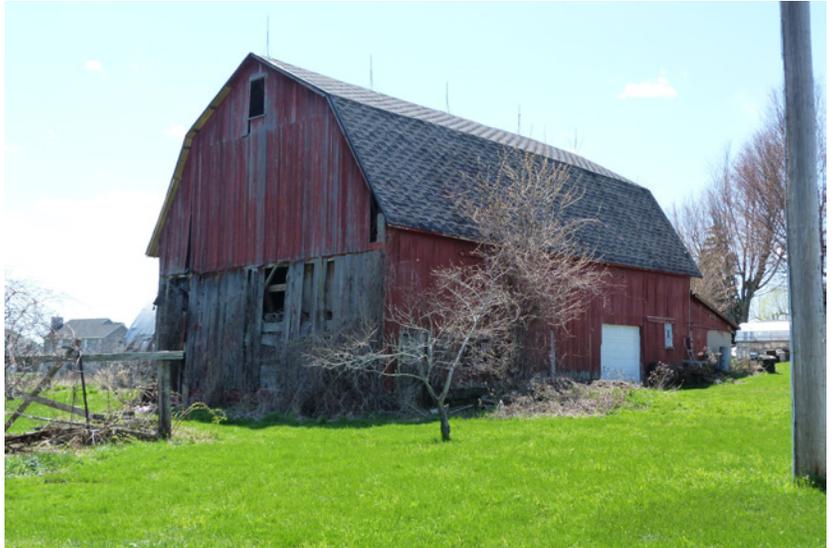
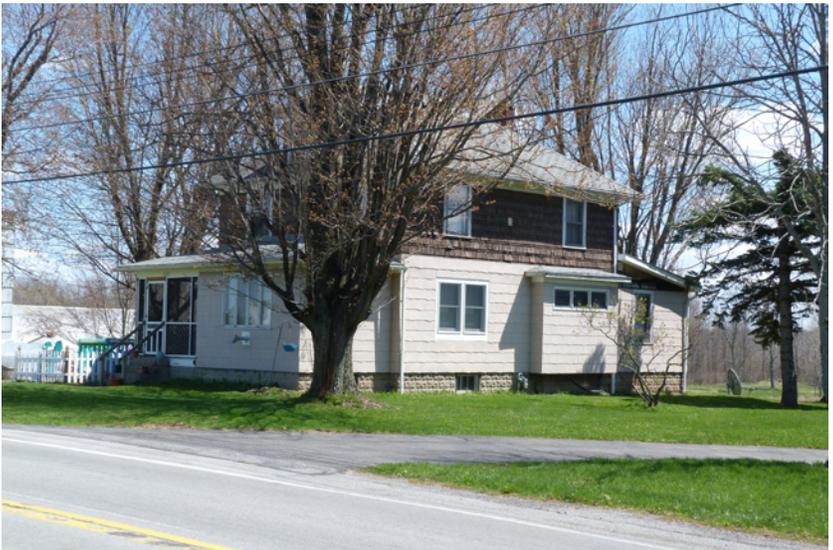
# 10285 Keller Rd.

The barn appears to a “basement” barn and is sided in vertical wood plank with an asphalt shingle roof. A concrete block milking shed is attached, which interlocks with a silo constructed of metal panels. Several windows are missing from the side of the barn at the first floor level.

The farmhouse has received a small addition on the rear. Its front porch has been enclosed and modifications have been made to the fenestration of the room adjacent to the porch.

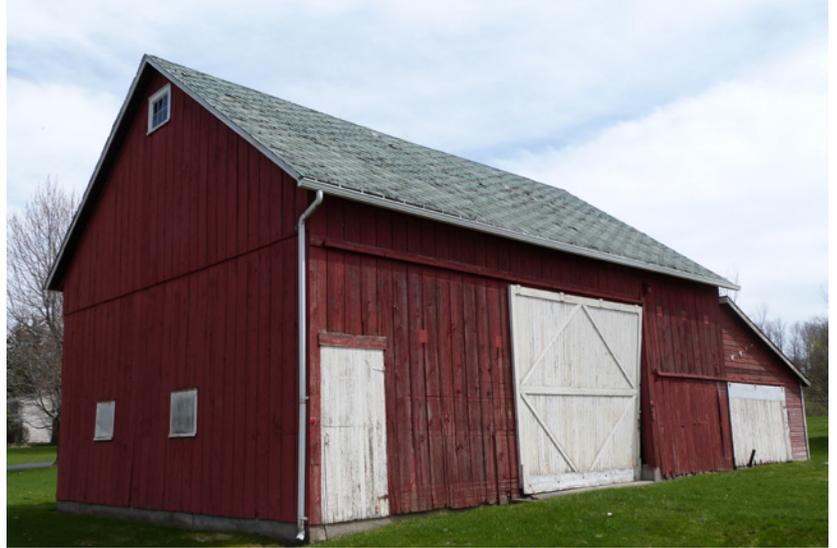
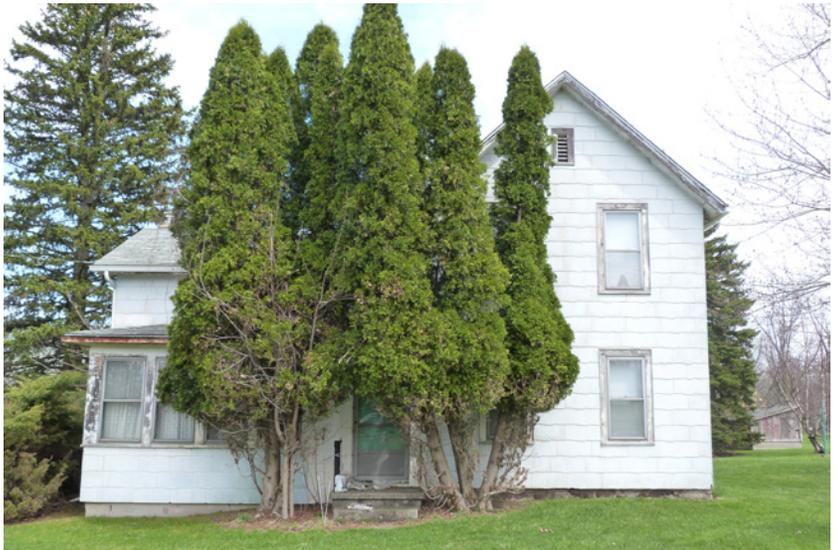
## 5201 Kraus Rd.

The barn likely dates to the same period as the house, c. 1860. It has a parged stone foundation, walls of widely-spaced vertical wood plank (two layers visible in some locations), and an asphalt shingle roof. A likely original wood window remains in the gable peak nearest the road. A wood milking shed is attached to the opposite gable end. The smaller doors retain their strapwork hinges. The property also contains a chicken coop, which has been moved to a new a concrete block foundation fairly recently.

Despite its small size, this barn complex has relatively high integrity and retains all of its original components.
