**RECONNAISSANCE LEVEL SURVEY  
of Barns and Agricultural Structures**

Town of Clarence, New York

September 30, 2014

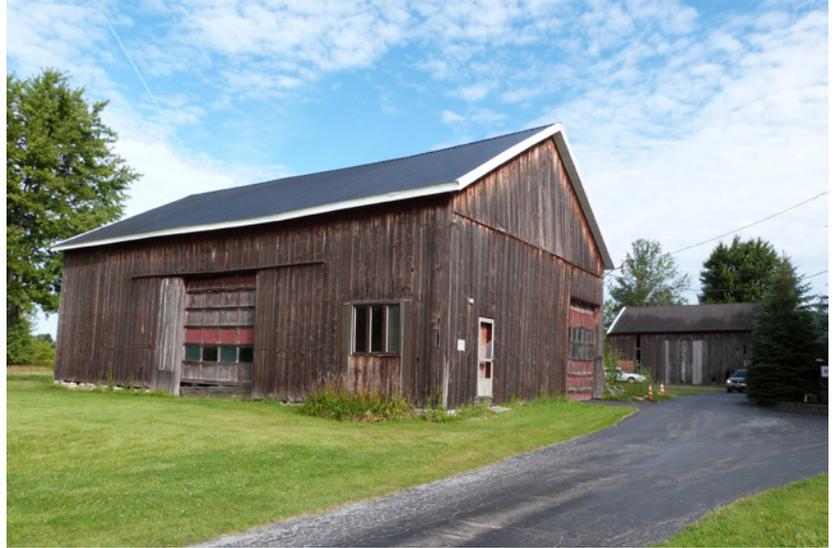
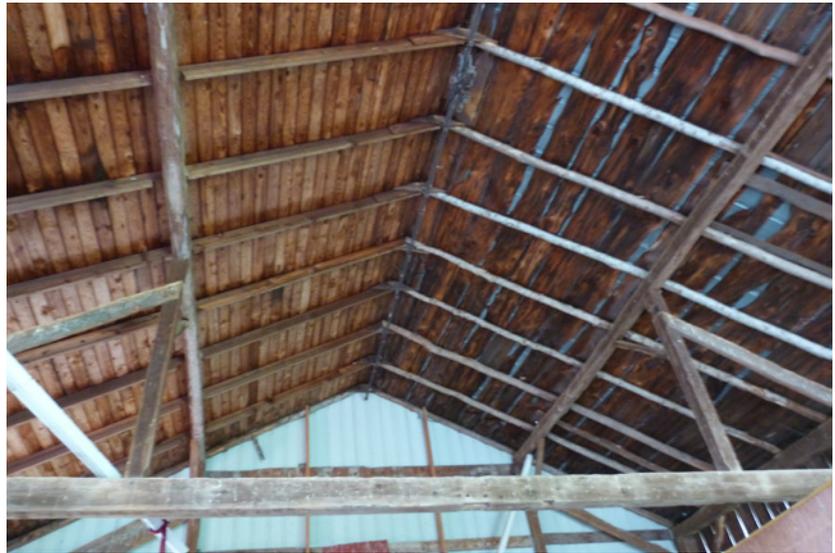
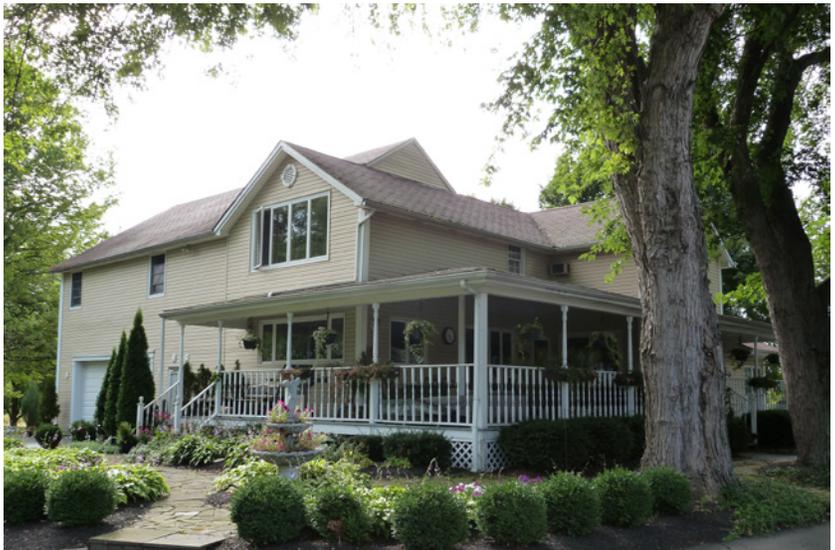
## 8750 Lapp Rd.

The farm was owned by Jacob Eshelman, likely one of several owned by this powerful family that ran the Square Deal store at the four corners in Clarence Center. Given their prominence, this farm was probably farmed by employees of the Eshelmans, not the family themselves.

The farmhouse is original to the complex, dating from c. 1860s, but has been substantially modified. The unique structural elements and craftsmanship of the barns and the complex's historical association with the Eshelmans lends this property significance.

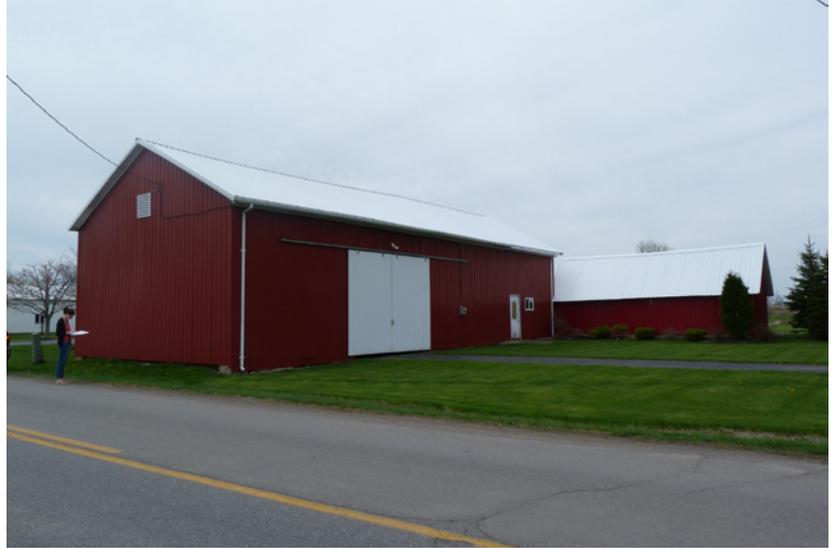
## 8894 Lapp Rd.

Property contains two barns. The rear barn with the wide overhanging roof has a stone foundation, which suggests that it dates from the 19th century but it has been covered with metal such that any historic details are no longer visible. The barn closest to the road appears to be a contemporary pole barn. The house on the property was constructed in the 1980s.

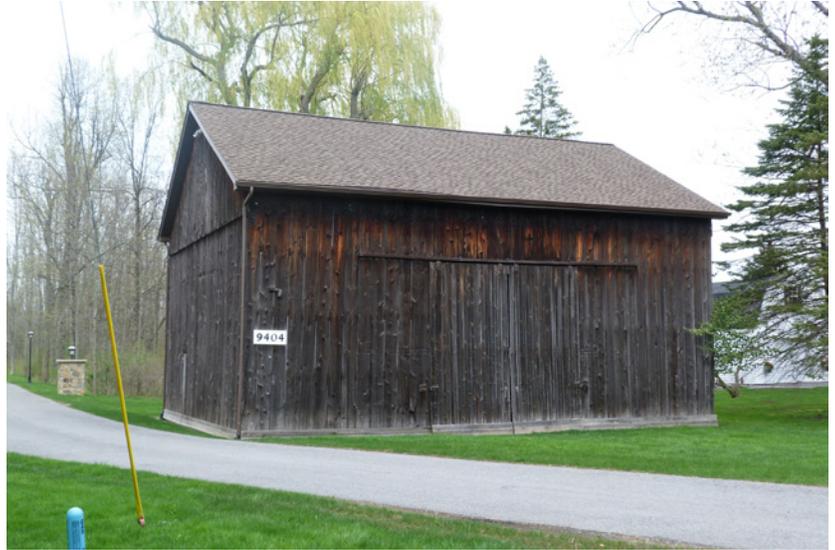
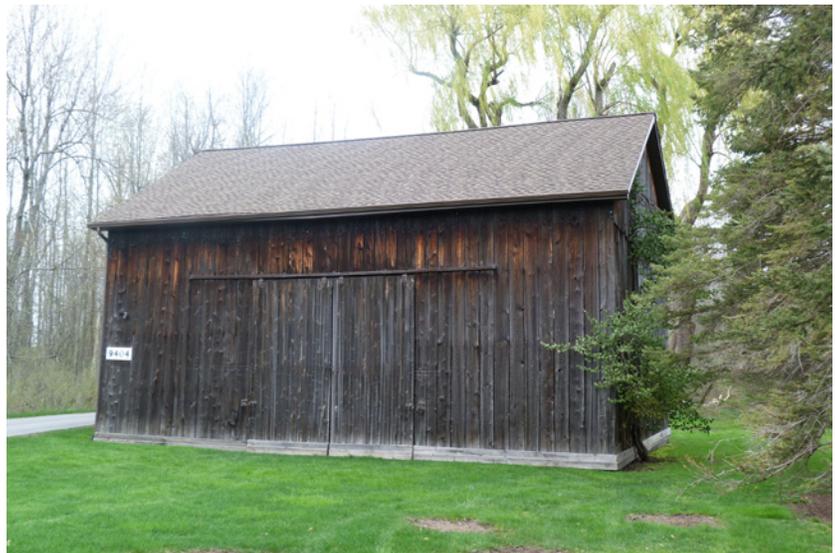
Property contains a contemporary home set far back from the road. Near the entrance to the driveway, a three-bay English barn is present, in very good condition. Walls are vertical wood plank and roof is asphalt shingle. The date of construction is unknown but similar examples in Clarence are typically c. 1875.

While this barn has been carefully restored, it lacks any context as to the farm it was once part of. For this reason, the property lacks historic integrity.

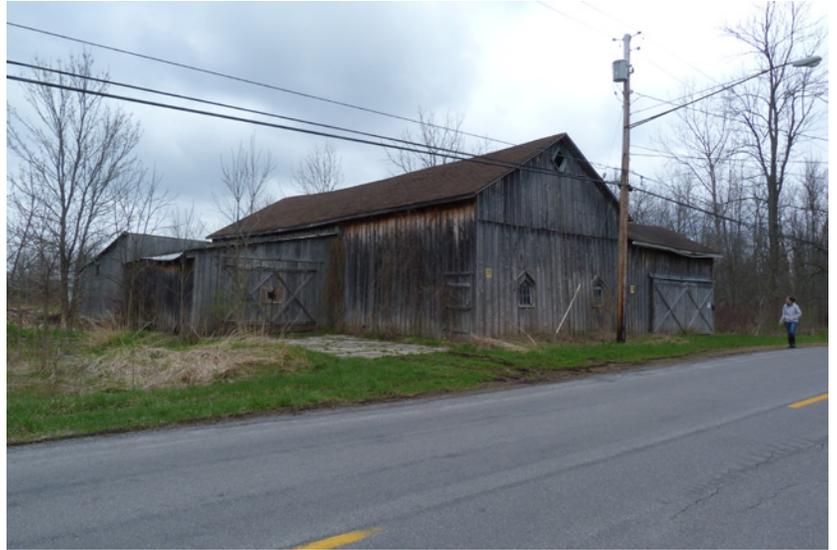
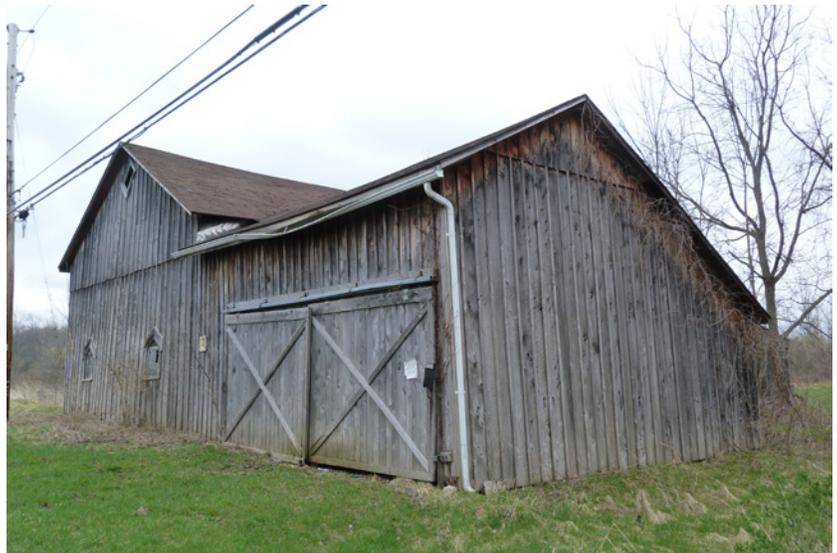
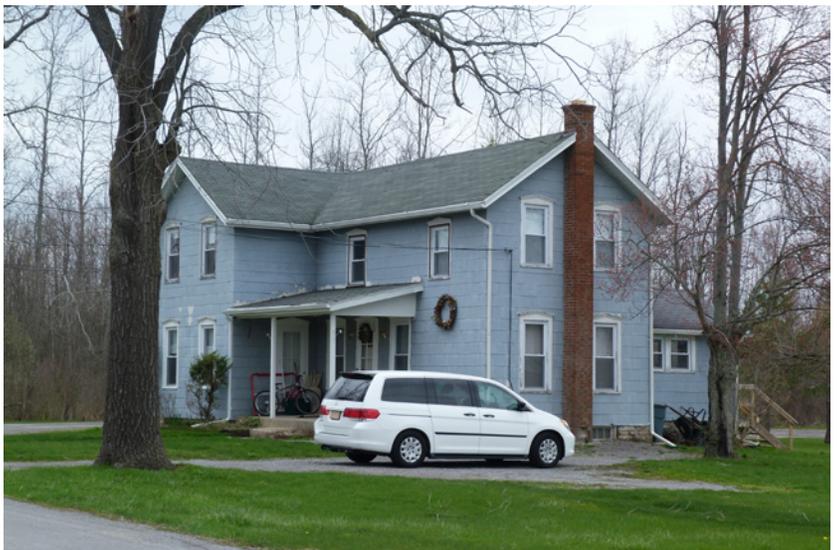
## 9785 Lapp Rd.

Property includes a barn and a contemporary house (constructed c. 2000s) set back far into the property. Barn is made up of a central gable roofed bar oriented north-south with two shed additions on the east and one salt box gabled addition on the west. Walls are vertical wood plank, with batten strips applied between the planks on some portions of some facades. A diamond-shaped martin hole is present at the top of front gable. Barn doors are either hinged or sliding, depending on the location, and have X's made of wood. Man door on side of main wing has strapwork hinges. Two wood windows on the front facade have chevron peaks above. The date of construction is unknown but is likely pre-1900.

It is likely that the c. 1870 house directly across the street (bottom photo) was originally associated with this barn, though it is now part of a different parcel (9780 Lapp) which does not contain any other older buildings. The farmhouse appears to be intact and retain its original wood windows, though it has been sided with asbestos siding.

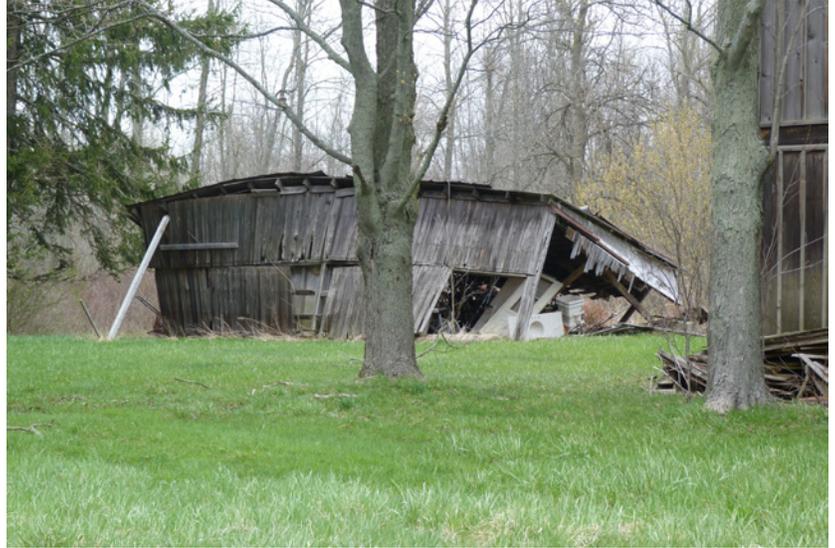
# 10280 Lapp Rd.

Property includes a collapsed barn at the rear of the property. The central rectangular portion of the house on the property has a stone foundation, dating it to construction pre-1900 but additions to the side and rear are much newer. The two-story garage is recently constructed. Both house and garage have been sided in contemporary board-and-batten siding.

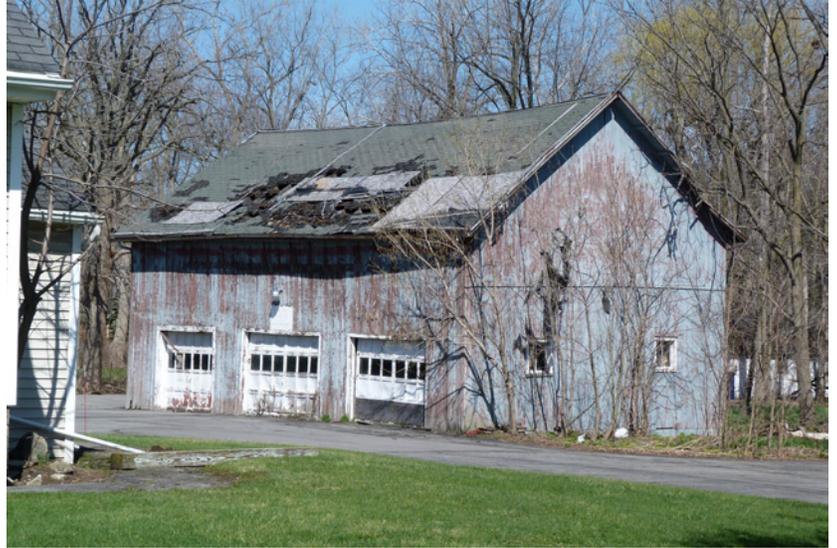
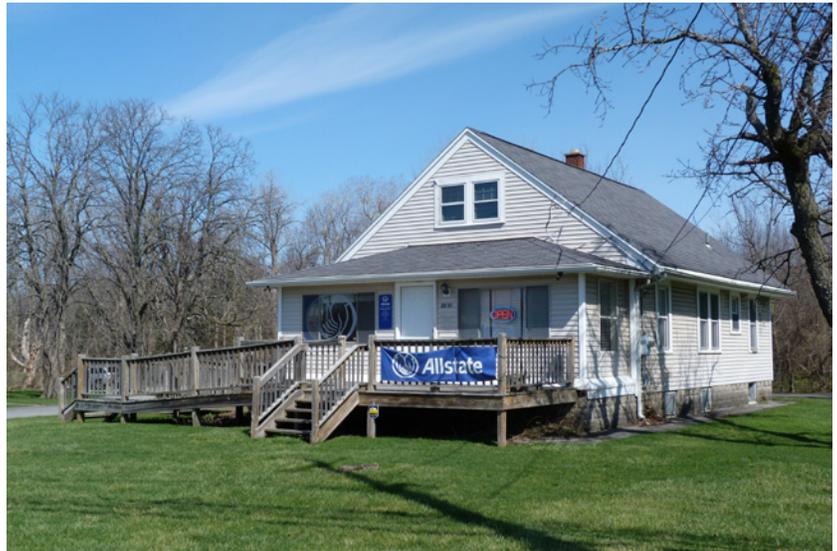
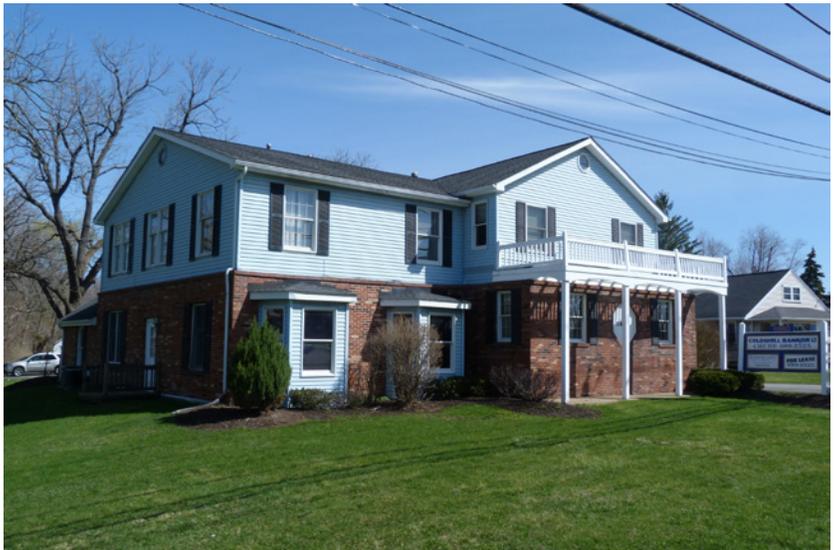
## 8860 Main St.

Property includes a large gable roofed barn at the rear that has been converted into a three-bay garage, which may suggest the interior framing was for a three-bay barn. Foundation is concrete, which suggests barn may have been relocated in the past. Walls are vertical wood plank and roof is asphalt shingle with severely deteriorated portions where the rafters are exposed. The former location of barn doors is not evident. The date of the barn's construction is not known, but its massing and size would suggest c. 1880-1900.

Property also includes two houses and a small wood garage. The small bungalow at the east side of the lot (center photo) appears to be the older of the two. Its concrete block foundation suggests it was built c. 1910. The house at the west side of the lot (bottom photo) appears to be contemporary construction, perhaps c. 1990. Both houses are currently in use as offices.

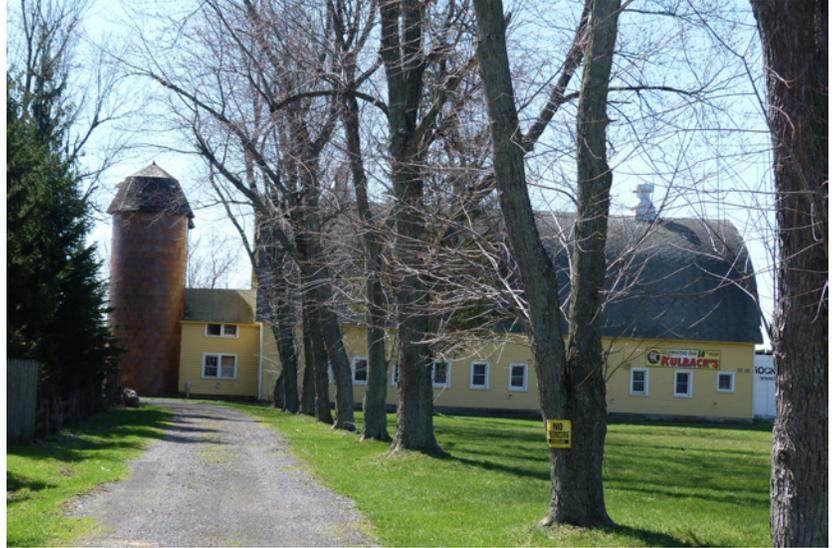
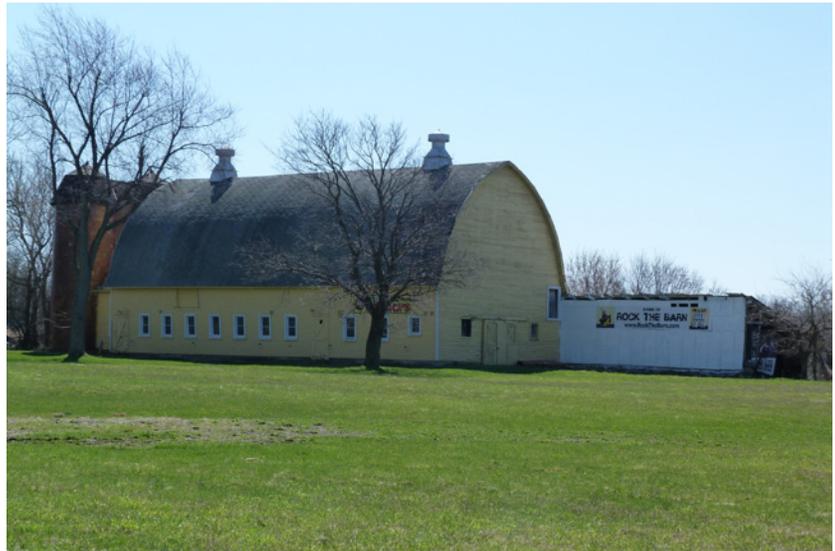
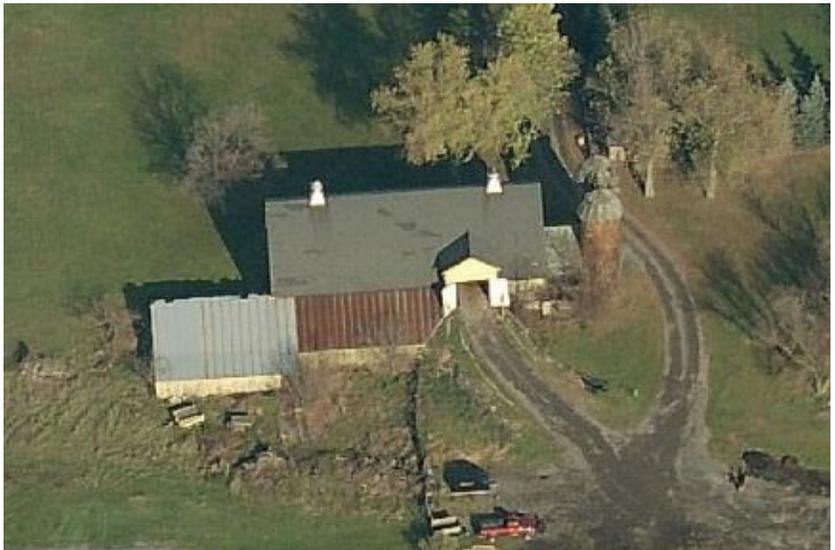
## 9015 Main St.

Property includes a large “basement” bank barn with a rainbow-arched roof and wood granary leading to two attached clay tile silos with wood shingle roofs. The barn has wood sliding barn doors with X-braced wood pattern. Existing hay door remains on the leading into the hay loft. Some of the windows are 6/6 wood but some on the first floor may have been replaced with vinyl. The front and sides are faced with horizontal wood clapboards, which may not be original. The rear side, which could not be accessed, has a raised earth berm with gable entry and hinged doors leading into the hay loft level (see bottom photo, from Bing Maps). Based on its limestone foundation\*, the use of the rainbow-arched roof, relatively “sophisticated” door and window styles, and the presence of metal ventilators, this barn appears to have been constructed c. 1900.

A small building attached to the gable end was likely originally a chicken coop. It has a stone foundation and metal shed roof.

\*It is difficult to tell from the public right-of-way where pictures were taken from, but the foundation appears to be limestone. If true, that would make sense because the remnants of the foundation of a limekiln that was formerly part of this farm are present behind the adjacent strip mall. (Limekilns were kilns for burning limestone.)

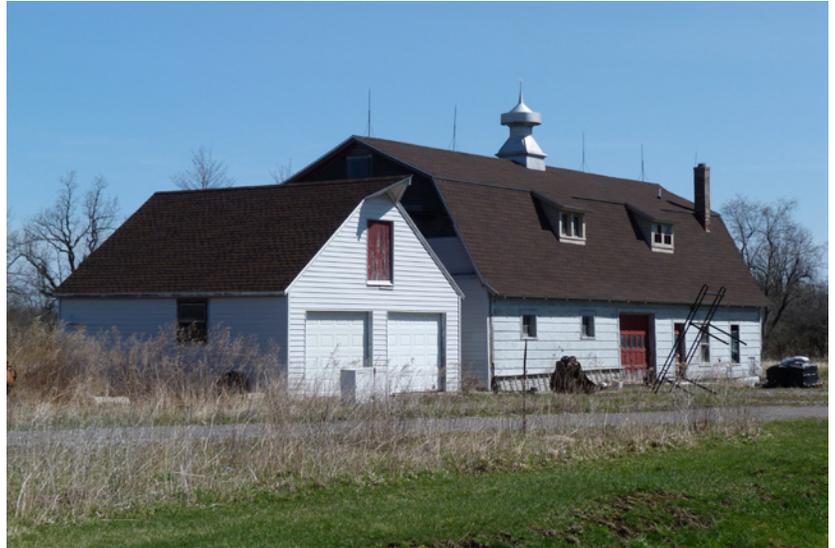
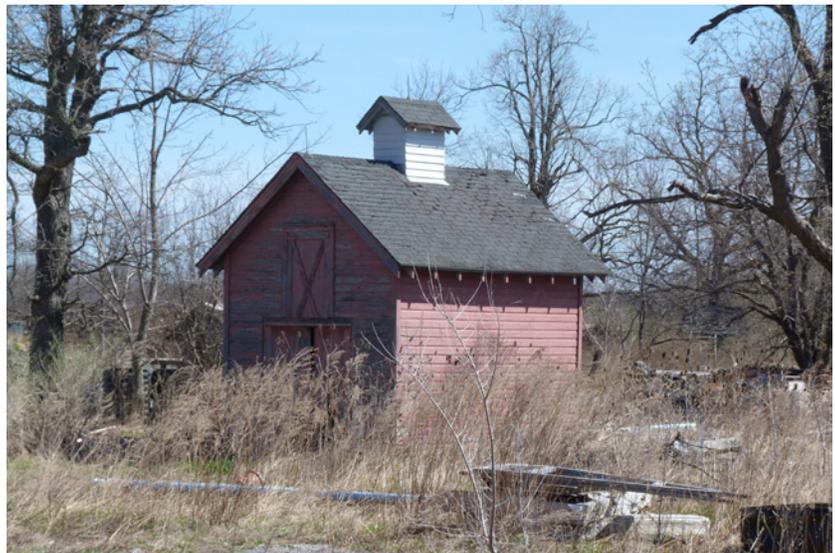
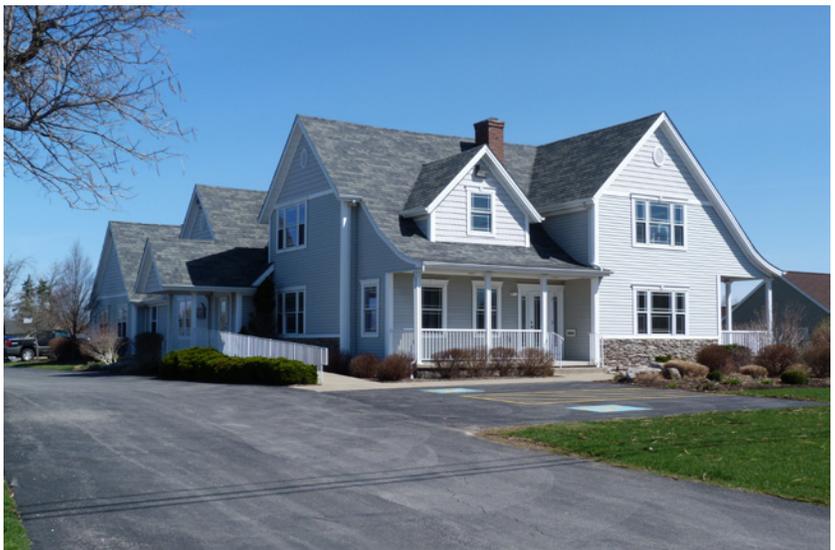
## 9300 Main St.

The main barn has horizontal wood clapboard siding, two dormers in its shingled gambrel roof, brick chimney, and a metal ventilator. Original wood windows remain in most openings. A garage door has been inserted into the exterior wall and the barn doors are no longer present. Portions of the exterior have been clad in permastone, and large portions of the siding elevation on the rear are missing. The barn likely dates to c. 1900.

The farmhouse has been significantly altered and received an addition to its rear that is larger than the original house. The original form and massing of the house is barely perceptible and nearly all historic materials such as windows and wood siding have been completely replaced or covered. Due to alterations, the age of the house cannot be determined. Remnants of a dry-laid stone wall along Main Street are present, once common features of farms in Clarence.

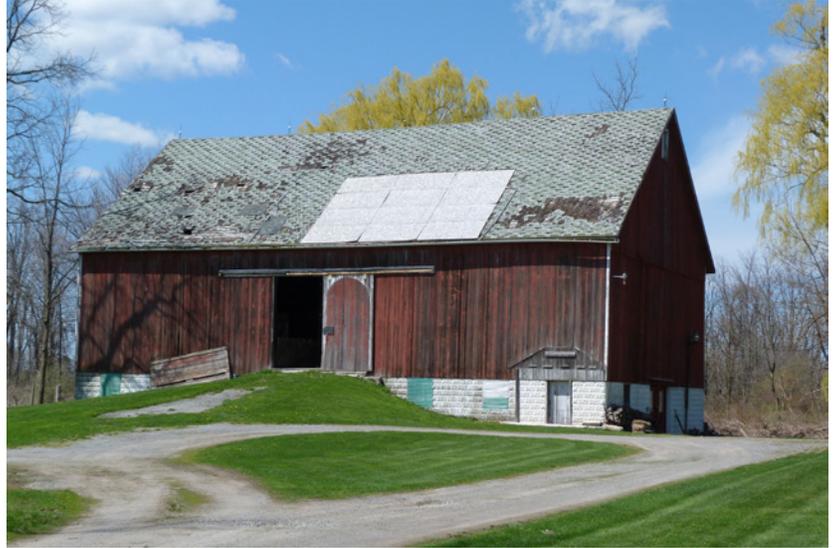
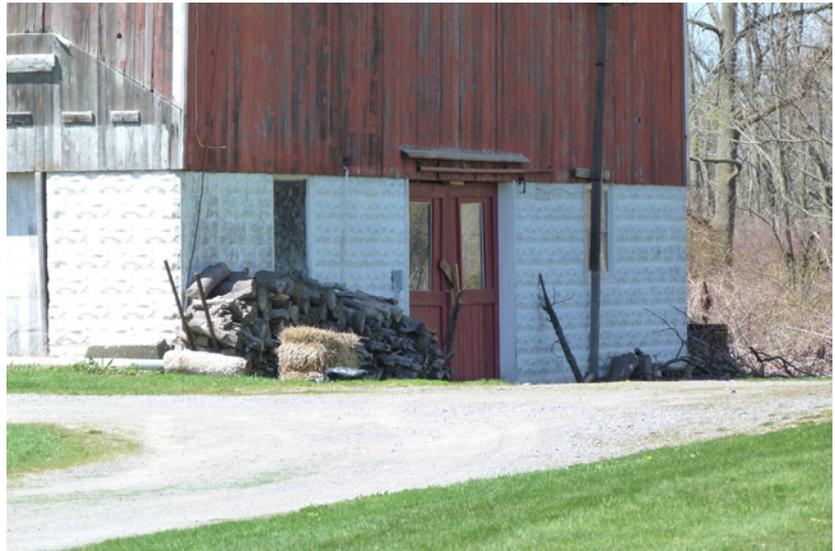
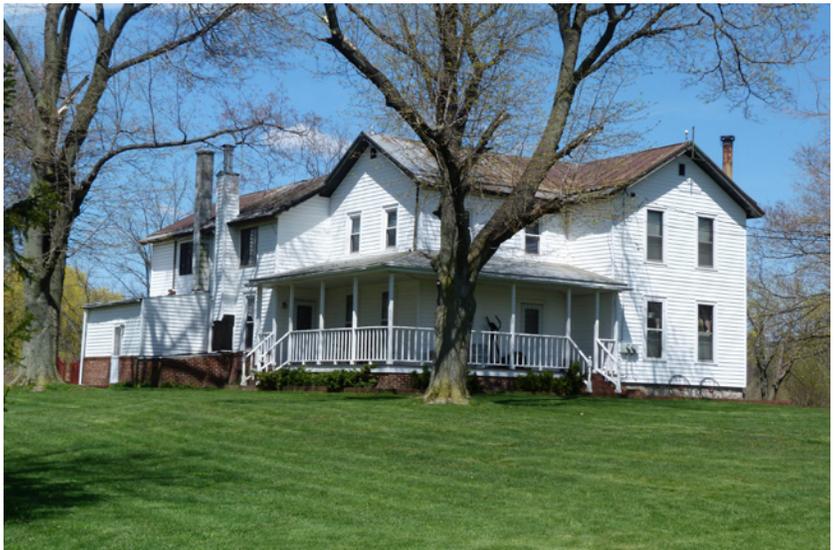
## 9520 Martin Rd.

Property is the Abraham Martin Farm, who was one of the original settlers in this portion of Clarence in the 1820s. Property originally had a Pennsylvania barn, but it was damaged by a windstorm and replaced by the current basement “bank” barn in 1933. The current barn has basement walls constructed of concrete block. The barn doors are painted with a white surround, which is likely a historic feature.

Based on historic photos, the farmhouse appears to date to c. 1870. The windows originally had Italianate-style hoods originally and the porch was high-style Italianate. The front part of the farmhouse appears to retain its original wood windows. The fenestration pattern in the rear portion has been changed from the original.

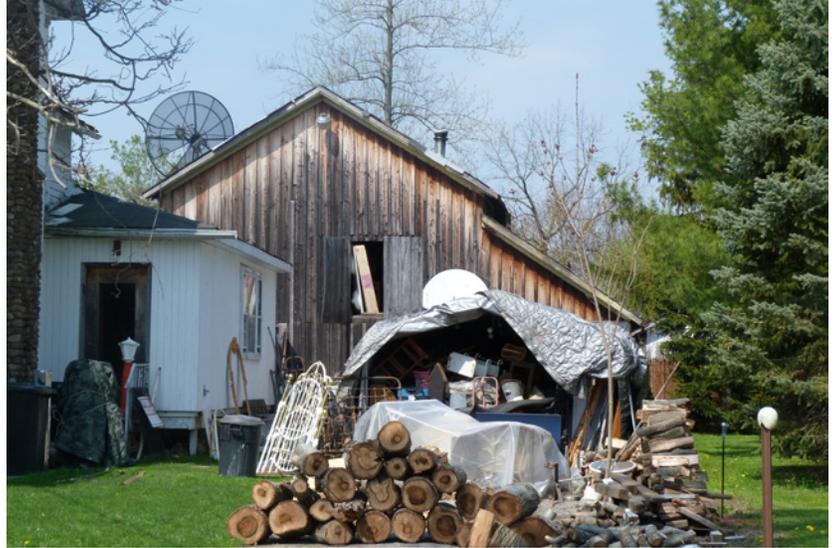
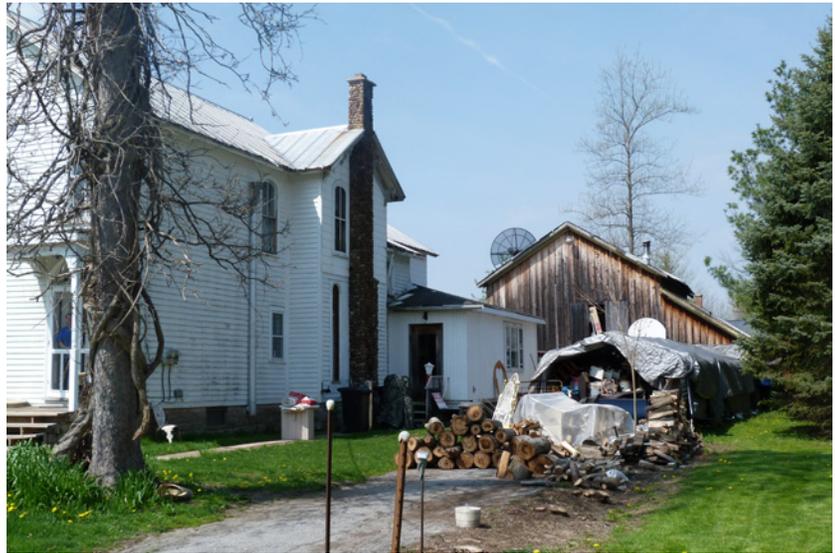
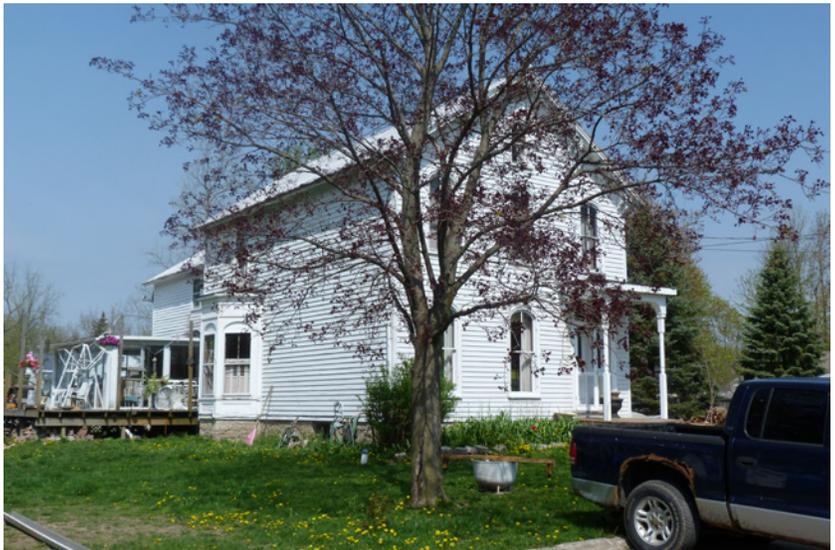
## 6070 Railroad St.

Property includes a high-style Italianate house, c. 1870, and a barn in its backyard. The house has a stone foundation, wood clapboard siding, and its original arched-top wood windows and eave brackets. Small additions have been made to both its north and south sides. The barn is gabled and has a shed-roofed side addition. The walls have been clad with board-and-batten siding. Given its in-town location, this is likely an former carriage barn.

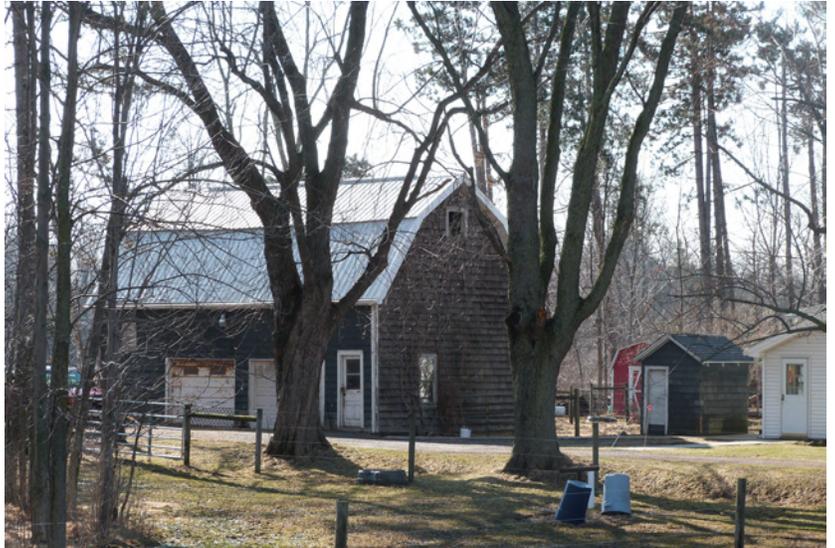
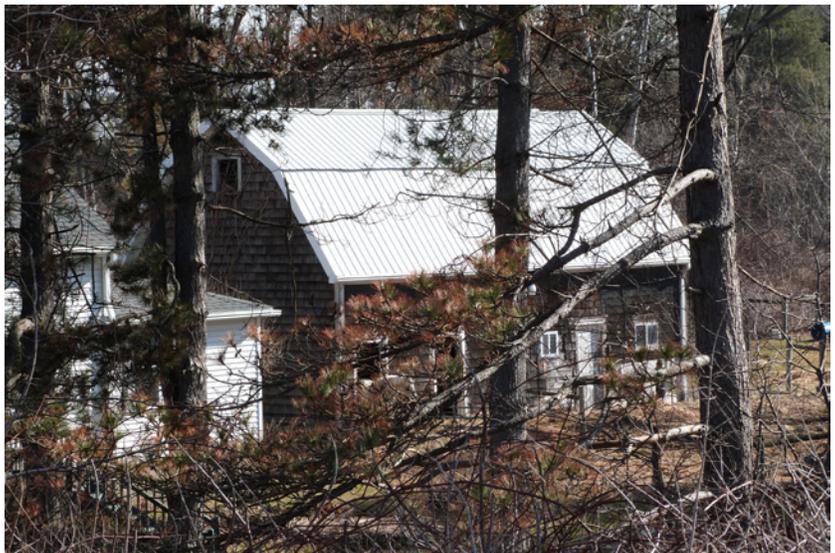
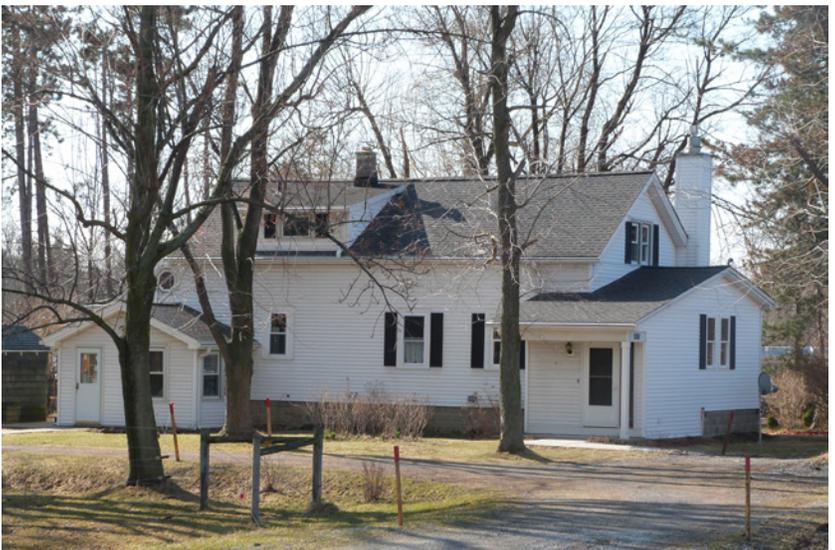
## 4025 Ransom Rd.

Property includes a gambrel roof barn, farmhouse, a small gable-roofed building of unknown purpose, and a modern shed. Based on foundation material and door style, both house and barn appear to date to c. 1925.

The barn has horizontal wood clapboards, which have been covered in cedar shakes, and its roof is metal. Some vertical wood plank dutch doors remain on the south elevation and a likely original door remains on the north elevation, but many new garage doors and windows have been added. The barn is in use as a horse barn.

The farmhouse appears to likely be a bungalow originally, but has received many additions over time and has been sided in vinyl, so its original form is hard to perceive.

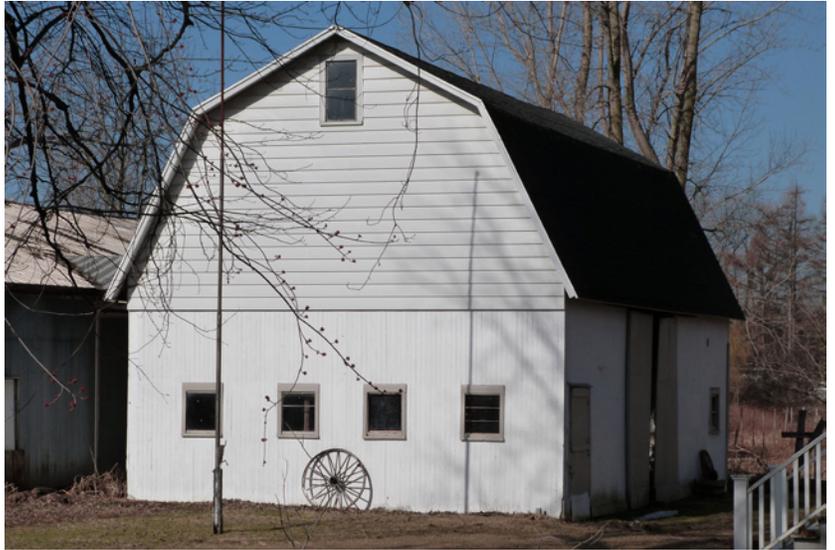
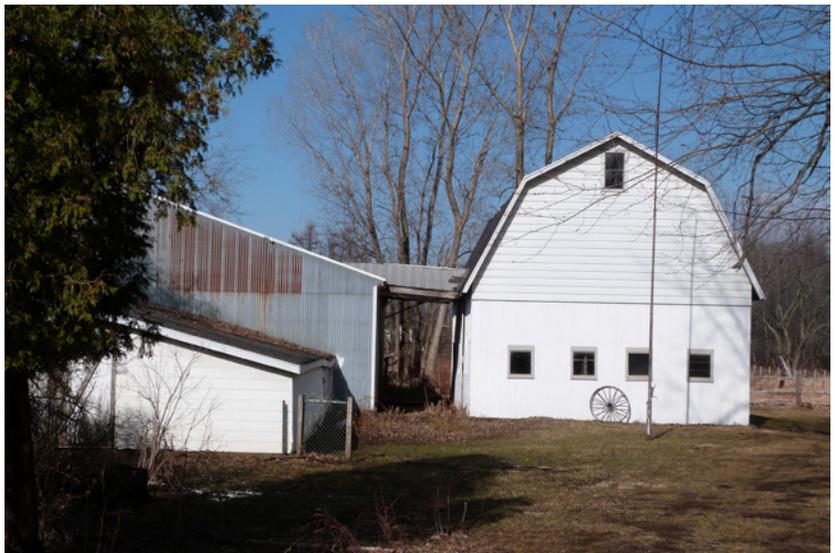
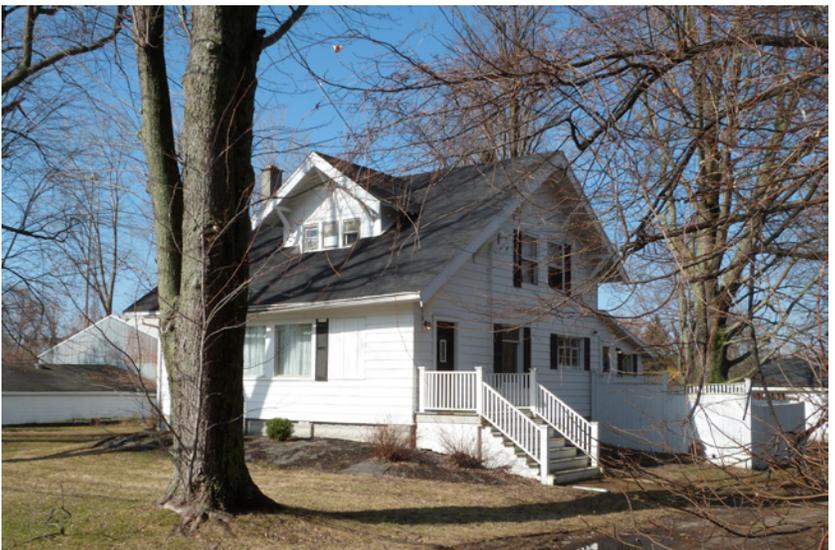
## 4050 Ransom Rd.

The barn is clad with vertical plank on its lower portions and horizontal clapboard on the gambrel ends. Square windows are present in the side. The sliding barn doors and a small man door remain. The metal shed may be an example of a manure shed, which is a type of farm building built in the early 20th century for manure storage in lieu of keeping it with the cows. Manure sheds were often connected to barns with roofs like this, but this function is unconfirmed.

The farmhouse is Craftsman-style. It has a concrete block foundation and has been clad in aluminum siding and some windows have been altered. Both house and barn date from c. 1925.

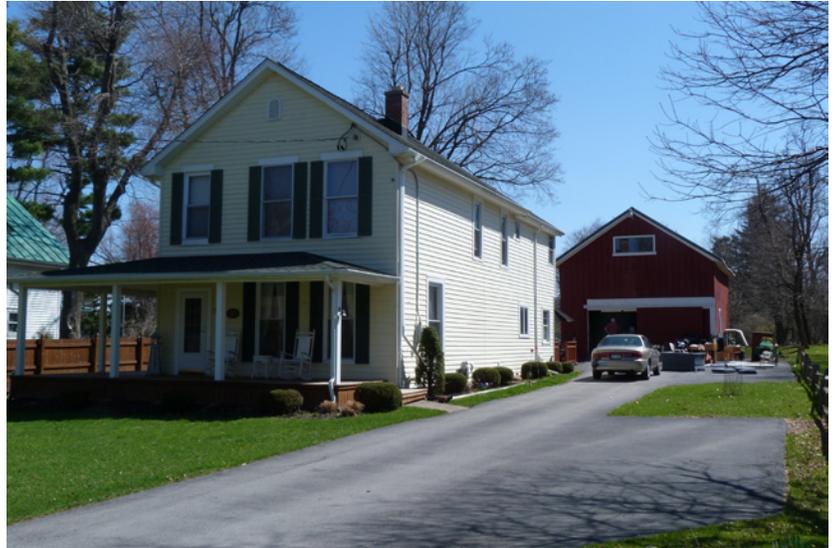
## 4735 Ransom Rd.

Property includes a home and a former carriage barn. The home, likely Greek Revival in style, appears to date to c. 1860 and retains its original wood windows, but has been clad in vinyl. The gable-roofed carriage barn likely dates to the late 19th century as well. A ghost of the former hay loft door remains, but the barn door has been replaced, the front wall has been clad in wood siding, and the window in the gable is a recent addition.

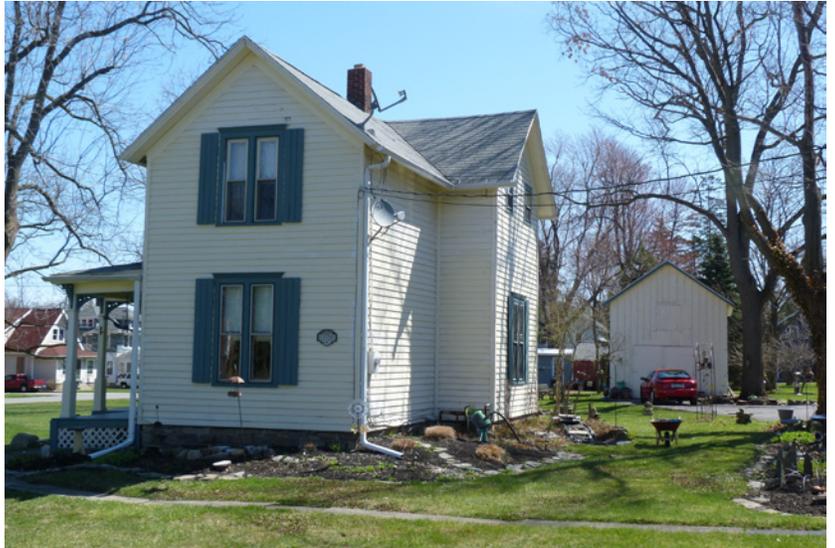
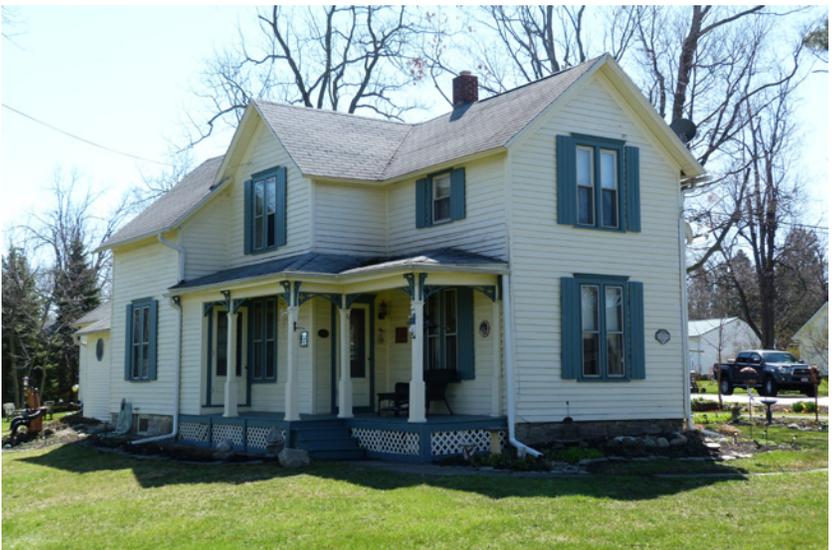
## 4765 Ransom Rd.

The carriage barn in the rear yard is one of the most intact of its kind remaining in Clarence. It has a stone foundations, exposed vertical wood plank walls, and an asphalt shingle roof exhibiting the telltale roof sag of mid-to-late 19th century construction. Thus, it was likely constructed contemporary with the house, c. 1860. Portions of the wood planks have been battened to keep the weather out. The hay loft door remains. The doors do not appear to be original.

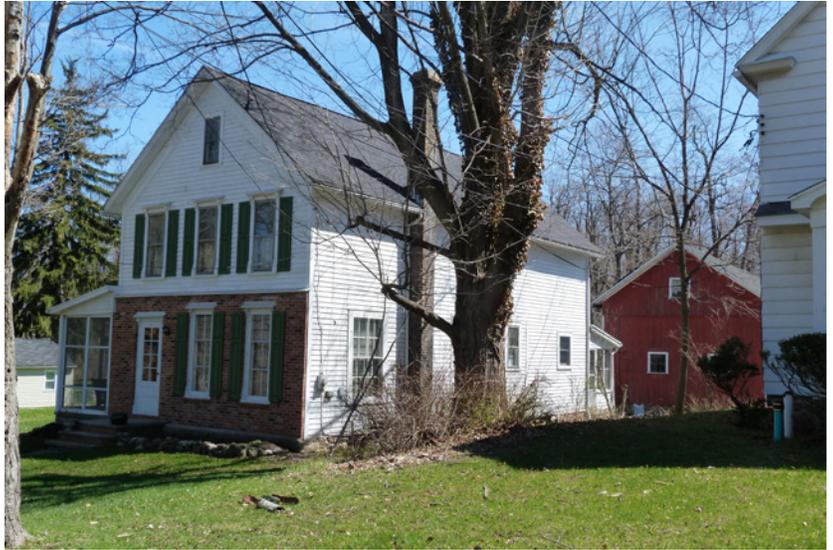
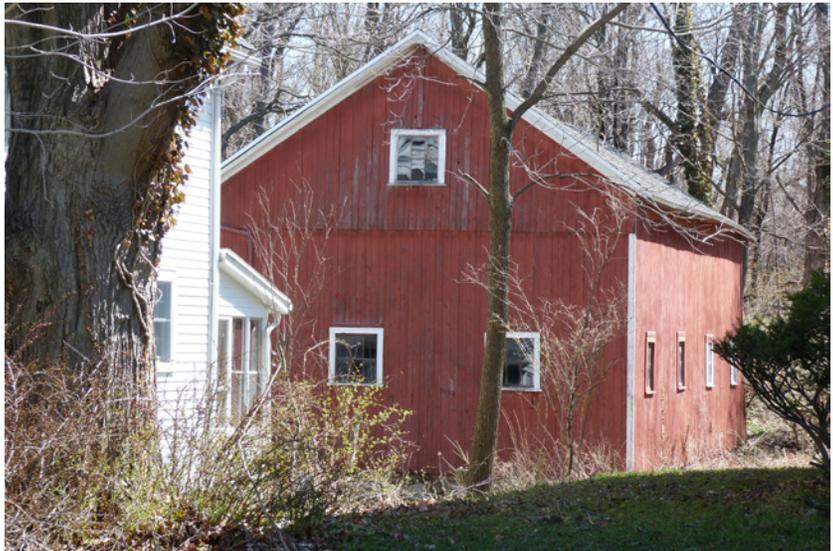
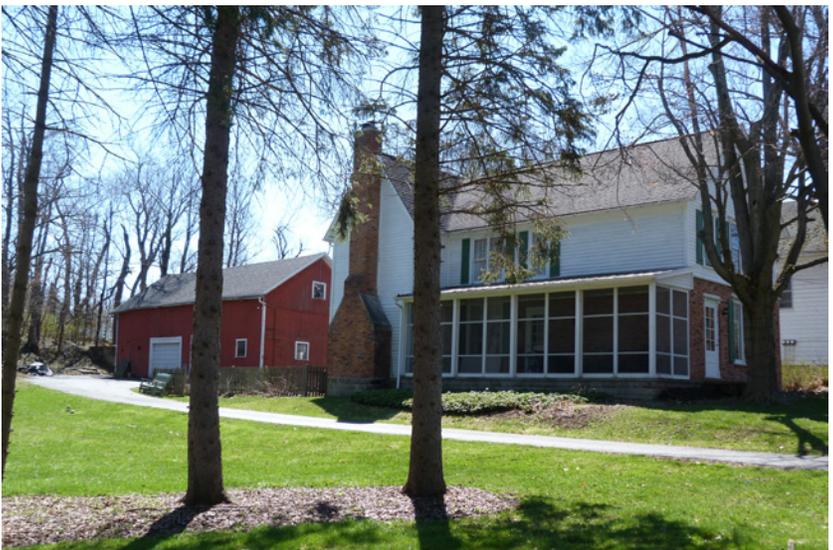
## 4815 Ransom Rd.

Given its location, the barn was is likely a former carriage barn, though it is larger than most that were used for that purpose. The barn has vertical plank walls, wood windows, and an asphalt shingle roof. A set of unusual hinged doors remain at the north end of the barn, but they may be a later alteration. The main barn doors appear to have been replaced with garage doors, but a hay loft door with strapwork hinges remains above the garage doors. The barn is likely constructed contemporary with house, c. 1850.

The house has a stone foundation, wood clapboard siding, and an asphalt shingle roof. The first floor of the house has been sided with brick veneer and a large glass addition and replacement chimney have been added to the north facade. The original wood windows remain at the second floor.

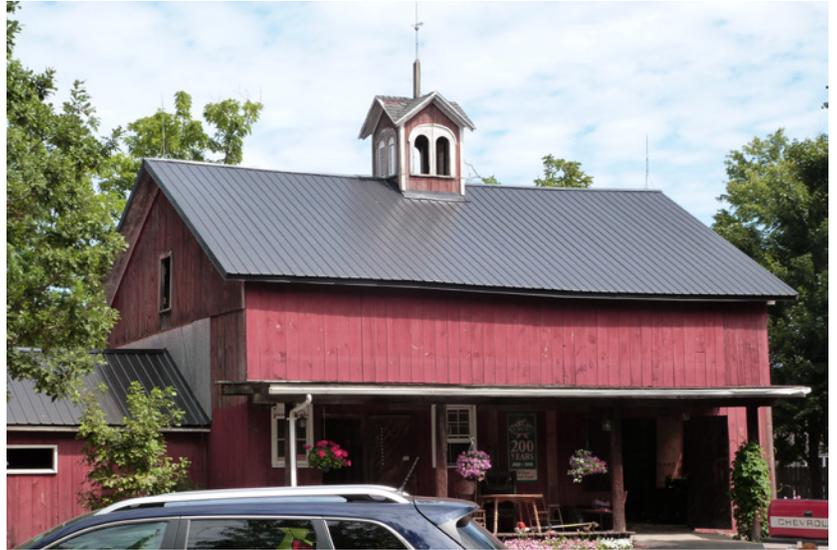
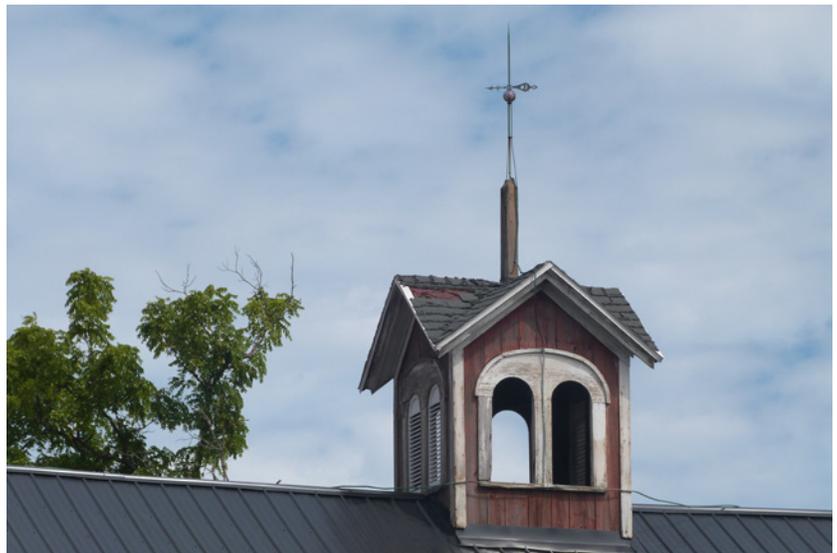
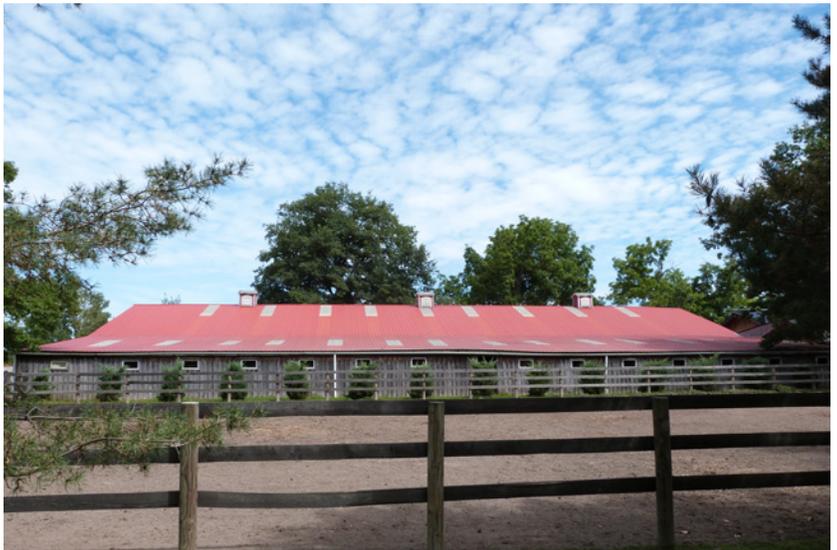
## 10195 Rapids Rd.

Property contains a c. 1860 barn that has been significantly modified and a connecting link to a contemporary horse stable structure. The vertical plank barn has a metal roof. Its first floor has had multiple windows and doors added. A farmhouse is present on the property, but was set far back in the lot so was not visible from the public right-of-way. Barn generally lacks integrity, but retains one unique feature: it is the only barn in Clarence that retains its ornamental wood cupola. Cupolas were the pre-1900 predecessors of the metal ventilators that are seen on some barns throughout the town.

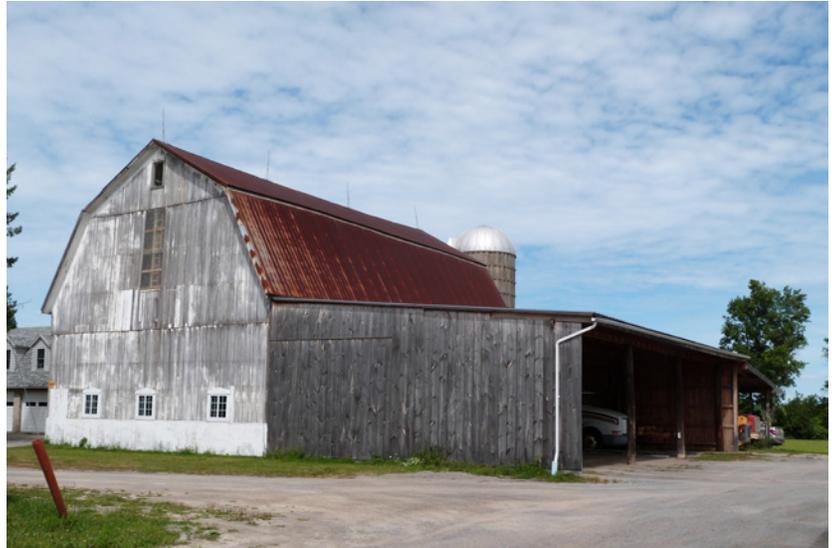
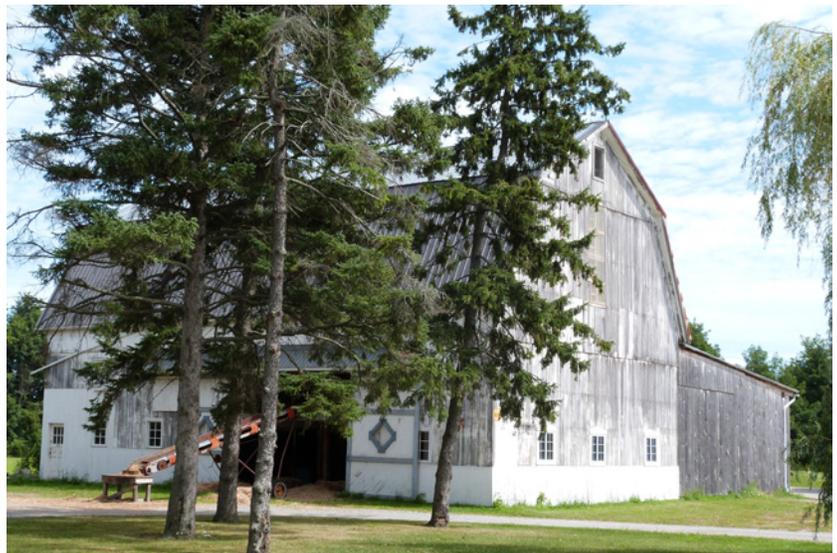
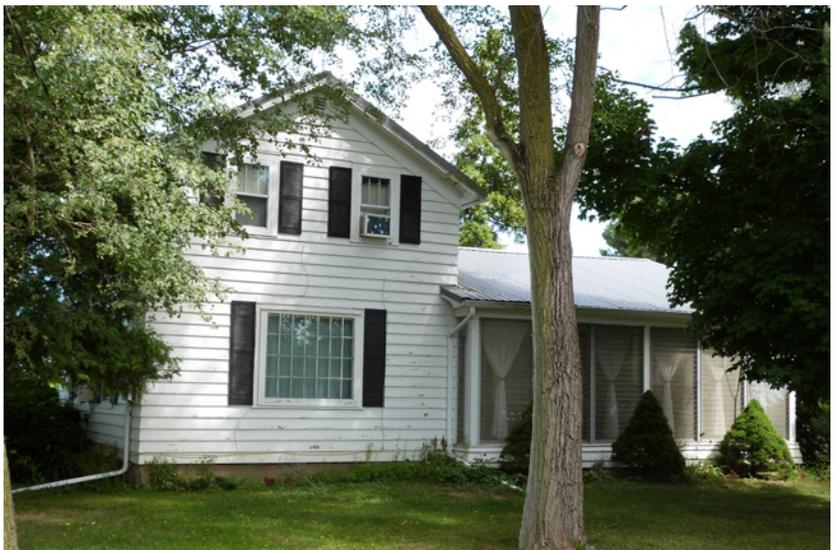
# 10450 Rapids Rd.

The barn has vertical wood siding and a metal roof. A hay loft door is visible in the south gambrel end. Modern windows have been added at the first floor. The barn was constructed c. 1910.

The farmhouse has a parge stone foundation, wood clapboards, and a metal roof. Significant window alterations were made and/or an addition was added in the mid-20th century.
