**RECONNAISSANCE LEVEL SURVEY  
of Barns and Agricultural Structures**

Town of Clarence, New York

September 30, 2014

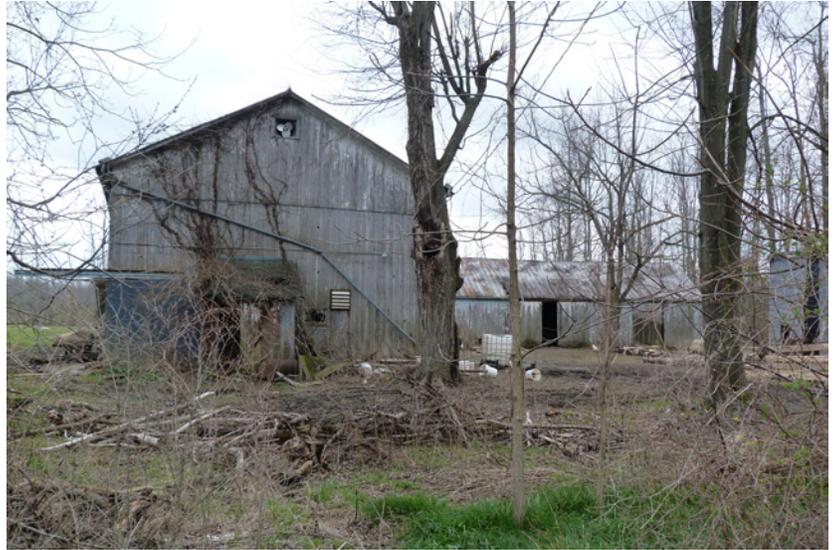
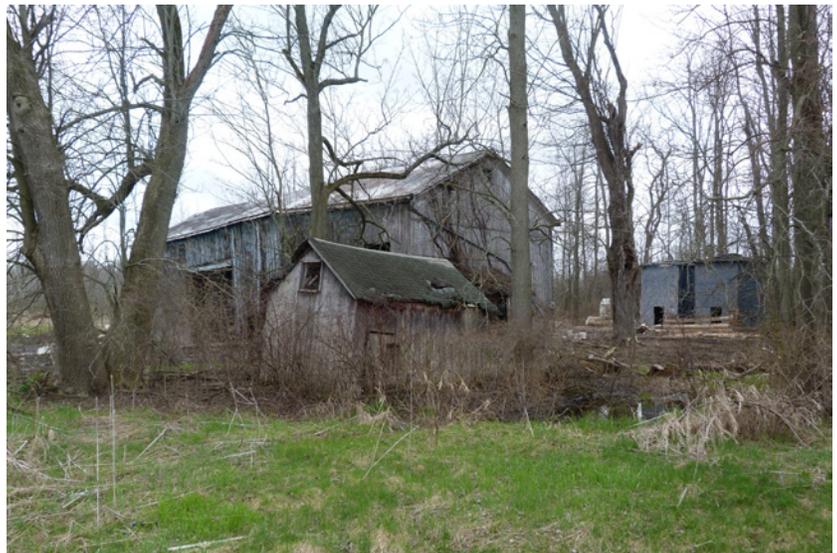
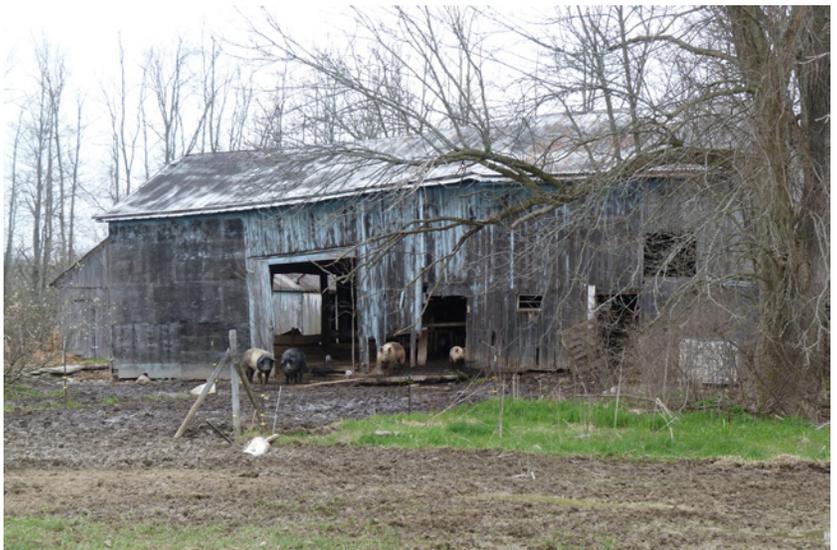
The barns are clad in vertical wood siding and have metal roofs. Portions of the exterior walls have been replaced with plywood and both barns are in poor condition. Many elements such as doors and windows are missing.

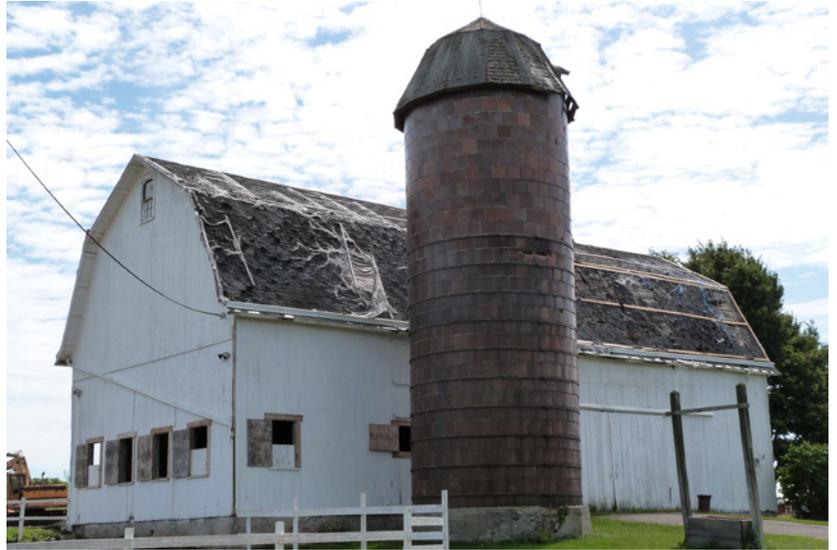
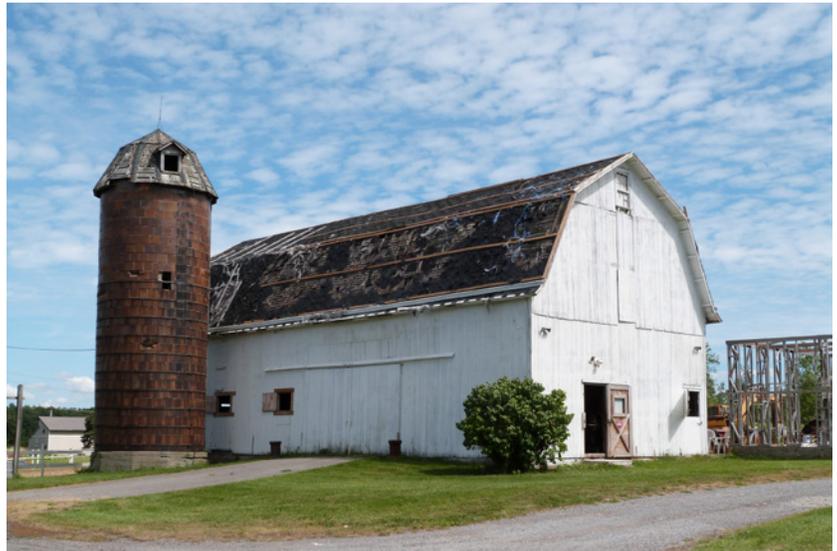
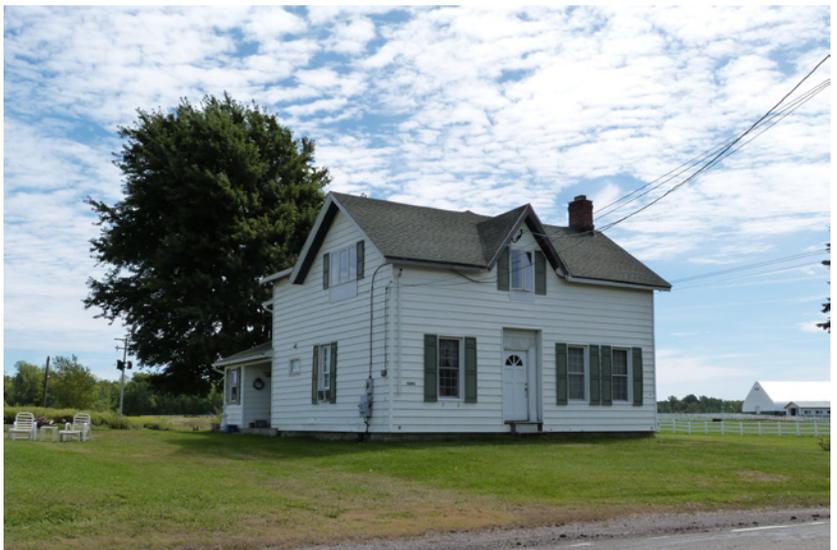
## 5774 Salt Rd.

The farmhouse includes high-style Greek Revival window casings on the exterior and wood paneling below the windows, among other unique details. It appears to retain its original wood windows.

Due to the intactness of all its principal farm structures, this property has high integrity and appears to meet the landmark criteria.

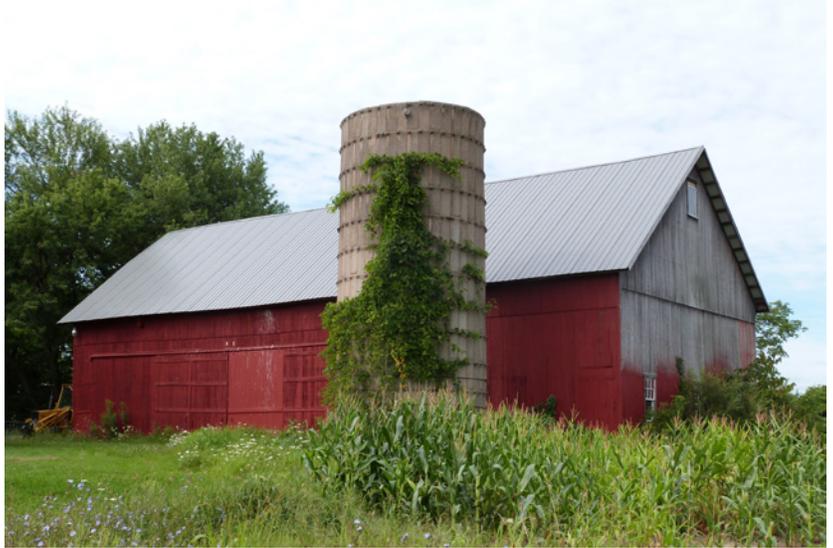
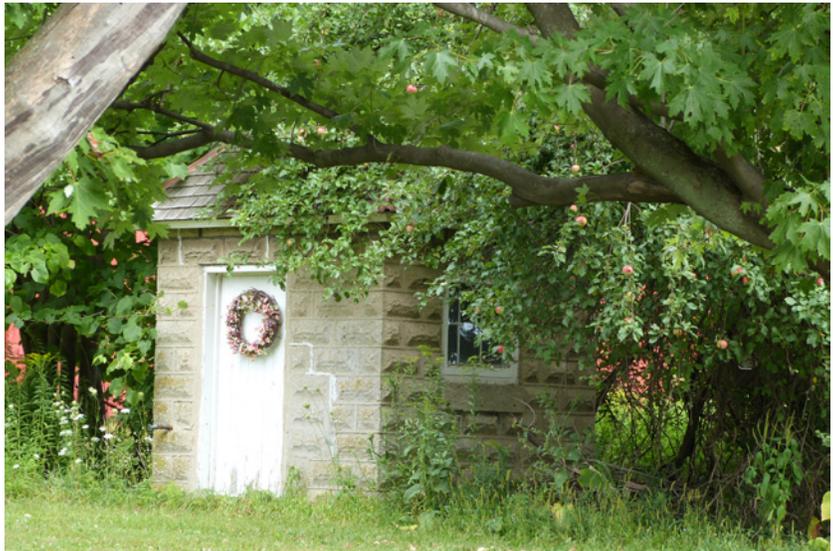
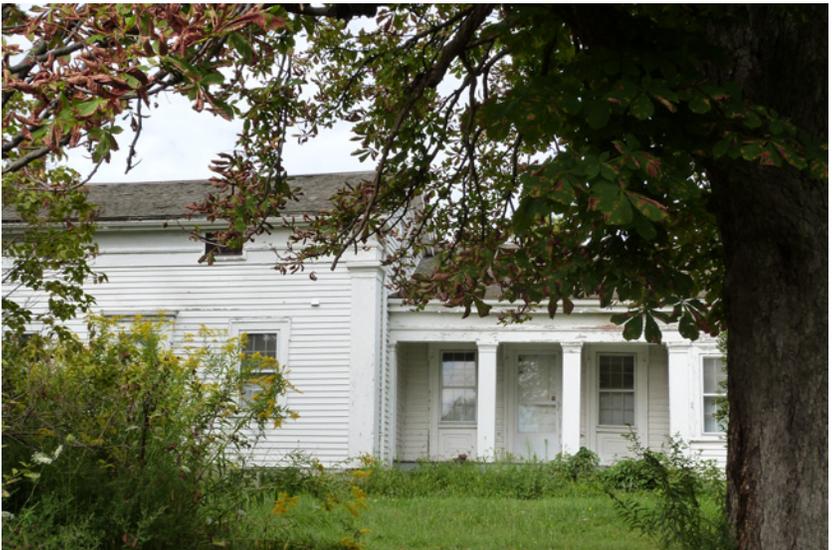
## 6110 Salt Rd.

Property is a former farm complex that contains a gambrel roofed barn and two gable roofed barns arranged around a central court. The property also contains a c. 1870 brick farmhouse. The farmhouse includes rounded window heads typical of the Italianate style. The porch has been replaced, but the original wood windows remain. A small gable roofed vertical wood plank carriage barn is present behind the farmhouse.

The two gable roofed barns may be contemporary with the farmhouse, c. 1870. The gambrel roofed barn, c. 1910, is a "basement" barn with hay hood and hay doors on the gambrel end and side. The gambrel roofed barn has a concrete foundation. All three barns have metal roofs, and some portions of the walls have been replaced with substitute materials.

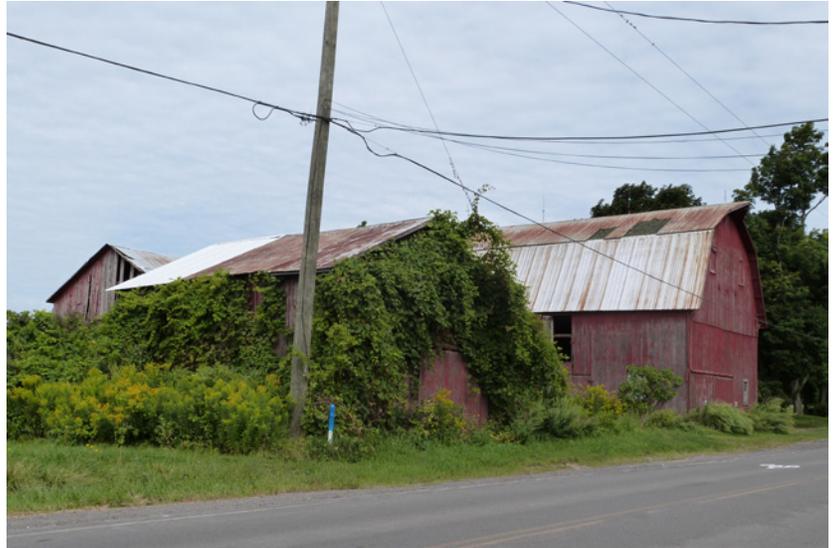
## 7141 Salt Rd.

Property includes a late 19th century gable roofed barn and a c. 1925 American Foursquare farmhouse. The top image is from Google Streetview, taken July 2011. The middle photo was taken during the survey. Much of the exterior vertical plank has been replaced with contemporary board-and-batten siding. A portion of the vertical plank remains at the gable ends. The barn is roofed in metal.

The farmhouse has seen several alterations. The front porch has been enclosed, and brick veneer has been added to the front facade.

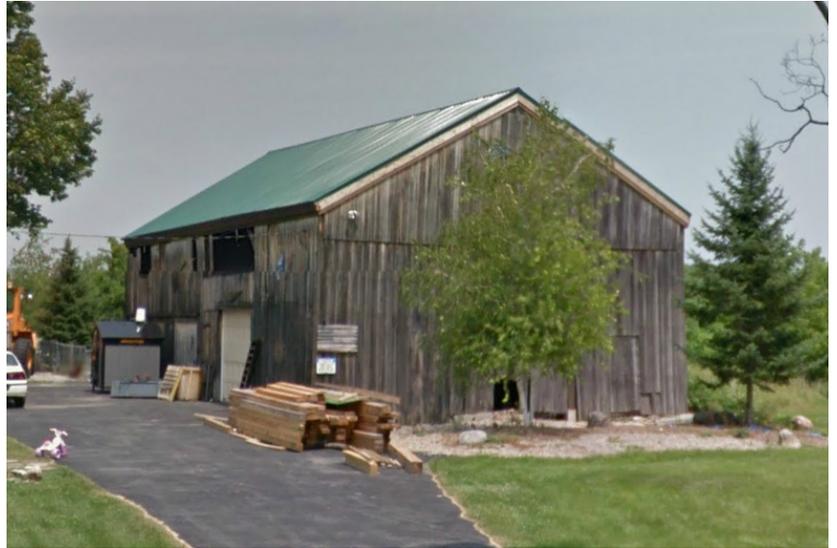
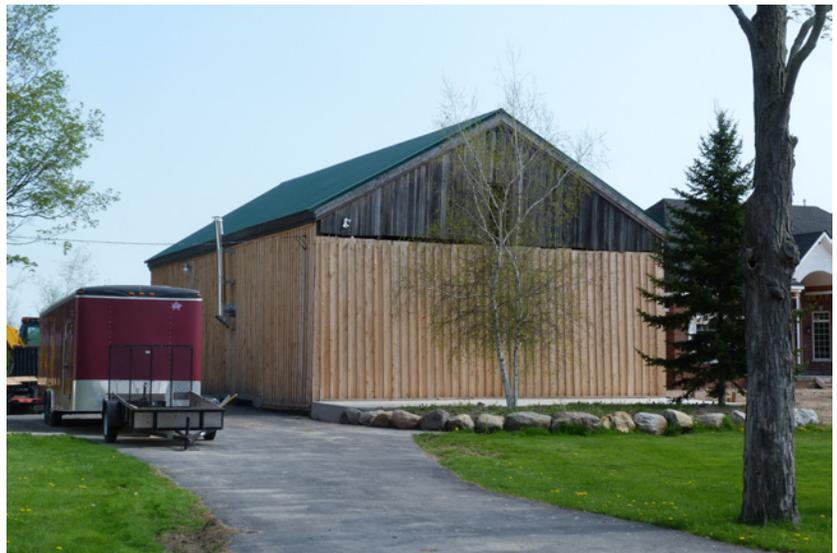
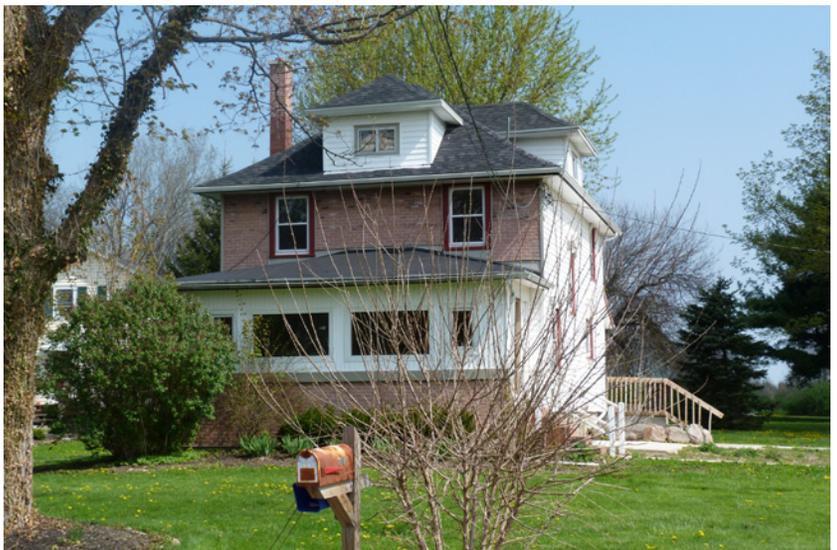
## 7161 Salt Rd.

Property includes an Italianate-style farmhouse, two barns, a stone smokehouse, and a corn crib. One of the barns has exposed vertical plank and has a small shed-roofed addition and is in use as a garage, but retains its sliding door. The other barn has been faced in tar paper or similar. Farmhouse has been sided in aluminum. Both farmhouse and barns retain their wood windows. Farmhouse and barns date from c. 1870.

Property has high integrity due to all primary and some secondary farm structures remaining and being largely intact.

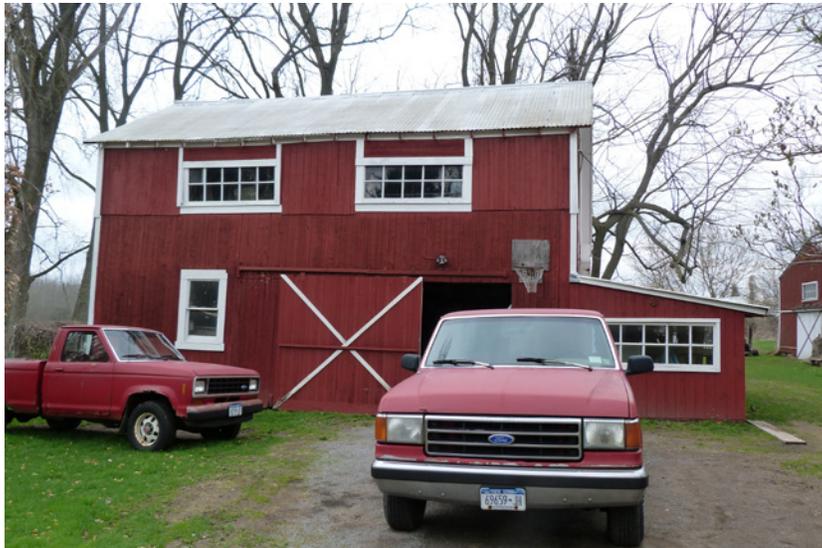
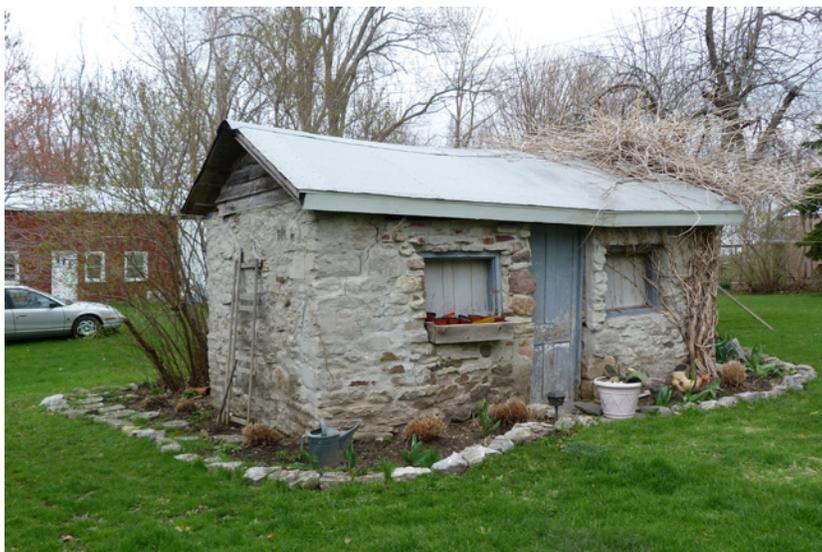
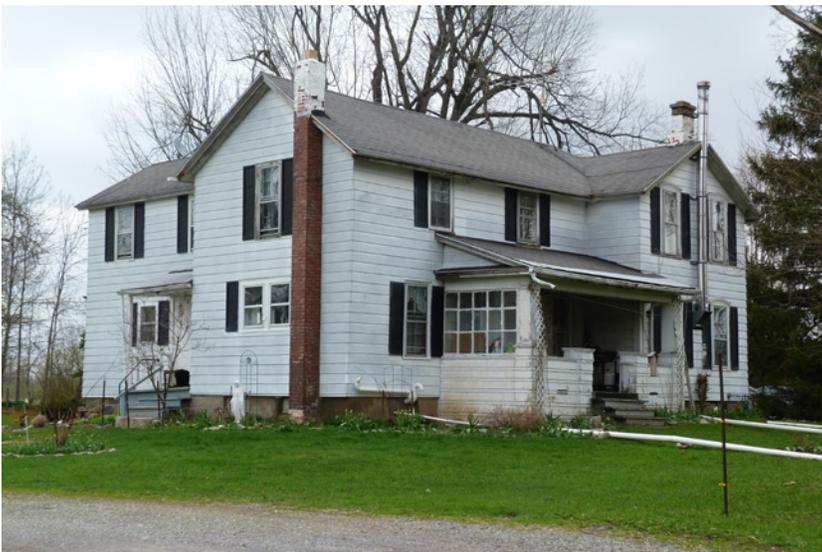
## 7375 Salt Rd.

Property includes a Queen Anne-style farmhouse, large gable roofed board-and-batten sided former dairy barn with attached concrete block milkhouse, concrete silo, and small gable roofed storage building. Both farmhouse and barn have stone foundations. Owner states farmhouse was built 1903, which is a likely date for this architectural style. Barn was likely built at the same. Attached milkhouse constructed slightly later, possibly 1914.

Property has high integrity due to very intact barn and farmhouse.

Note: It has been reported that this barn was once a Pennsylvania barn, but that is unlikely because that is an 1820s style in Clarence and this portion of Clarence wasn't settled until after 1850.

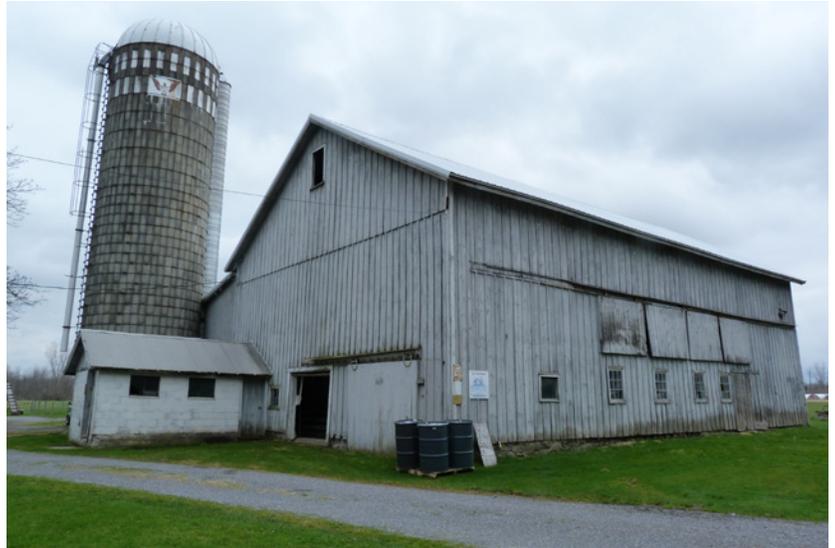
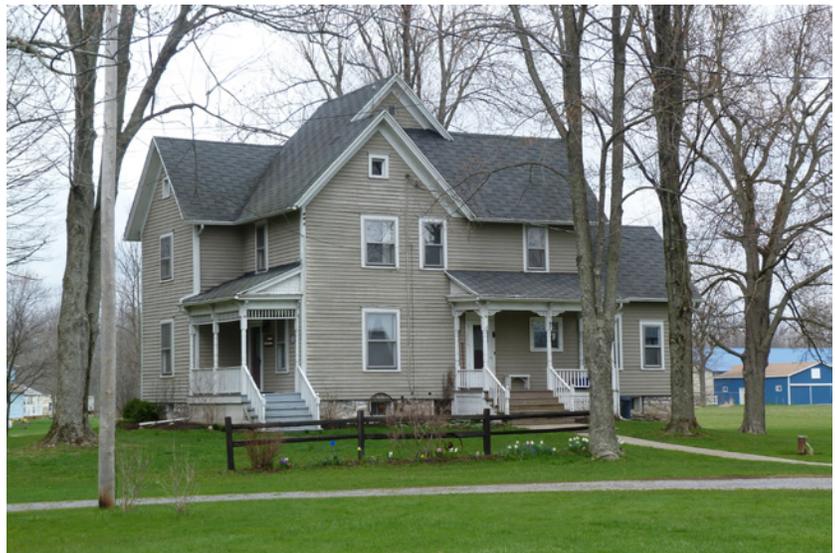
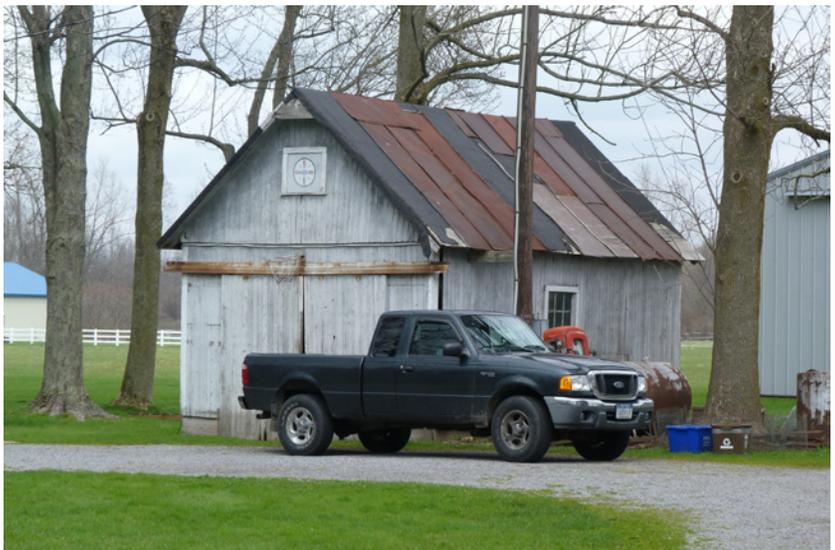
## 7735 Salt Rd.

Property includes a late 19th century vertical wood plank gable roofed barn with battens, a metal workshop that may have been adapted from an older agricultural building but has been modified beyond recognition, a contemporary garage/shed with board-and-batten siding attached to the older bank with a link, and a residence that appears to date to the mid-20th century.

The 19th century barn is no longer attached to its foundation and has received significant modifications, thus lacking integrity. The remaining buildings do not appear to be historic.

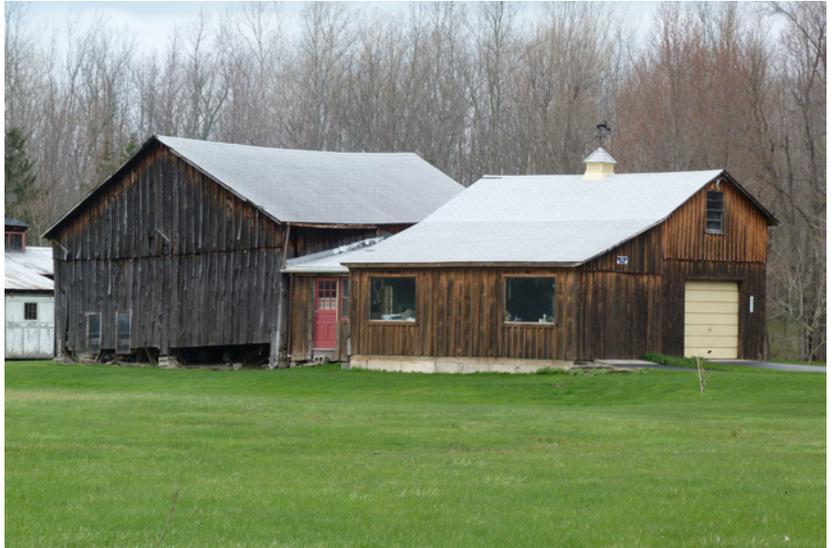
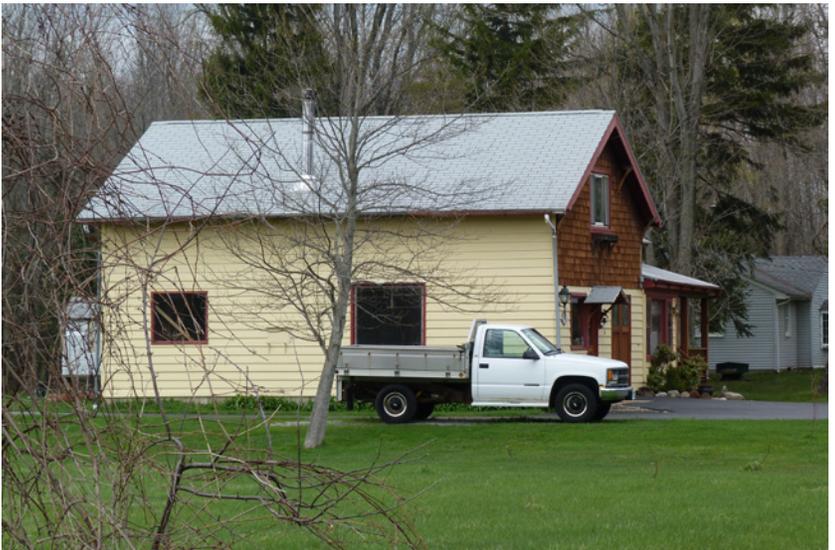
## 7750 Salt Rd.

Both barns have gabled roofs and vertical plank siding. The front barn is English in style and has wood windows with peaked Italianate window hoods. The front first floor of the rear barn appears to be constructed of cut stone. This barn has a hay hood, has been partially sided in plywood and permastone, and has had shed additions to both sides and the rear. According to the owner, one of the barns has a date of "1911" in the concrete in the inside (unsure which barn), so this is likely the construction date of the rear barn since the red (front) barn appears to be older than that and has only a partial concrete foundation. Farmhouse has a concrete foundation, so it may have been constructed in 1911 as well. Red barn appears to be c. 1870. Chicken coop appears to be constructed c. 1900.

The partial stone front of the rear barn is an unusual element of this property that suggests further study including site and interior access may be warranted.

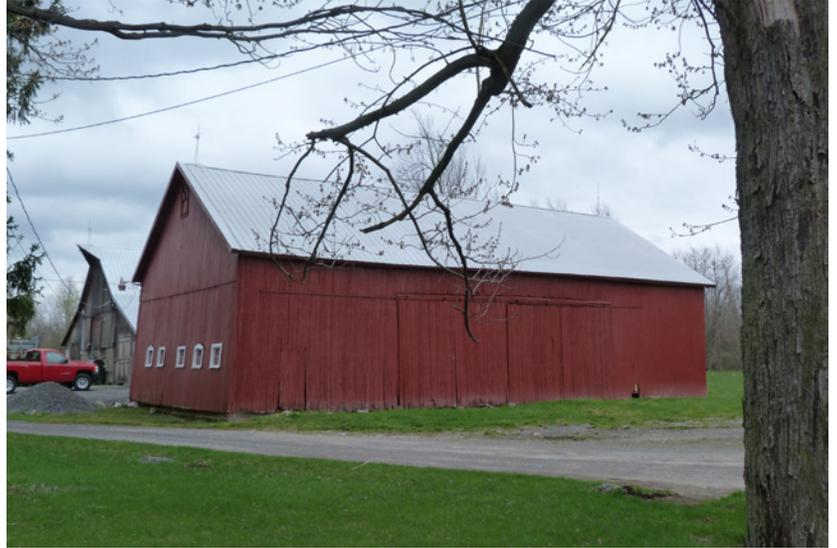
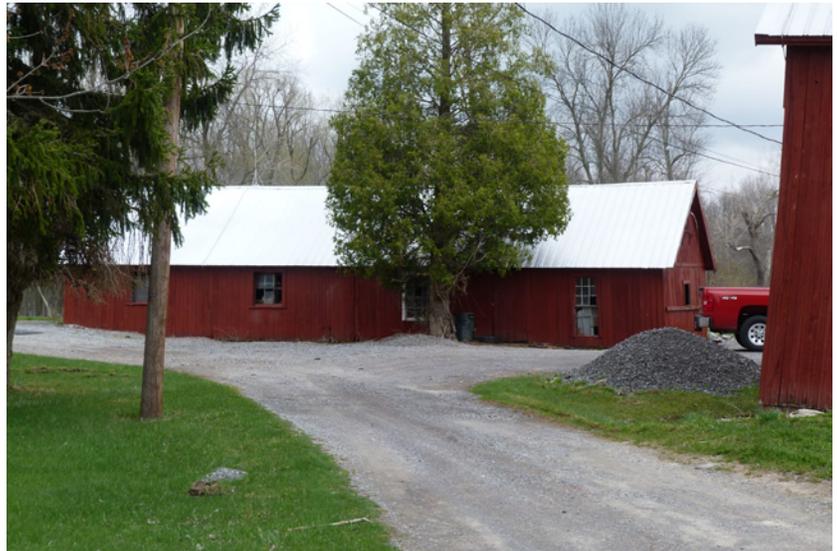
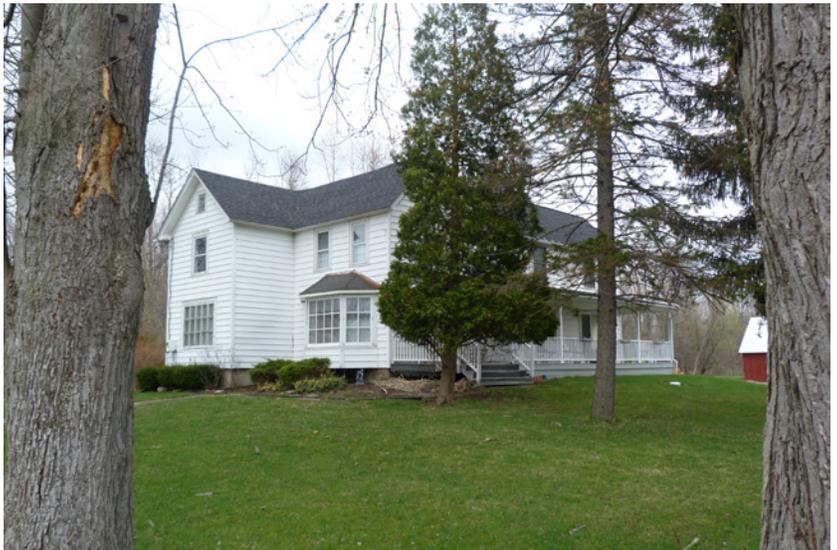
## 8011 Salt Rd.

Property includes a c. 1860 gable roofed English barn with small gable roofed addition with concrete foundation, c. 1860 farmhouse, and small mid-20th century gable roofed building at the rear of the lot. Barn addition dates to c. 1915. Barn has vertical wood plank walls but has been clad with horizontal wood siding. Farmhouse has received vinyl siding and some window replacements.

Barn is especially wide for its type and has an especially low-sloped roof, which suggests a unique construction or purpose, which could lend the property significance. Interior access would be needed to confirm.

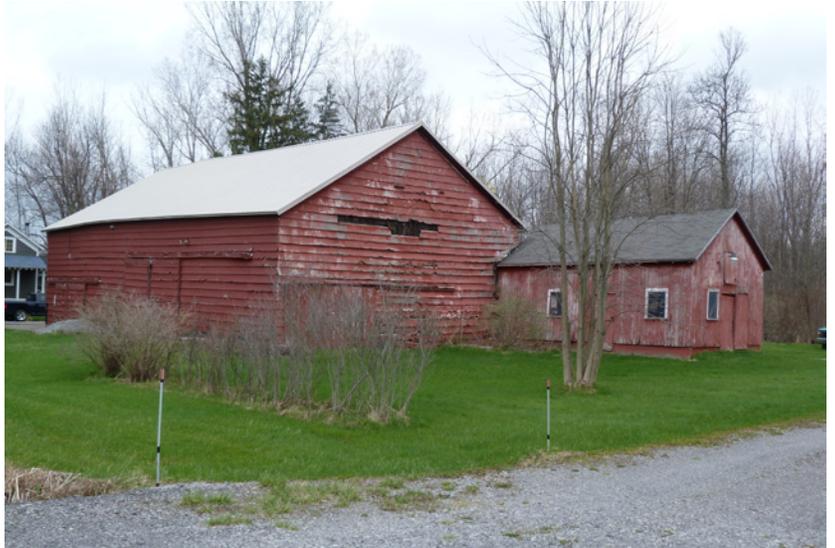
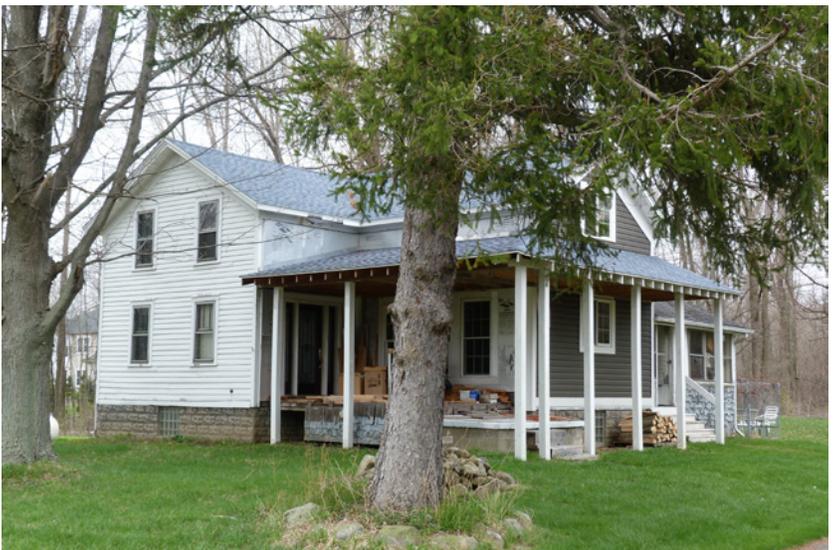
## 8845 Sesh Rd.

Property contains two c. 1860 gable roofed vertical wood plank barns, shed-roofed chicken coop, gable-roofed piggery, an additional small gable-roofed building of unknown purpose, a hand water pump, and a c. 1860 Greek Revival-style farmhouse. One of the barns has an "H" painted at its peak, but the significance of this is not known.

The farm buildings that make up this complex are generally in fair to poor condition, having lost windows, doors, and siding in some areas, but overall complex has integrity because of the large number of surviving buildings on the complex and the intactness of the farmhouse. Further study is needed to determine the significance of this property.

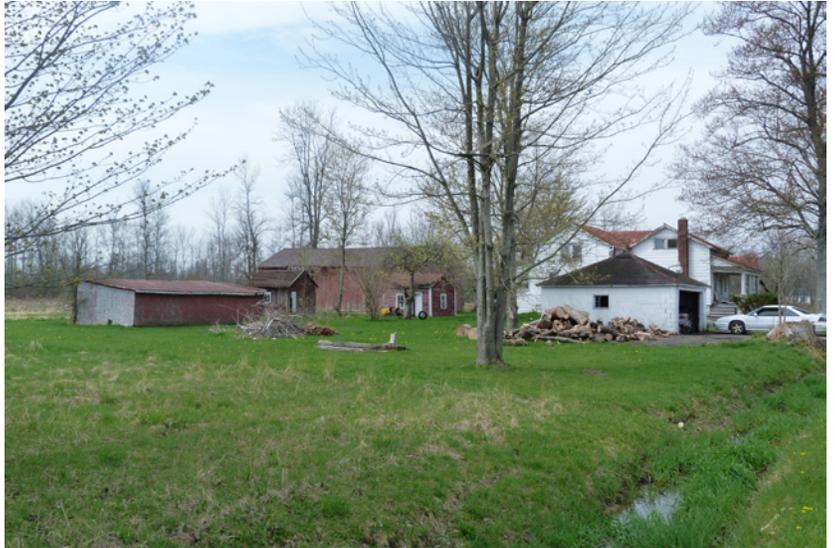
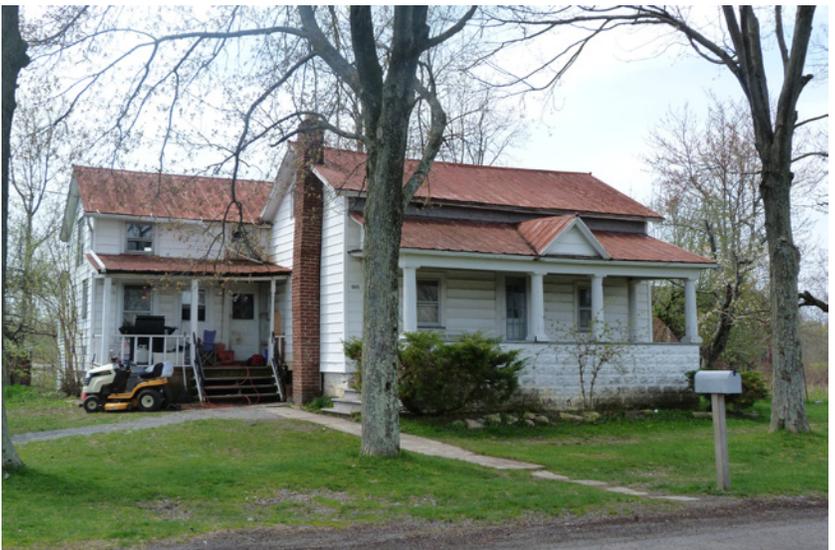
## 8870 Sesh Rd.

Property contains a c. 1870 farmhouse, a gable roofed barn with attached concrete block milkhouse and multiple pole barn additions, and a gable-roofed piggery.

Barn has a martin hole in its peak in the shape of its construction date, "1883." Milk house is from the 20th century. First floor of barn has been largely infilled with concrete block and gable end has applied battens. Farmhouse has stone foundation attesting to its age but has been clad in vinyl and all window openings have been changed.

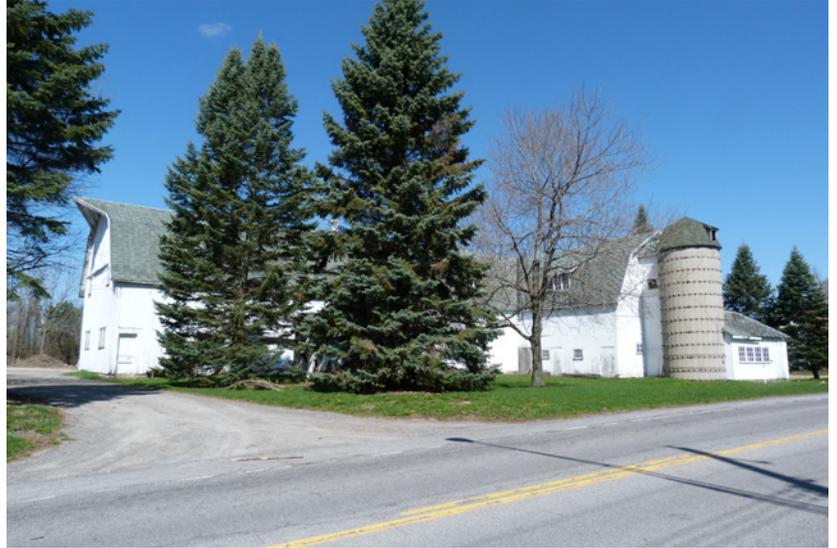
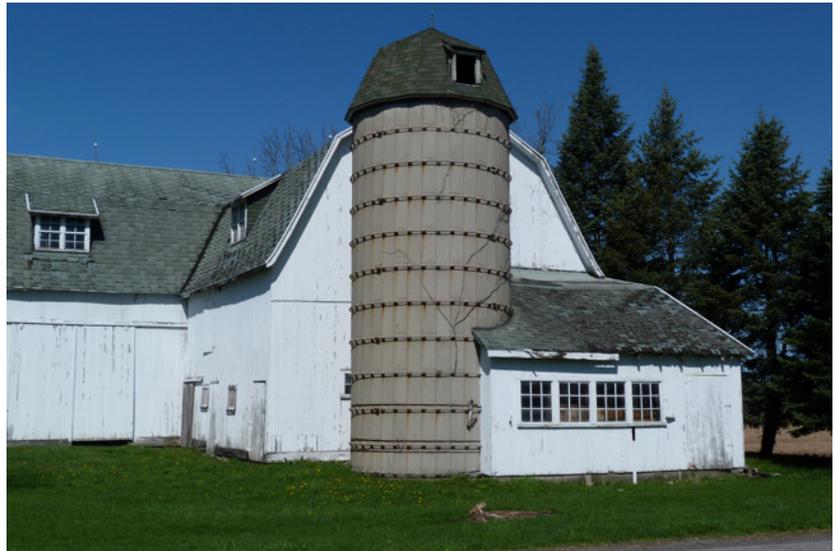
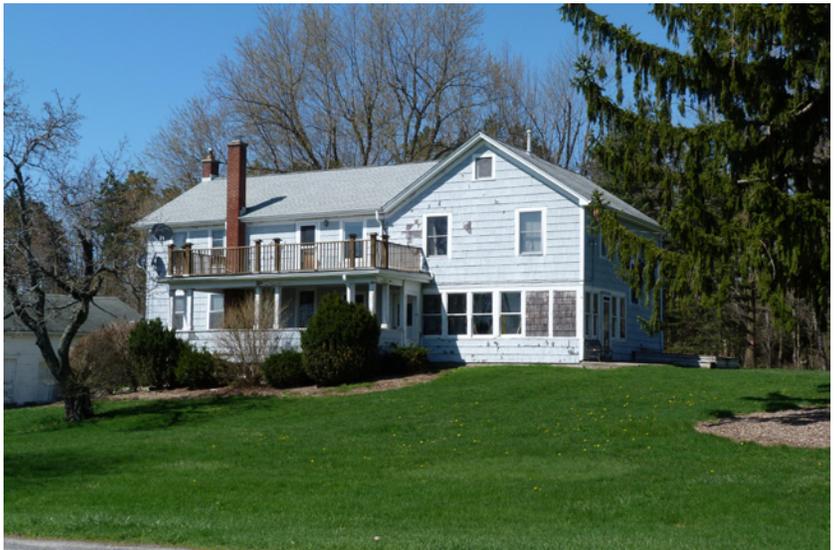
# 8070 Stahley Rd.

Property contains a c. 1860 Greek Revival farmhouse, small frame garage, and a small c. 1900 vertical wood plank gambrel roofed barn. Barn has a concrete foundation, suggesting it may have been relocated in the past.

Barn has received several alterations. Doors and door rail have been replaced and windows on the end wall have been infilled. No other historic details are present. Residence retains exposed wood clapboard siding.

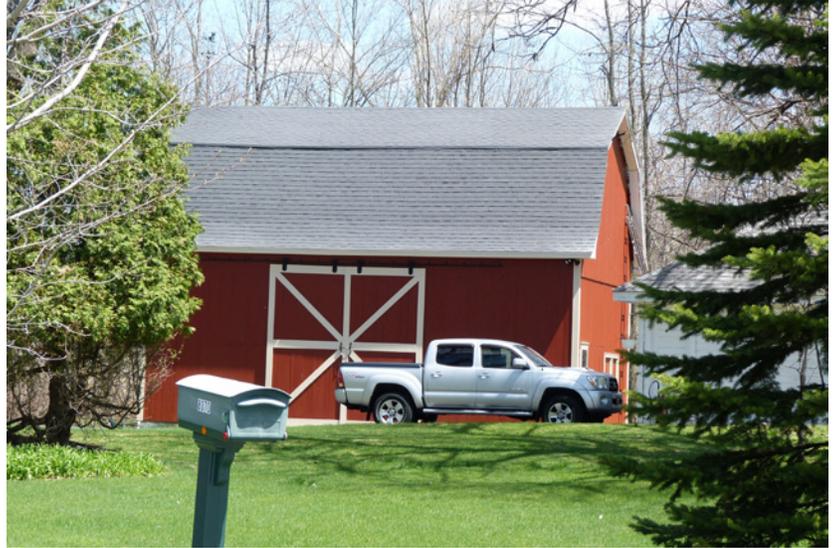
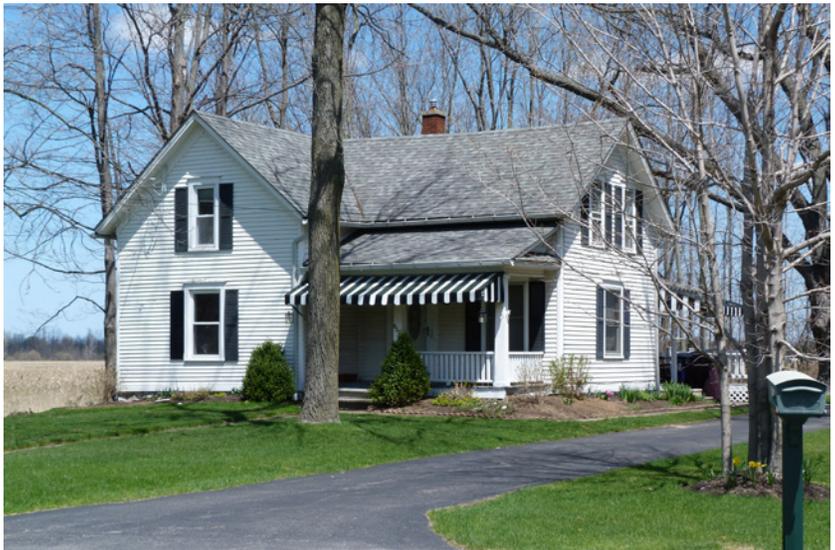
## 5375 Strickler Rd.

Property contains a c. 1840 side gabled Greek Revival farmhouse with ashlar stone foundation, square fanlight above door, and its original 6/6 wood windows. Vertical wood plank Greek Revival barn is of similar age and has had bays removed in its side elevation for adaptation as a garage. Property also contains a small gable-roofed board-and-batten sided tool shed with exposed rafter tails and a contemporary gambrel roofed shed.

Property may have significance due to the historical association of its owner and the intactness of the farmhouse and presence of the original barn.

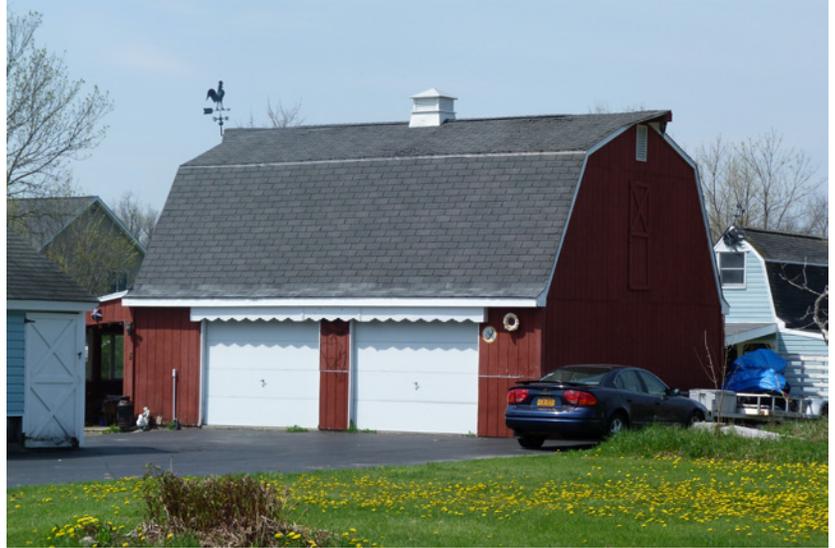
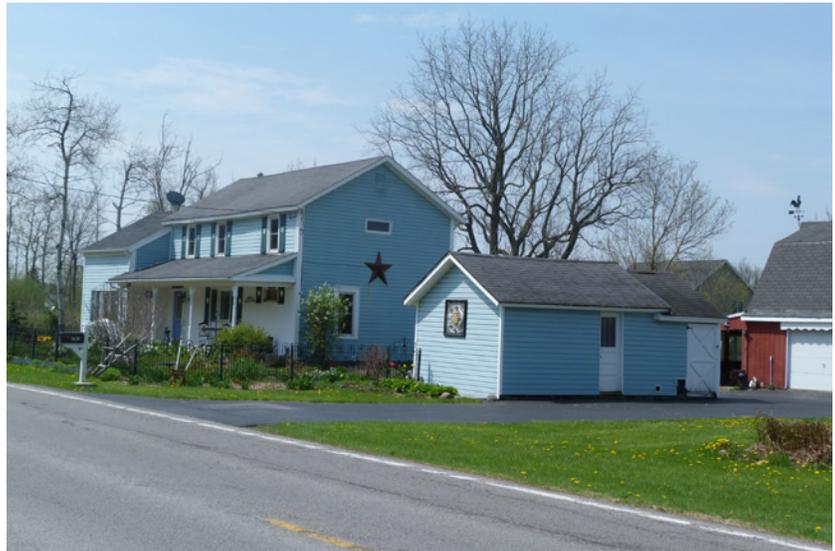
# 5601 Thompson Rd.

## Significance: None

Property contains c. 1860 farmhouse, gable roofed three-bay English barn of the same age, and garage that may be adapted from a small older agricultural building or carriage barn, also dating from the 19th century judging from its stone foundation.

Main barn has been sided with asphalt and all elements have been covered or replaced, including door rail, windows, and roof. Garage has been sided with asphalt as well. Farmhouse has had its porch infilled, has been sided with vinyl, and windows replaced with vinyl.

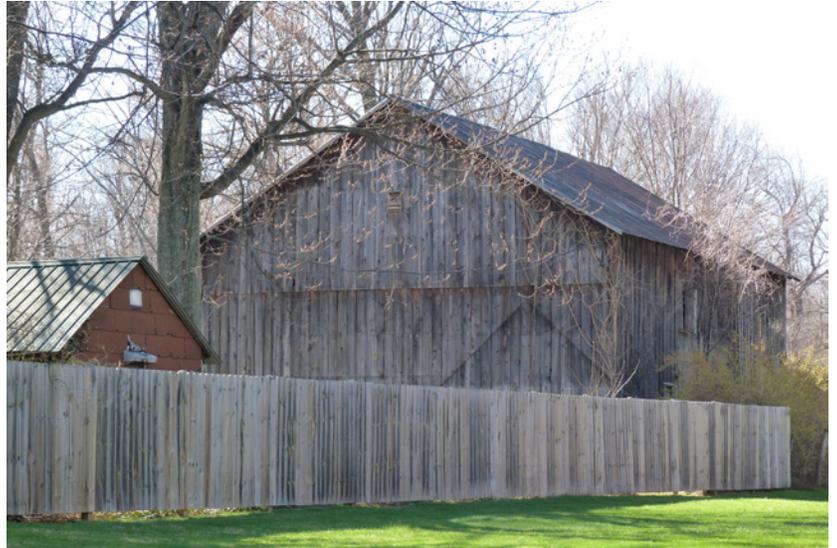
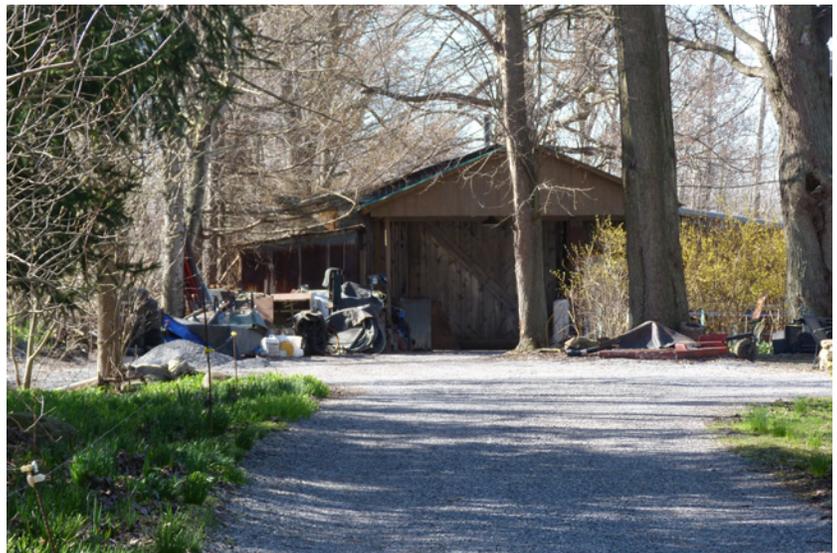
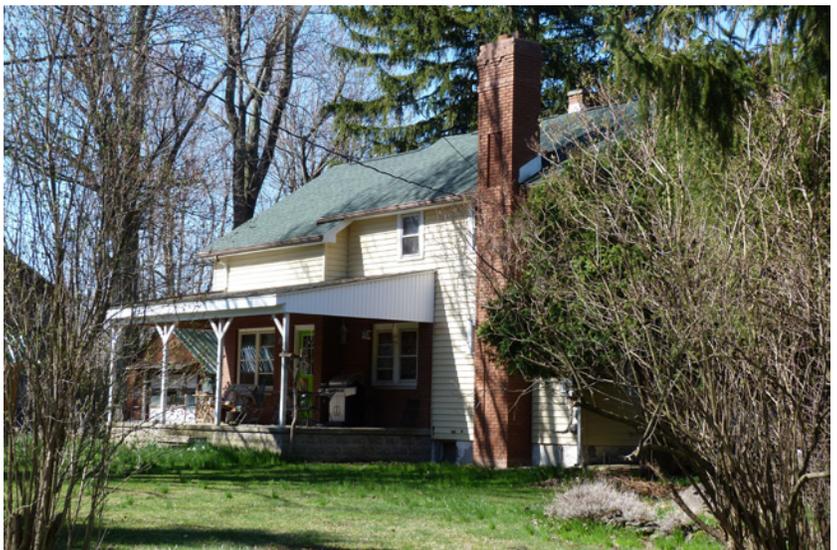
## 8501 Tonawanda Creek Rd.

**Significance: Medium - possibly significant, further study needed**

Property contains a vertical wood plank gable roofed barn constructed c. 1885, a gable-roofed piggery with board-and-batten siding, and a wood plank chicken coop with concrete foundation, dating it to 1915 or later. No farmhouse is present on the property, but a c. 1870 farmhouse remains across the street that may have originally been associated with these structures. It is now part of a separate parcel (8490). The farmhouse has received significant modifications, with all window openings altered and it has been clad in vinyl siding.

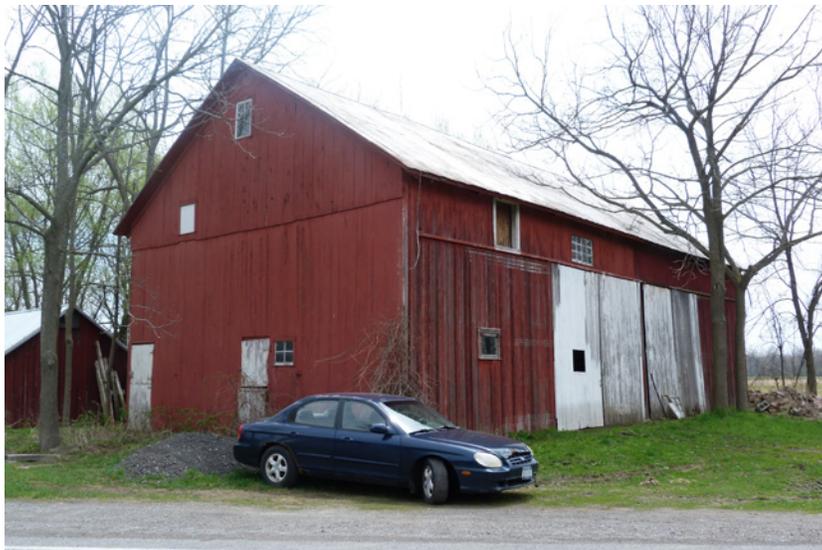
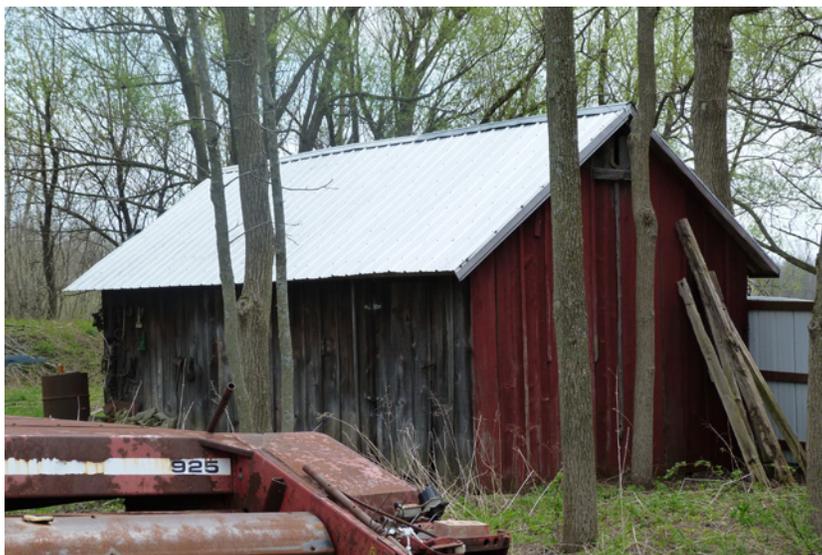
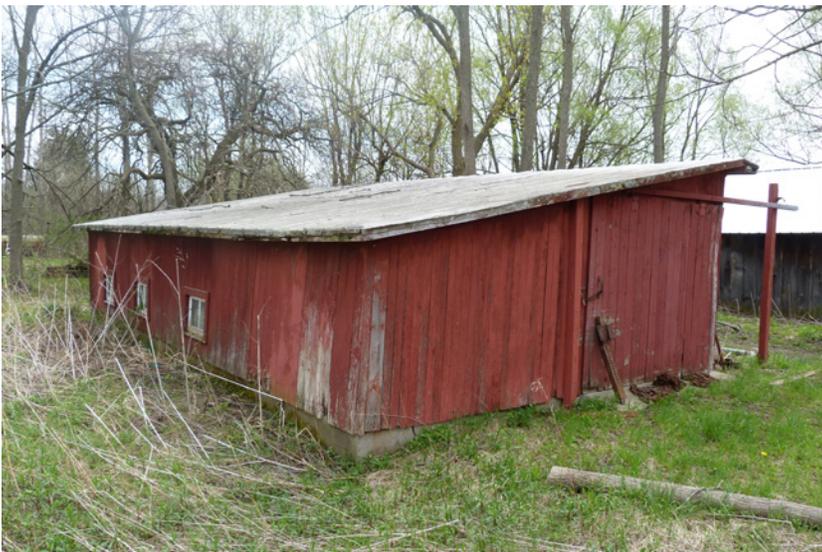
## 8525 Tonawanda Creek Rd.

**Significance: Medium - possibly significant, further study needed**  
**SHPO USN: 02907.000555**

Larger barn has a cross-shaped martin hole (also called a “barn cross”) at its gable peak and an earthen “bank” leading to its door. Both barns have been partially sided with plywood.

This is a unique configuration not seen elsewhere in Clarence. The low roof pitches suggests a structural arrangement and/or function different from other barns in Clarence. The proximity to St. Stephen’s Church suggests some connection with the Prussian immigrant community. Barn crosses and earthen “banks” are fairly rare features. Further research on this property is warranted, preferably including interior access.

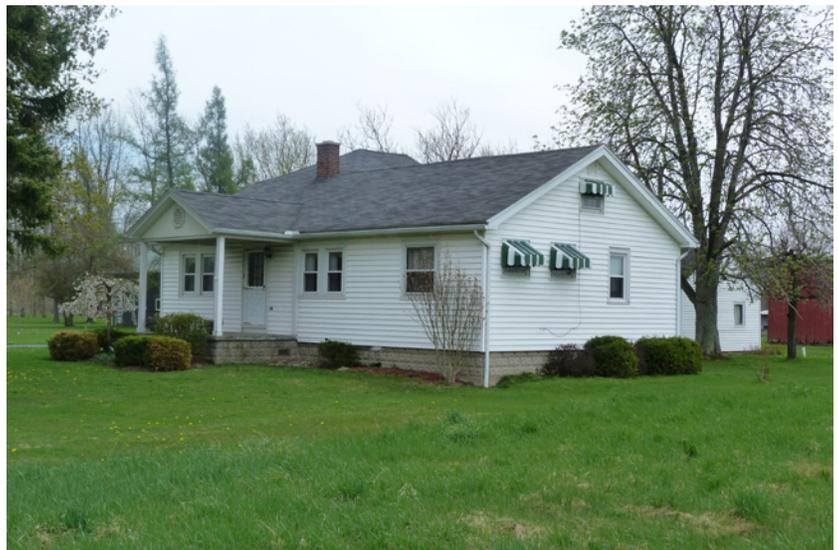
## 8620 Tonawanda Creek Rd.

### Significance: Low

Property contains a c. 1920 vertical wood plank barn with saltbox roof, contemporary pole barn, and small gable roofed contemporary metal building. Property also contains an abandoned vertical wood plank gable roofed structure and a former privy immediately next to the creek bank, both likely dating to the late 19th century. Property may have originally been associated with the farmhouse and carriage barn at 8625, but these are now separate parcels.
