**RECONNAISSANCE LEVEL SURVEY  
of Barns and Agricultural Structures**

Town of Clarence, New York

September 30, 2014

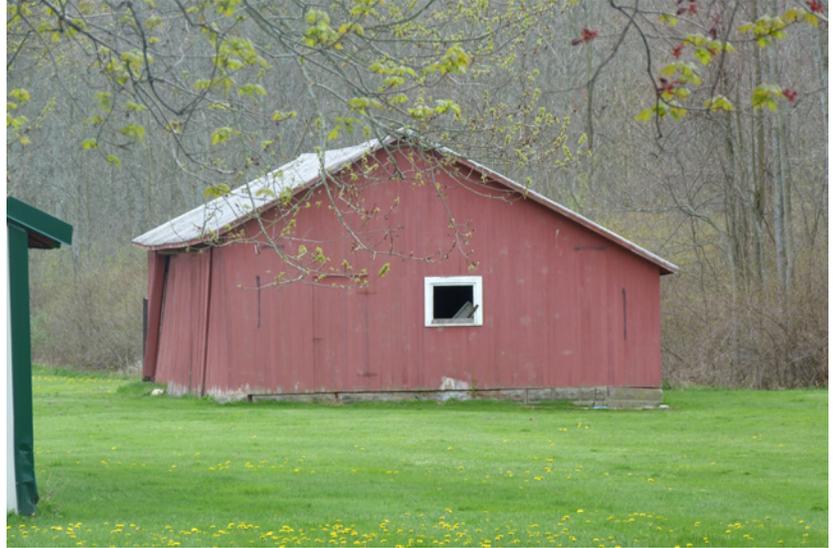
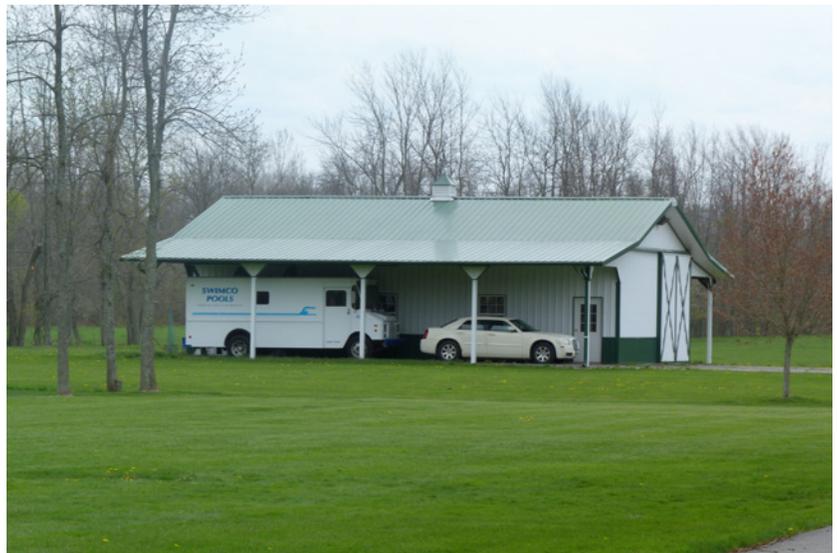
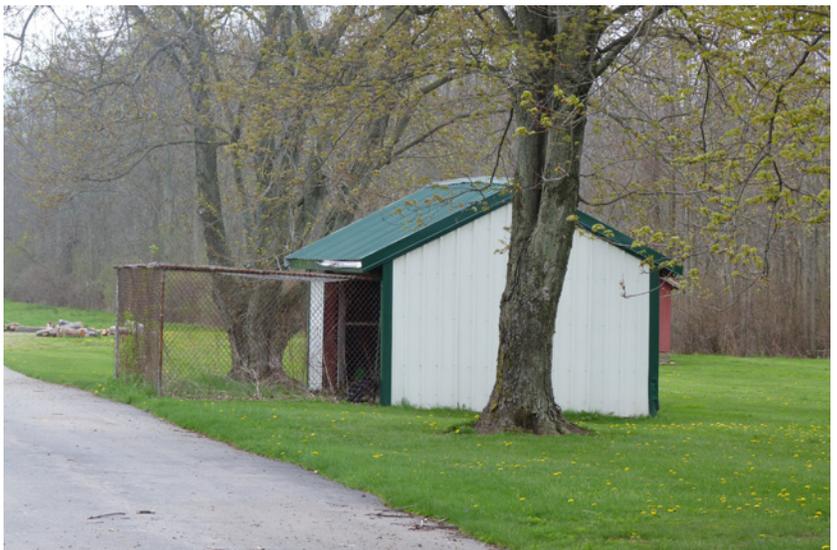
## 8625 Tonawanda Creek Rd.

### Significance: Low

Property contains a c. 1870 Italianate-style farmhouse with ashlar stone foundation and contemporary rear addition. Farmhouse retains its exposed wood clapboard siding.

Property also contains a vertical wood plank carriage barn that has been converted to a garage. Exterior walls of carriage barn have been largely replaced with plywood, but former hay door with strapwork hinges remains above garage door and circular window may be a former martin hole. Barn and creek-side buildings at 8620 may have originally been associated with this property.

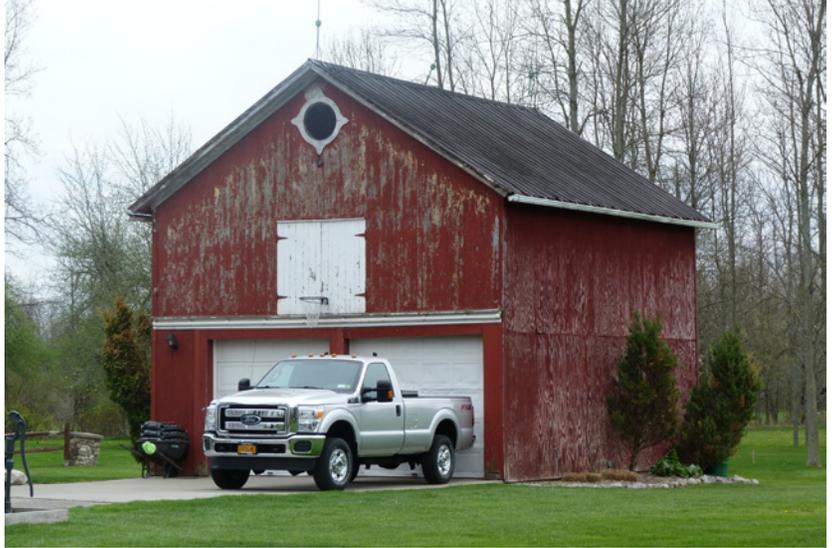
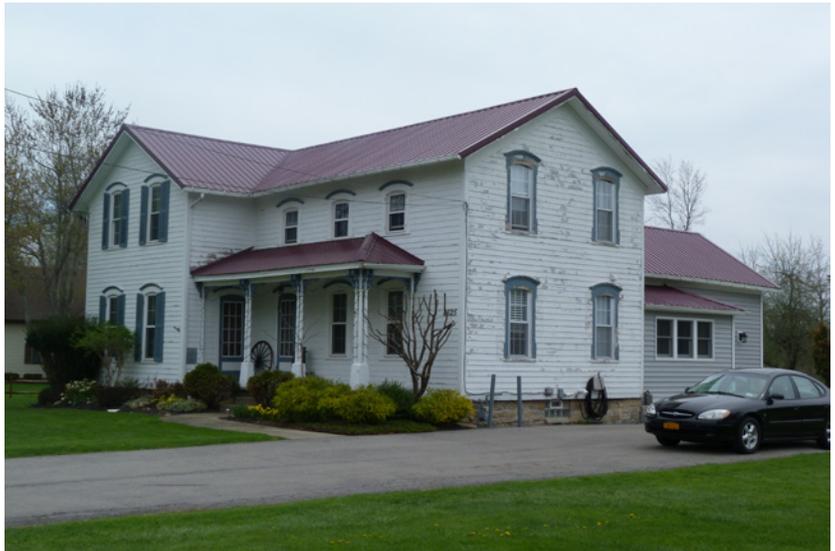
# 8935 Tonawanda Creek Rd.

## Significance: Low

Property contains two gable roofed barns, one dating from c. 1880 and the other from c. 1915. The older barn a stone foundation that has been replaced with concrete in some areas and has lost nearly all of its exterior walls so that its entire heavy timber frame is exposed. The frame has diagonal framing above its center beam, as would have been built for use with a hay trolley. The newer, smaller barn retains most of its exterior walls and features a hay hood and hay door with strapwork hinges.

Property was likely formerly associated with the c. 1870 residence across the street at 8930, but it is now on a separate parcel. Two stone pillars remain at either side of an entry road to the property.

Property has diminished integrity due to the condition of the larger barn.

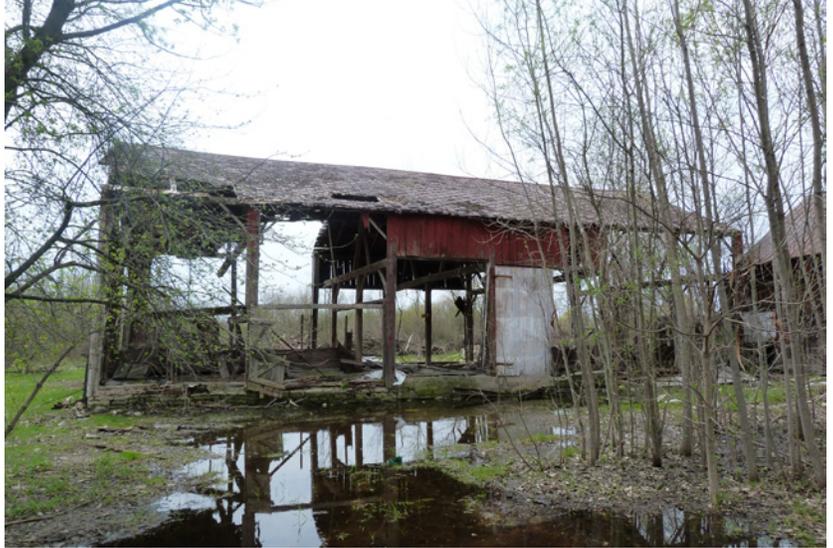
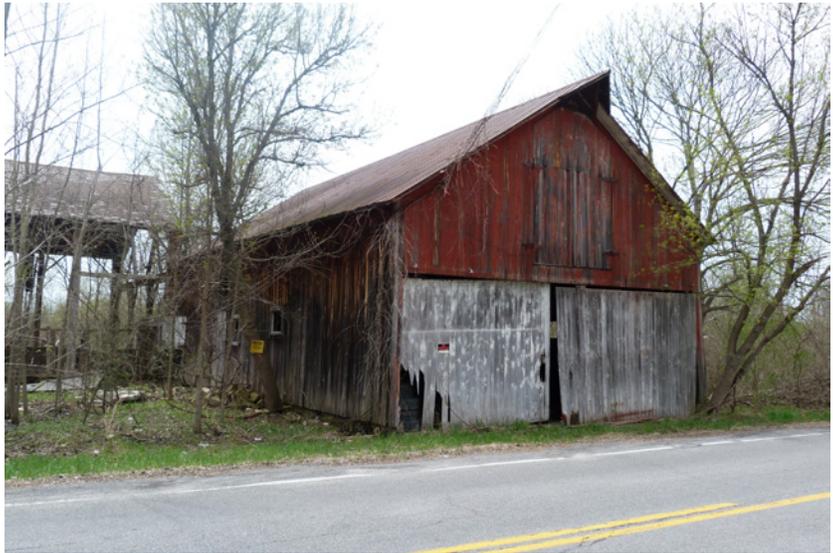
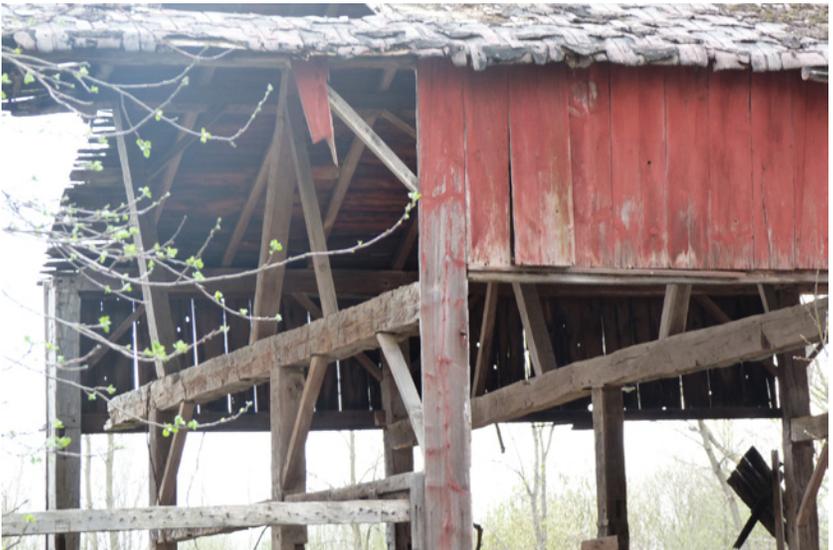
## 8945 Tonawanda Creek Rd.

### Significance: None

Property contains a vertical wood plank gable roofed English barn with ashlar stone foundation, constructed c. 1880, that was converted into a garage and is now partially collapsed from at its center. Property also contains a ranch-style residence, c. 1960. Original farmhouse no longer exists.

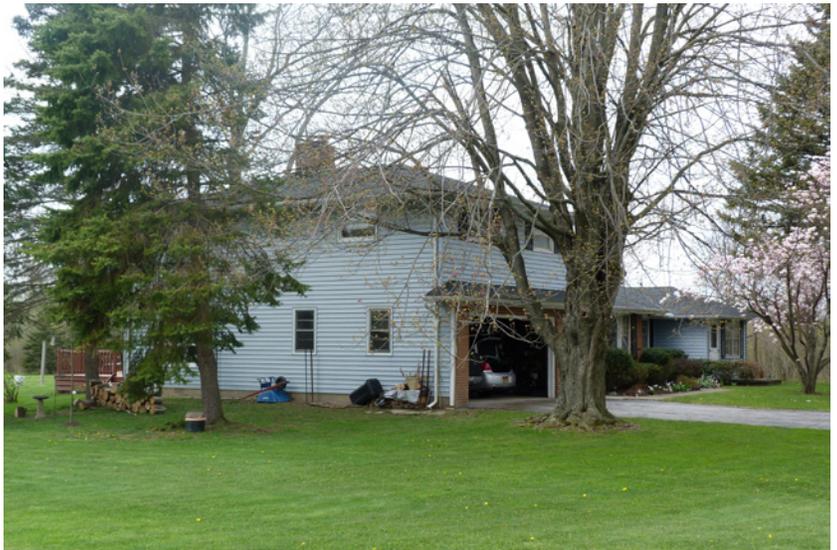
# 9065 Tonawanda Creek Rd.

## Significance: Low

Property contains a c. 1860 farmhouse with ashlar stone foundation and a large vertical wood plank barn with stone foundation, likely also c. 1860, and a contemporary pole barn. Gable peak of barn has a martin hole that was likely originally star-shaped but has been enlarged by weathering. Farmhouse has received vinyl siding and windows. Barn door and door rail has been removed and infilled. Ghost of former addition remains on side wall of barn.

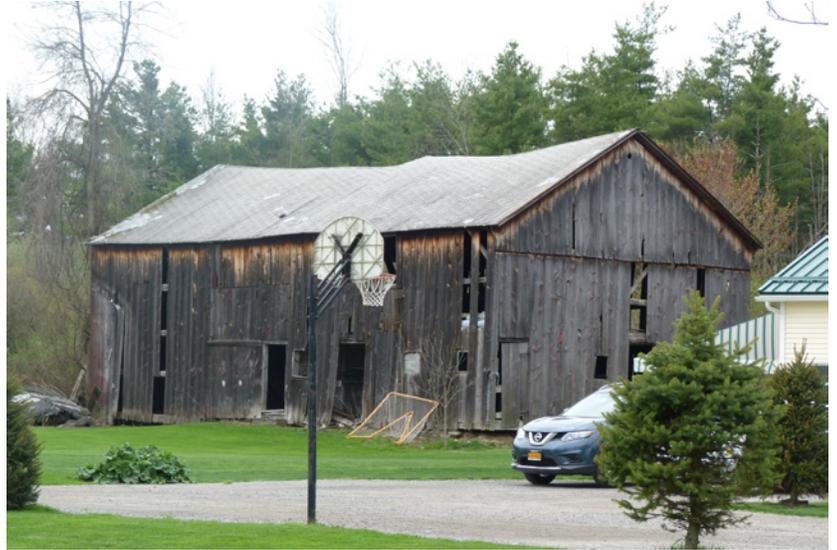
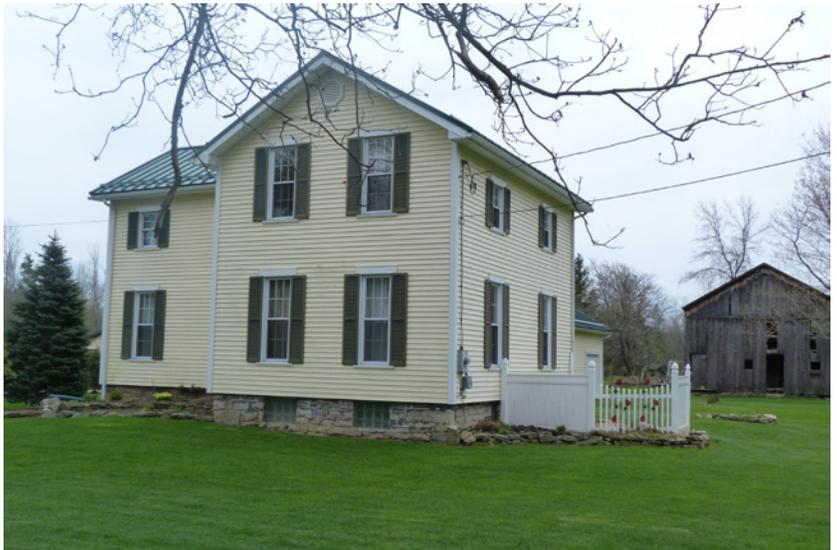
# 9185 Tonawanda Creek Rd.

## Significance: Low

Property contains a c. 1920s residence and two large c. 1880 vertical wood plank gable roofed barns attached in tandem in the rear yard, Rear barn has very tall barn doors in its side. A garage door has been inserted into the gable end of the front barn. Front barn may be slightly newer than rear barn. Residence has been modified with additions and window modifications, and has been clad with vinyl siding, such that the original massing of the farmhouse is difficult to discern.

The very large size of the barns suggest that these were once part of a larger farming complex, but that context is no longer present.

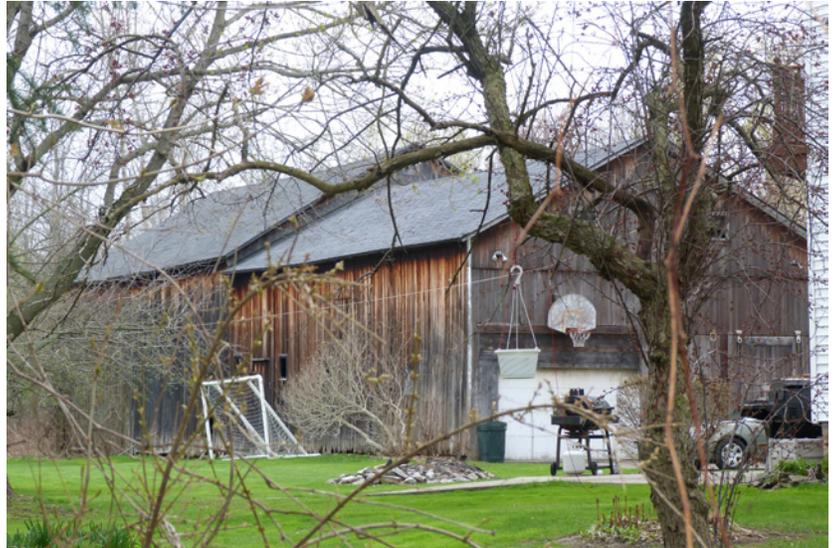
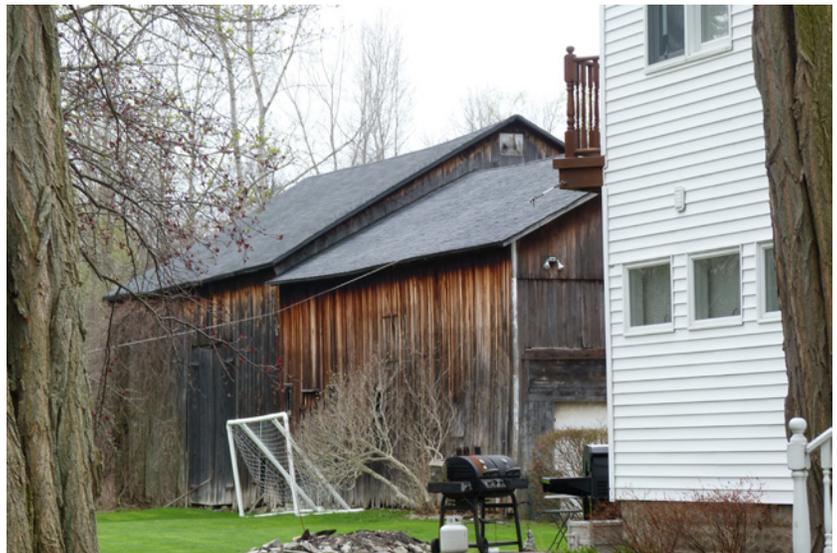
## 9221 Tonawanda Creek Rd.

### **Significance: Low**

Property contains a c. 1920 gambrel roofed vertical wood plank barn, a c. 1870 farmhouse with ashlar stone foundation, and c. 1960 residence. Barn has a gable roofed addition and added windows and doors. Farmhouse has received window alterations and vinyl siding.

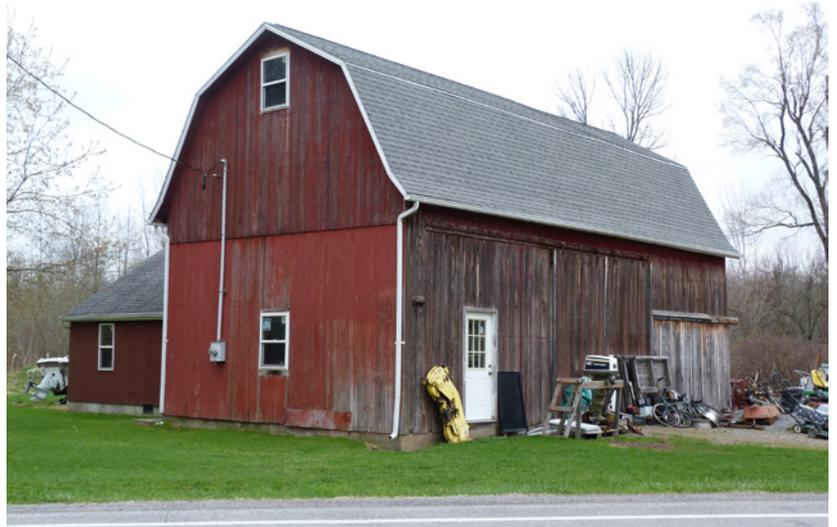
## 9415 Tonawanda Creek Rd.

### Significance: Low

Property contains a cross-gabled c. 1880 vertical wood plank barn. Barn retains original barn door and door rails, but has been adapted as a garage, windows have been added to the second floor, and a concrete block chimney has been added. Property also contains an open carport, an abandoned c. 1925 residence, and a concrete block commercial building (former restaurant or similar.)

Residence has received multiple rear additions and has been vinyl sided, but retains its original wood windows.

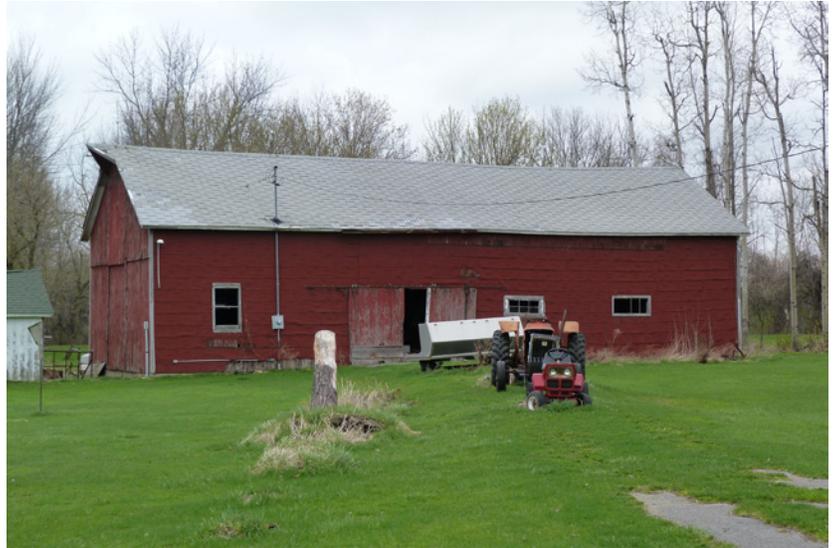
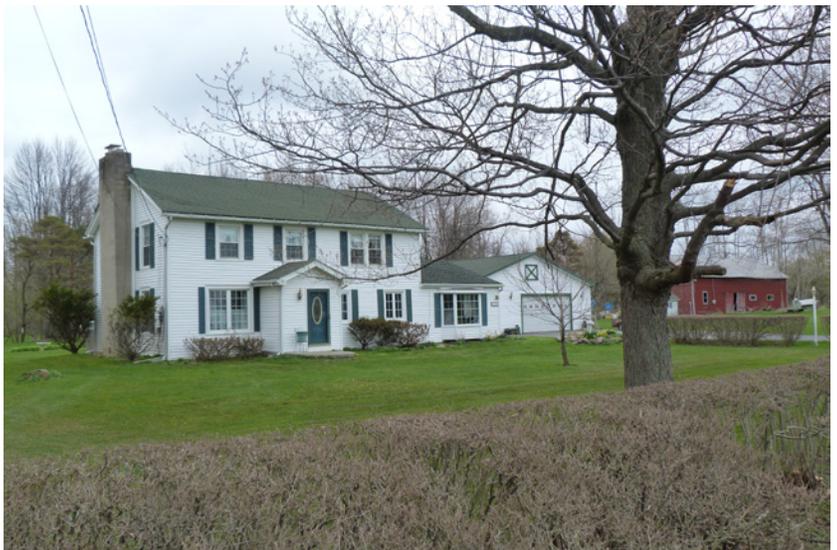
## 6995 Transit Rd.

### Significance: Medium

Property contains a large c. 1900 cross gabled gambrel roof “basement” barn that has been converted to a multiple-unit retail center, two vertical wood plank c. 1880 gable roofed barns in the rear that have been converted to garages, and a board-and-batten sided storage building that has been adapted as a retail store. Complex was likely formerly a dairy farm.

Especially given their change in use, all the barns including the main one retain much of their historic detail. The large main barn retains its metal ventilators, some of its wood windows, circular martin hole converted to a window, and the winch beam at the hay hood. New awning and windows have been added at the first level only. Overall, farm complex remains largely intact. The high-style Italianate residence, c. 1875, now on a separate parcel at 6989 Transit may have been the original farmhouse.

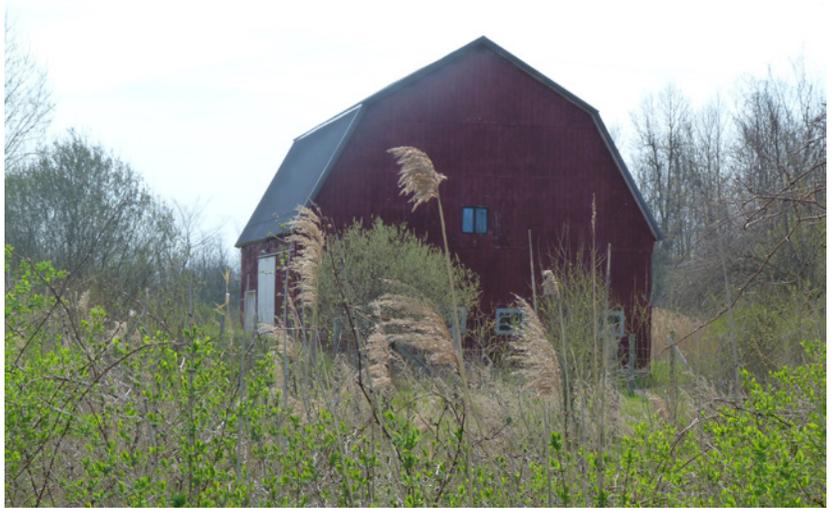
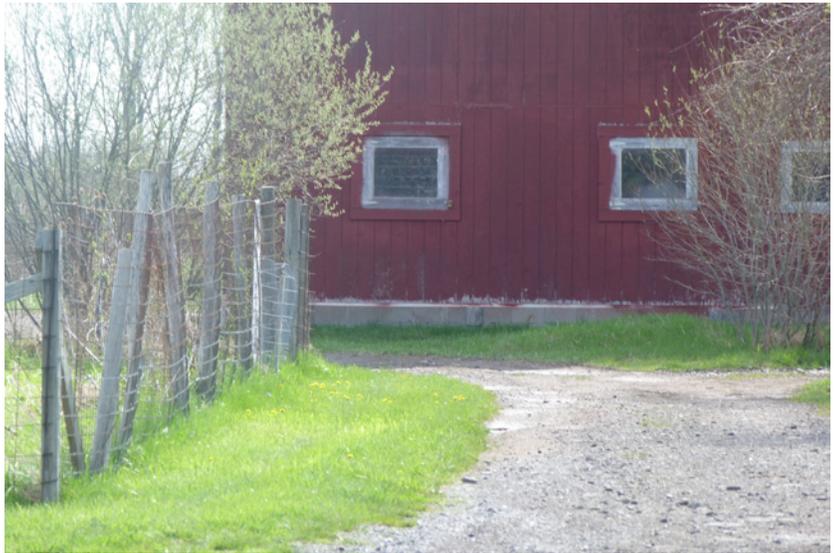
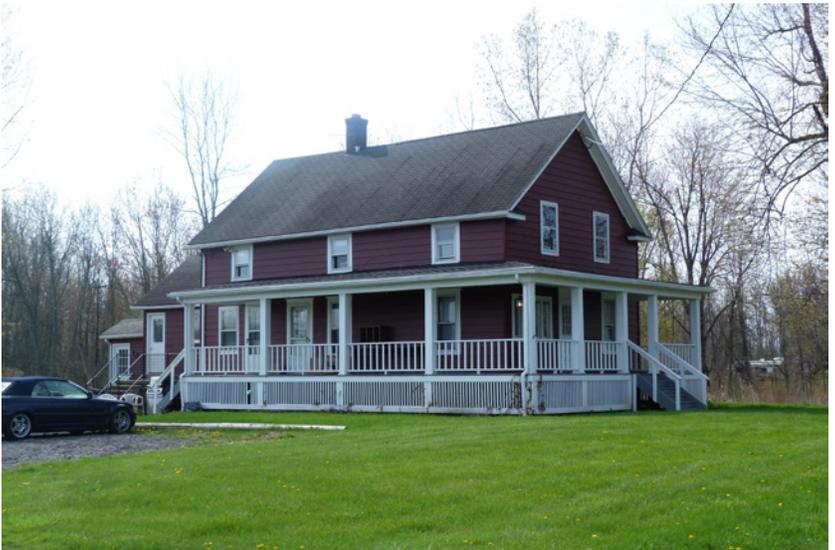
Property contains a c. 1925 farmhouse and gambrel roof barn of similar age. Garage door has been added to the side of the barn, but original barn door remains, and windows have been added to the first and second floors of the gable ends. Farmhouse retains its original wood windows and doors.

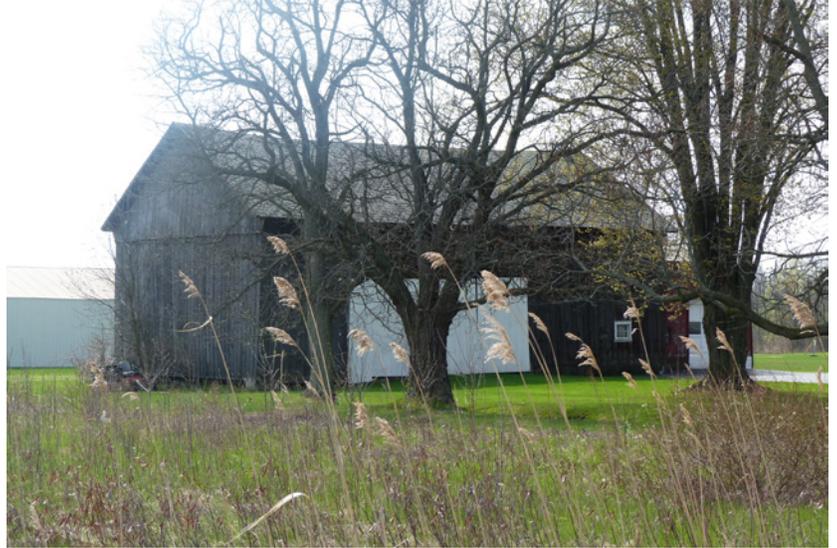
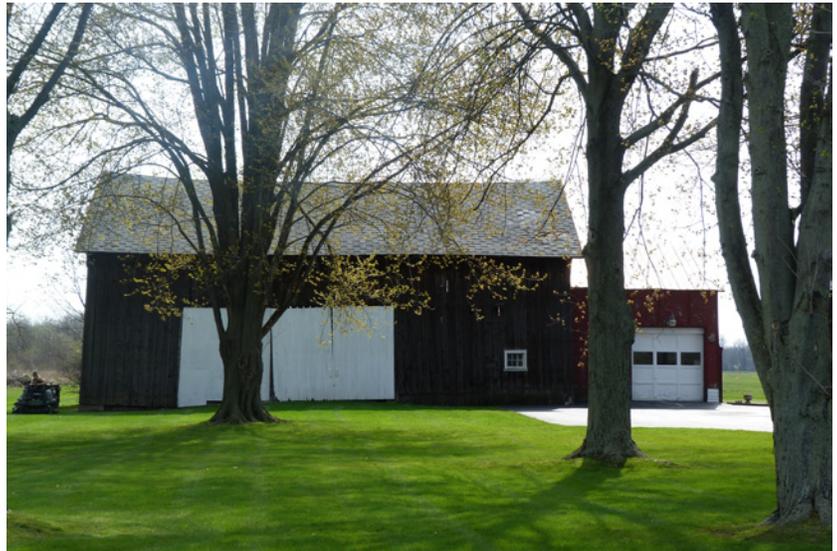
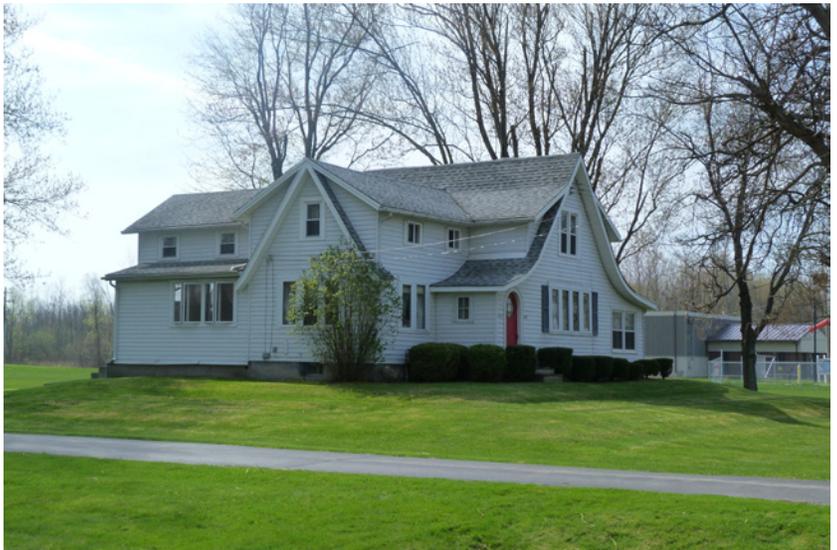
## 806 I Transit Rd.

Property contains a c. 1880 vertical wood plank gable roofed English barn with star-shaped martin hole in its south gable end. Earth is slightly ramped leading up to door of barn. Barn received a gable roofed addition that dates to the early 20th century but has been clad in plywood. Property also contains a frame hipped roof garage and a farmhouse.

The farmhouse dates from c. 1930 and was once a Tudor Revival building. All the Tudor detailing has been covered with vinyl siding and multiple additions have been added to the roofline and the rear, but the sweeping eaves and rounded-top front door are common features of the style.

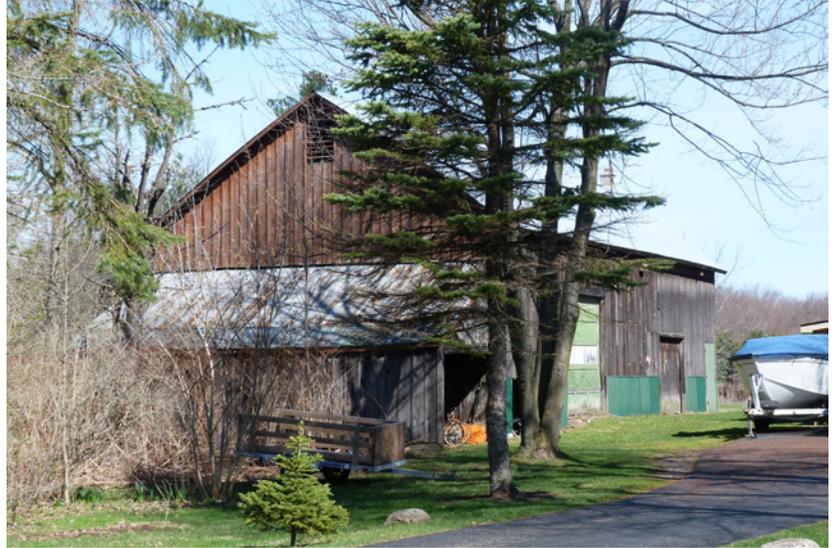
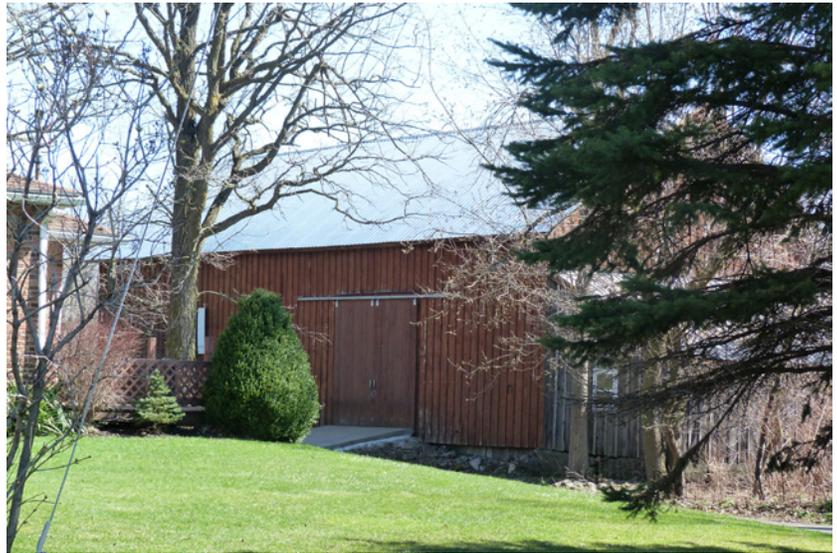
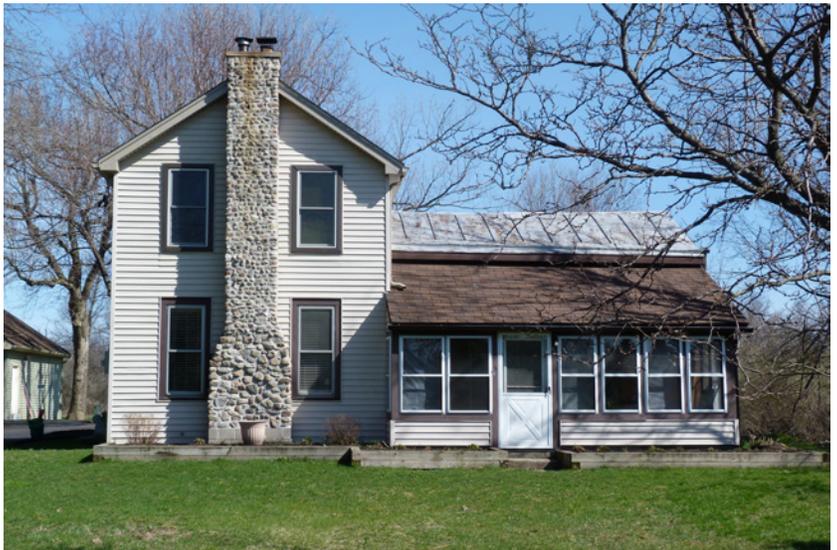
# 9500 Wehrle Dr.

Property was likely a former dairy farm and contains a c. 1870 vertical wood plank gable roofed English barn with shed-roofed milking shed addition. End of barn opposite the milk shed may be a later addition because it uses different plank size from central portion. Barn door on one side of the barn has been removed, garage door added, and walls infilled with various materials. Gable end and other side have been sided with board-and-batten siding and barn doors and rail have been replaced.

Farmhouse likely dates to c. 1870 as well. Sun room addition has been added to its front and the house has been clad with vinyl siding. Stone chimney is a recent addition. Property also contains a contemporary frame garage and two small gable-roofed chicken coops.

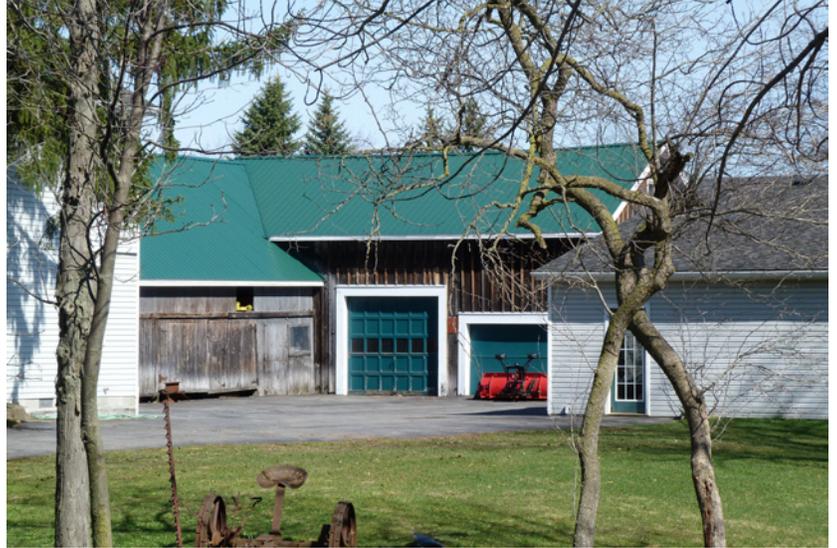
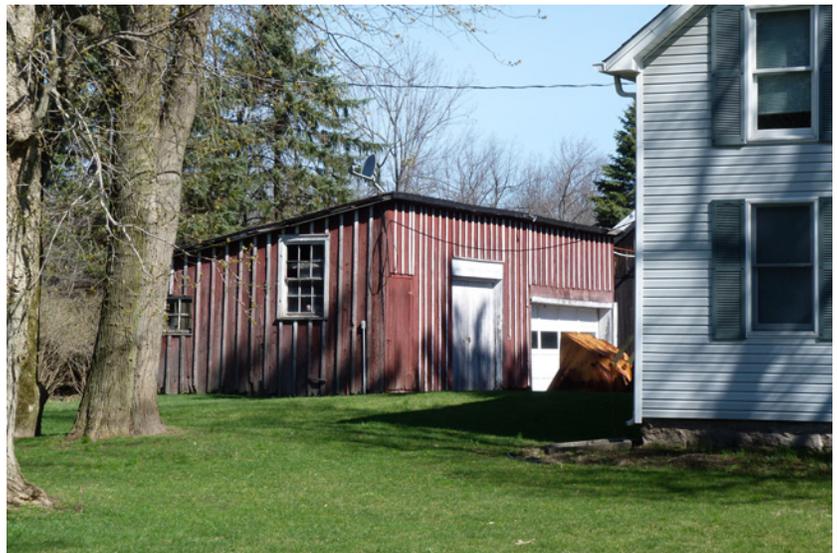
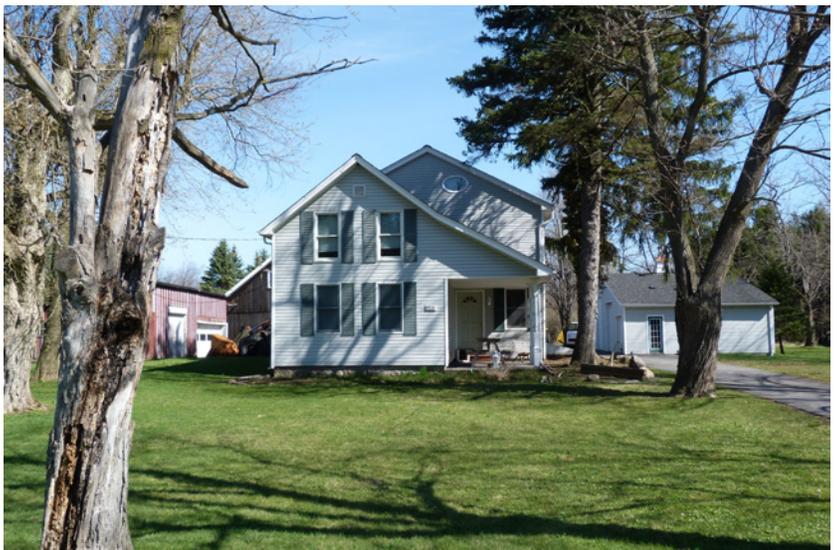
## 9530 Wehrle Dr.

Property contains a vertical plank sided gable roofed barn dating to the 19th century that has been added on to and is now part of a larger garage. The property also contains a late 19th or early 20th century shed-roofed chicken coop. Farmhouse dates from the late 19th century as well, but its massing has been significantly altered due to multiple additions over time. A contemporary frame garage is also present.

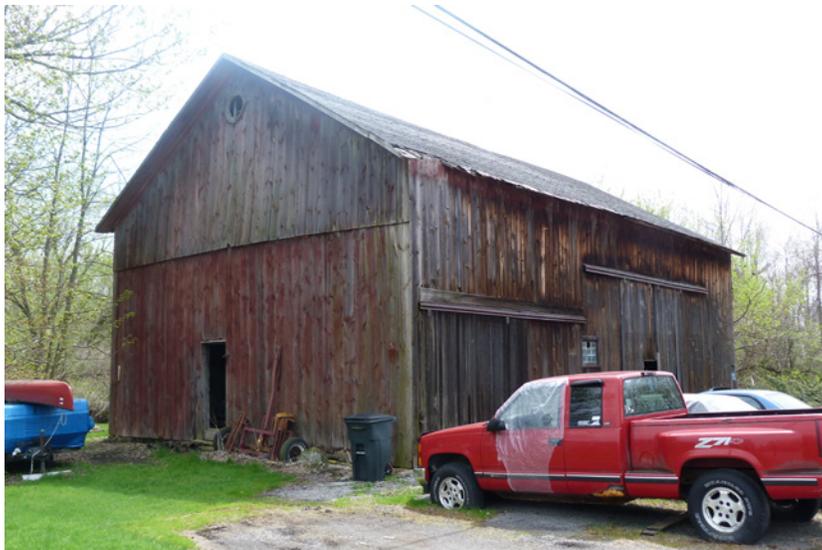
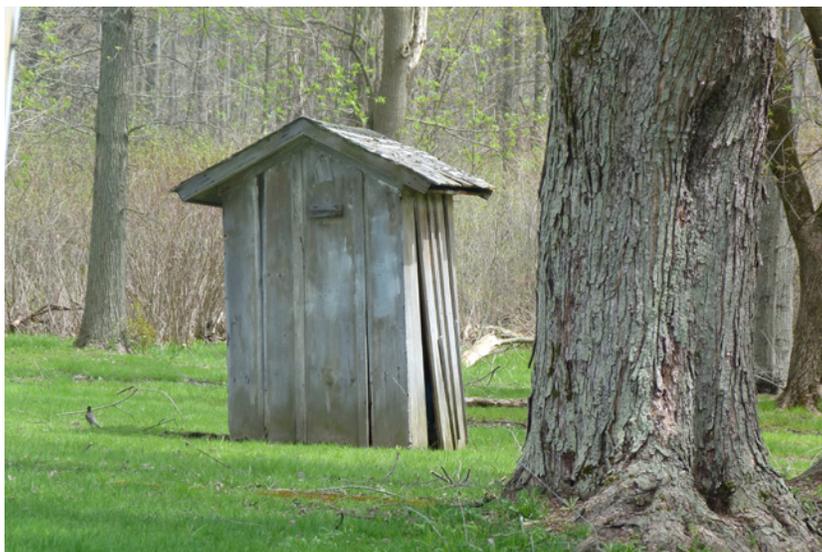
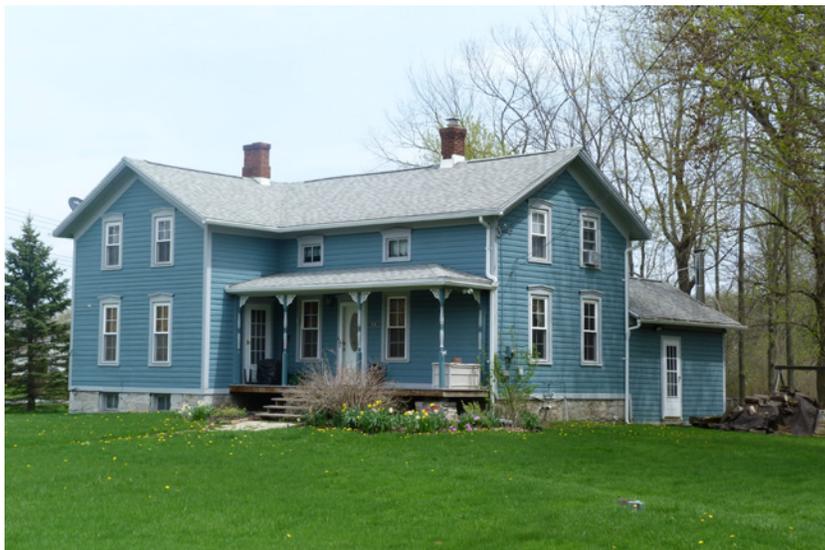
## 8145 Westphalinger Rd.

Property contains a vertical plank sided gable roofed barn, constructed c. 1870, that features a circular martin hole in its gable peak with ornamental wood surround. A very intact c. 1870 Italianate style farmhouse with stone foundation, exposed wood clapboard, original wood windows and possibly original porch supports. Small gable-roofed shed remains, which make a former privy.

Property has high integrity due to intactness of both barn and farmhouse and thus likely meets landmark criteria. Further study including interior access would be preferable to better determine the significance of the barn.

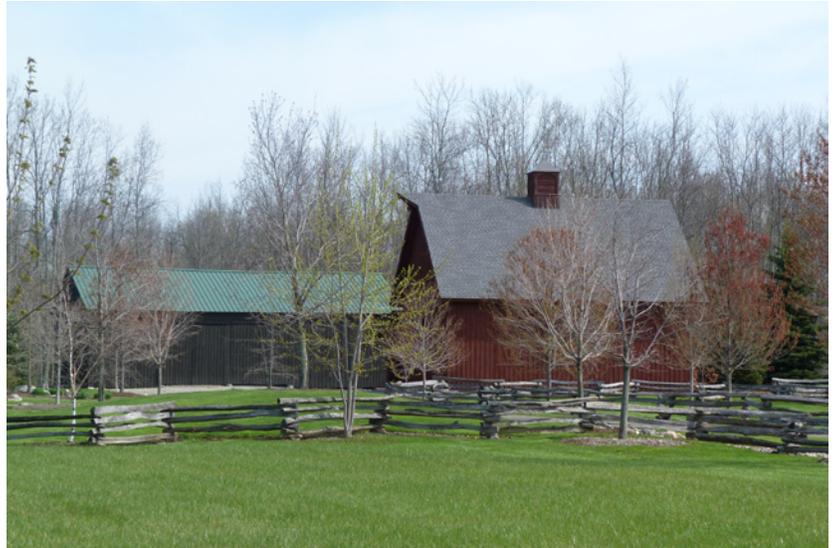
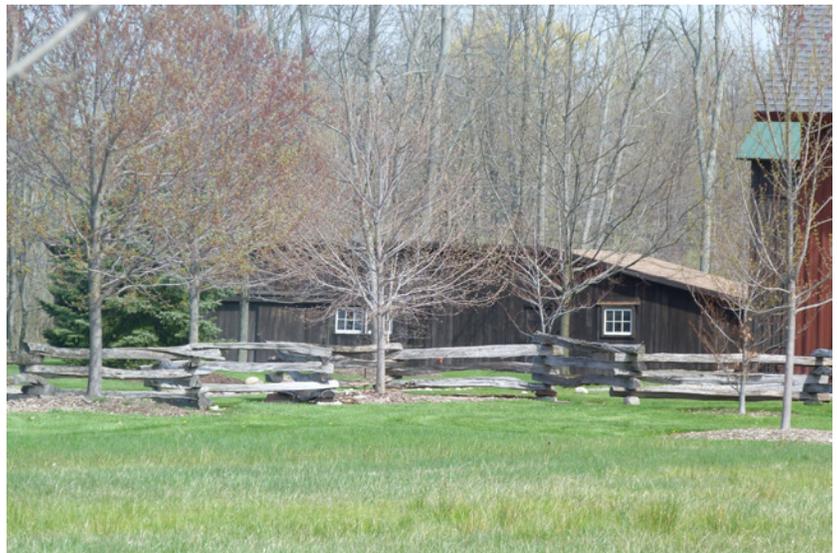
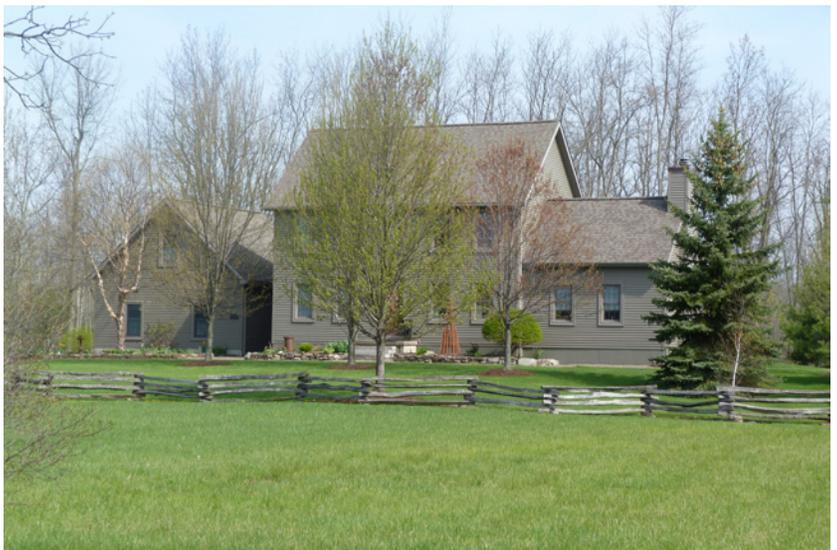
## 8060 Wolcott Rd.

Property contains an “idealistic” replica farm complex that is intended to look historic and like it was built in stages over a long period of time, but was actually constructed around the 1990s. Replica structures include gable roofed and gambrel roofed barns, a chicken coop, and a large farmhouse built to look like it had received additions over time. The property is bounded by a split-rail wood fence of a type that was once widespread in Clarence but is now rare.

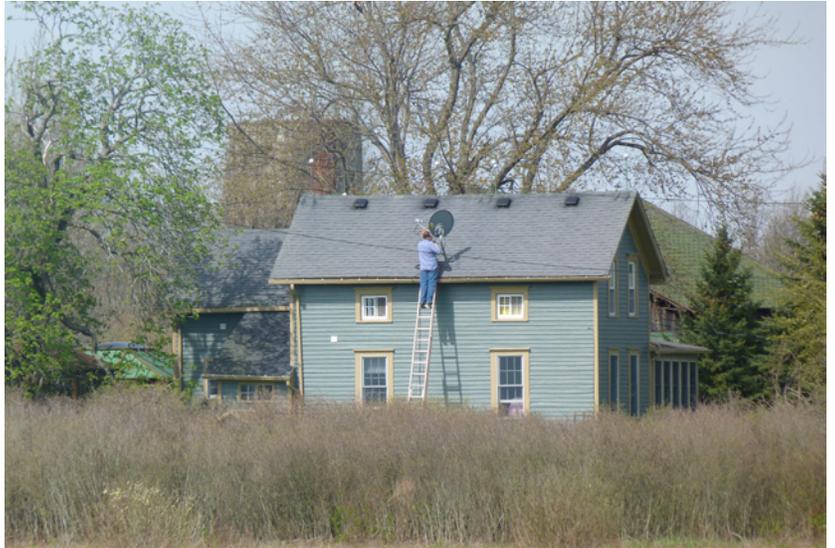
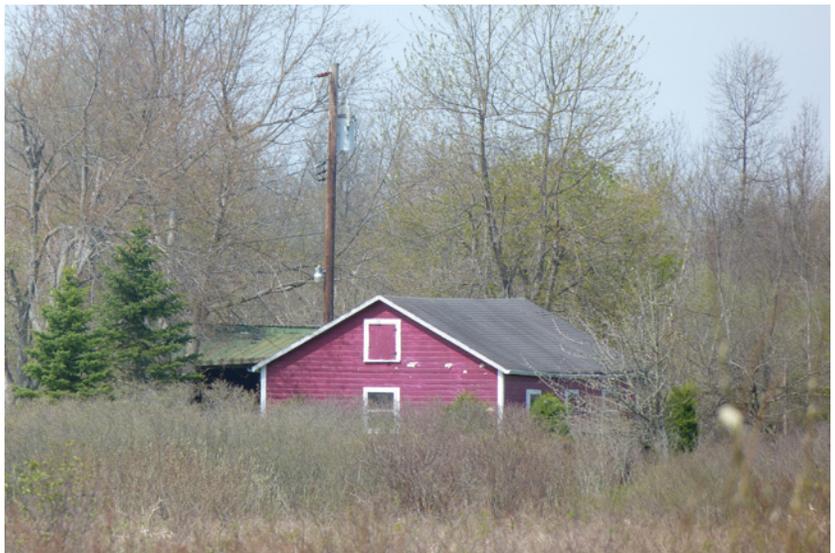
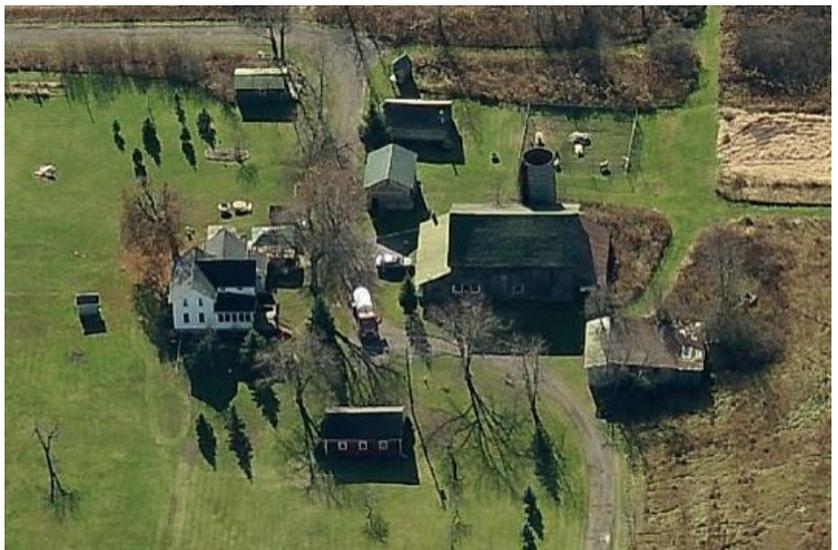
## 8535 Wolcott Rd.

Property is a large farm complex. It is set far back from the rear, so access was difficult. Further study including on-site access is needed to fully catalog the structures on this property.

Based on the photos that were possible to get and aerials from Bing Maps (bottom photo), property contains a c. 1850 Greek Revival farmhouse, gable roofed barn with shed addition, and concrete or concrete block silo, piggery, chicken coop, and miscellaneous other structures.

*Aerial view from Bing maps, looking east*

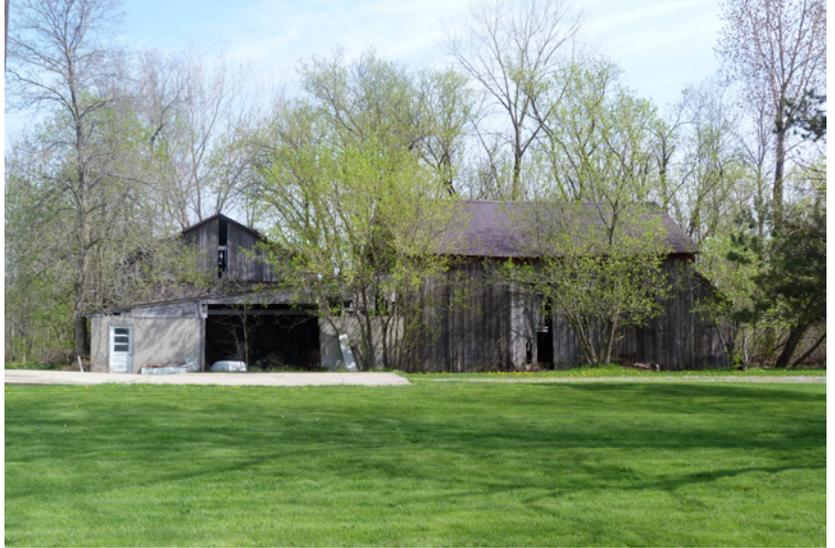
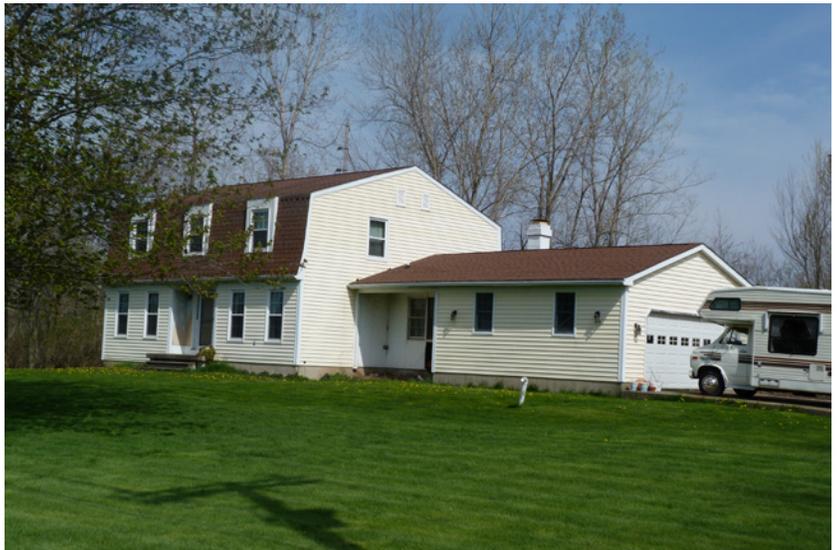
## 8600 Wolcott Rd.

Property contains two 19th century vertical plank gable roofed barns arranged in an L-shaped configuration and joined by a concrete-block shed-roofed structure. Front barn has a wood shed-roofed addition to its gable end, perhaps a milking shed. A 1970s residence and garage is also present on the property. The original farmhouse is no longer present.

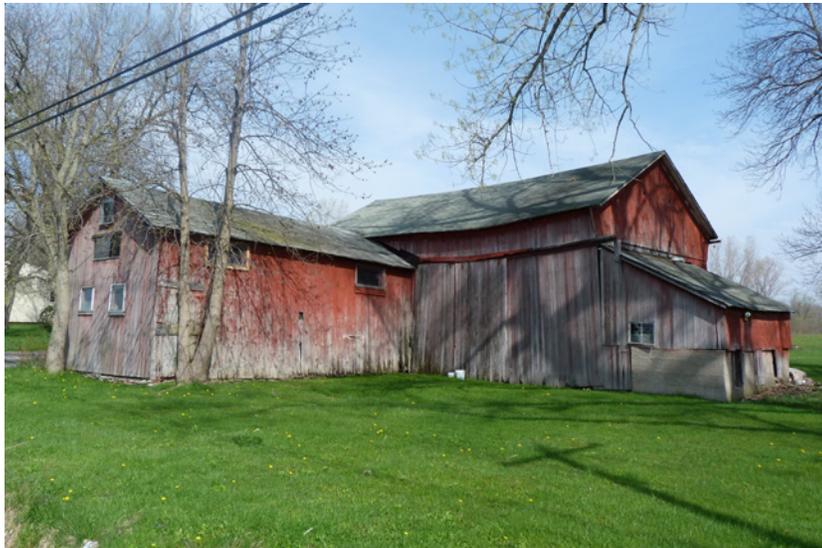
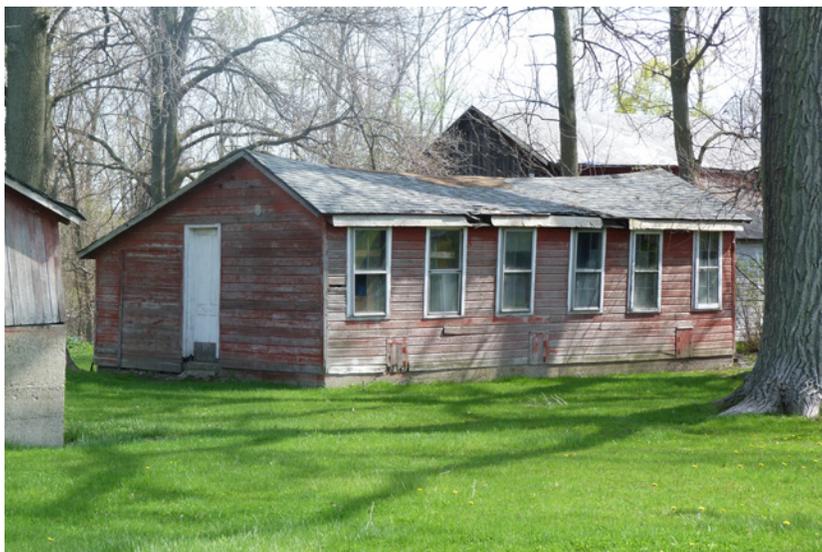
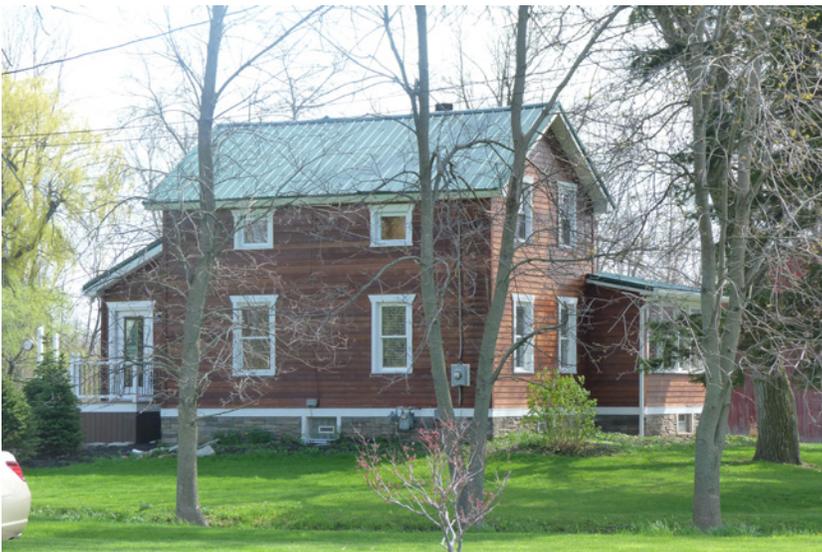
## 8620 Wolcott Rd.

Property contains a Greek Revival farmhouse, cross-gabled vertical wood plank barn with milking shed addition with concrete base, and piggery with saltbox roof. Both farmhouse and barn date to c. 1855. The barn and farmhouse was likely built by some of the first Prussian immigrants soon after arriving in Wolcottsburg. The farmhouse has been siding with new wood siding and has received large front and side additions.

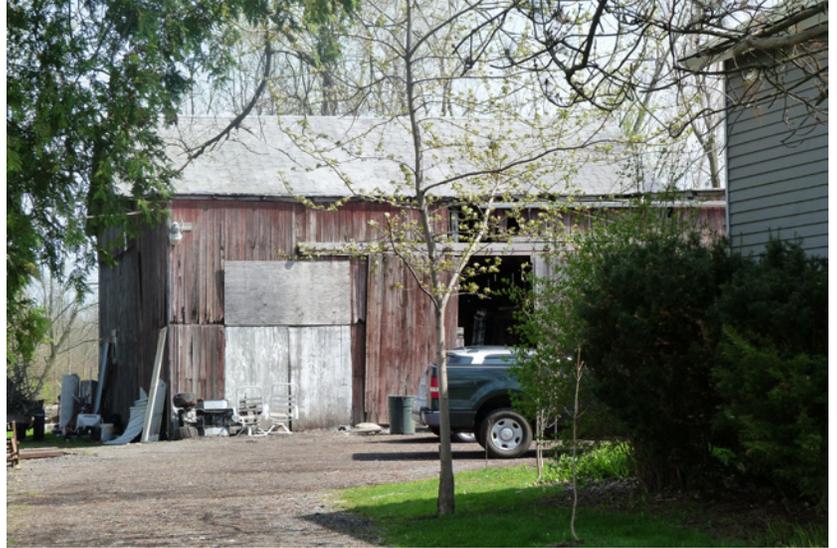
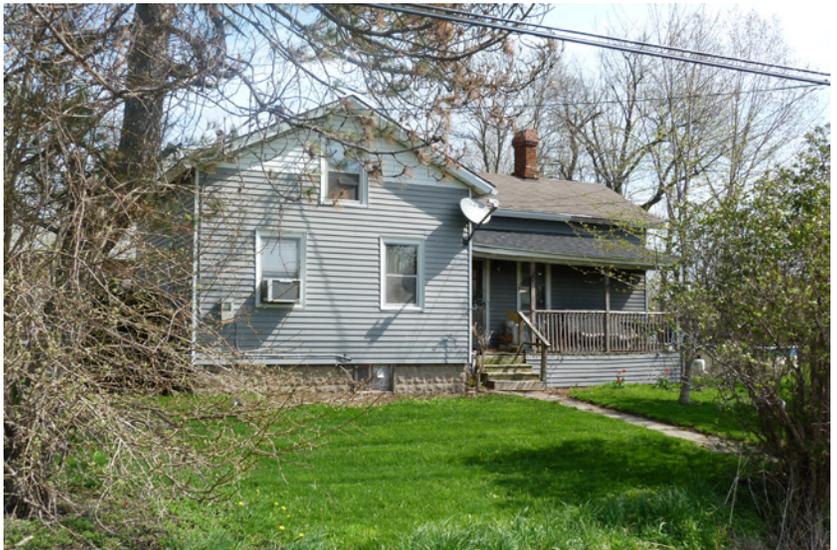
## 8640 Wolcott Rd.

Property contains a c. 1870 farmhouse and a vertical wood gable-roofed English barn of similar age. Chicken coop, piggery, frame garage, and an additional gable roofed structure are present. The farmhouse is largely intact but has been vinyl sided. The barn walls have areas of plywood infill and the smaller gable roofed building has been sided with permastone. The piggery and other secondary structures are in deteriorated condition.
