**RECONNAISSANCE LEVEL SURVEY  
of Barns and Agricultural Structures**

Town of Clarence, New York

September 30, 2014

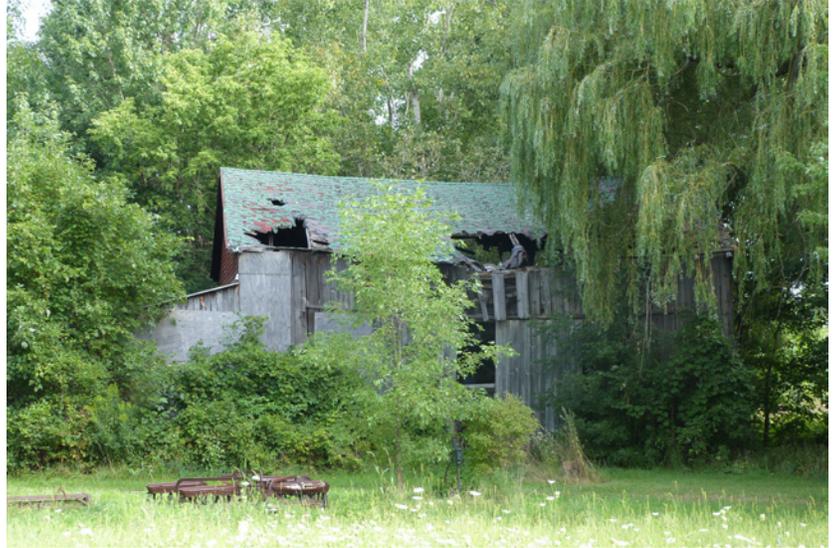
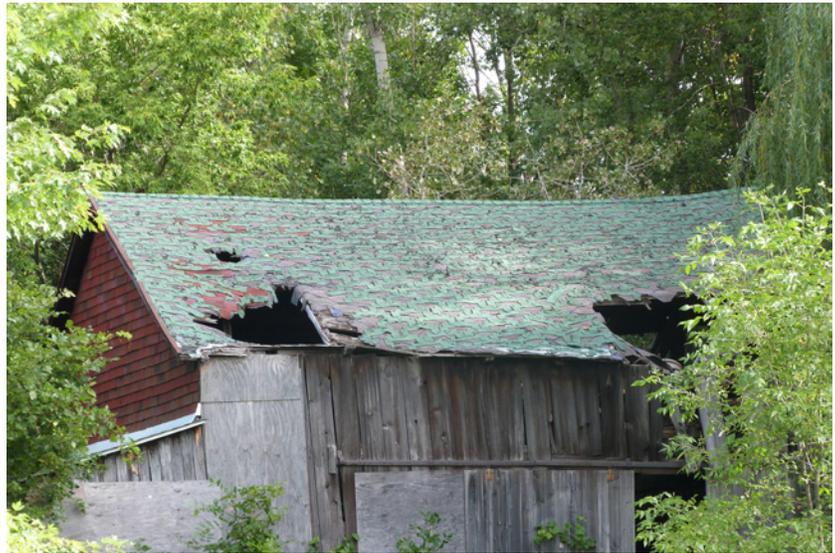
## 8660 Wolcott Rd.

Property contains a 19th century vertical wood plank gable roofed English barn with shed addition to the west, likely a milking shed, suggesting this was a former dairy barn. The barn has been largely subsumed in the tree canopy and exhibits partial collapse or the roof and side wall. Barn was previously partially clad in plywood and permastone.

A modest farmhouse is present on the property as well, but was not visible from the public right-of-way at the time of survey.

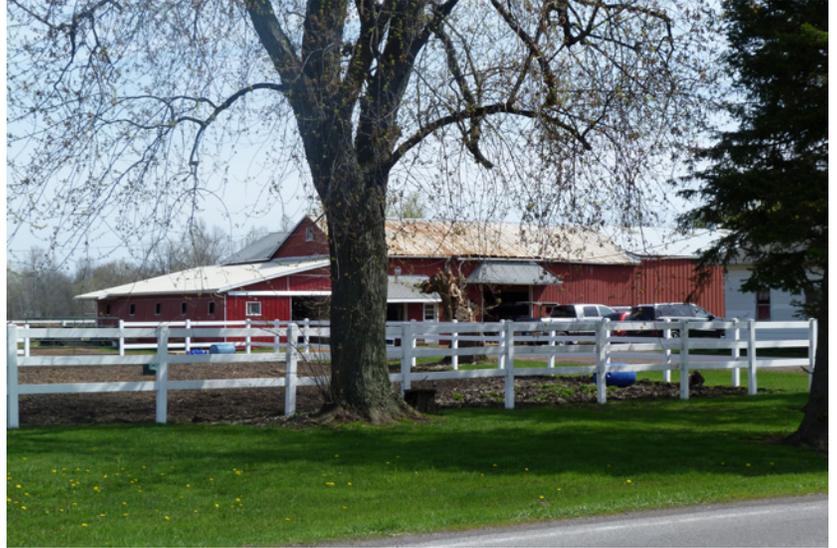
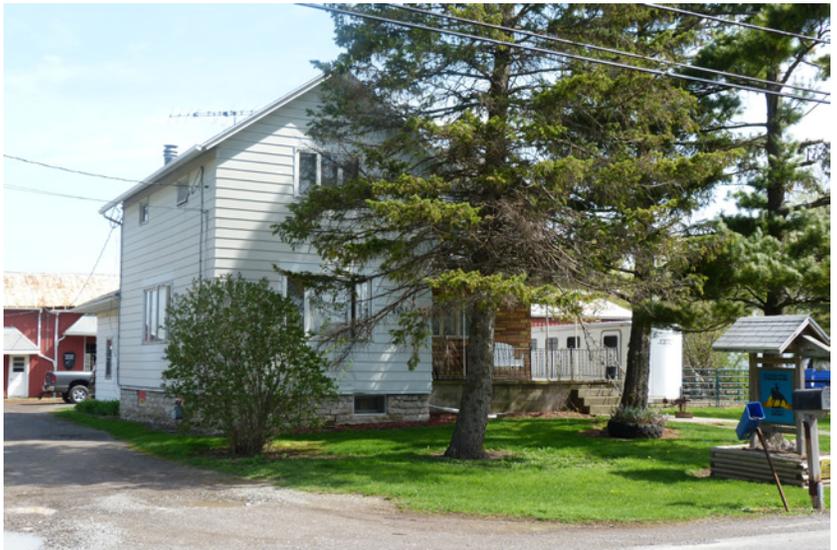
# 8690 Wolcott Rd.

Property is a horse farm that includes a c. 1870 farmhouse with stone foundation and a series of in-line 20th century metal barns, dating from the 1930s or 40s to present. Farmhouse has been sided with aluminum and permastone and many window openings have been modified.

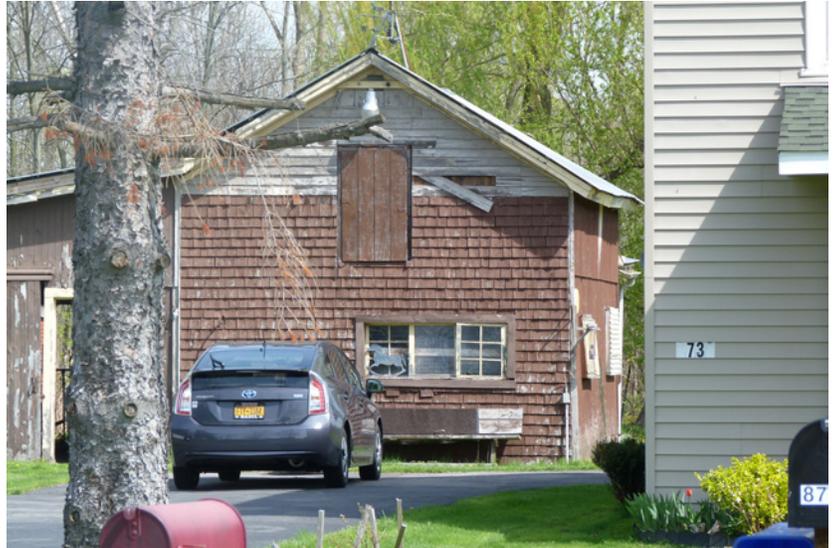
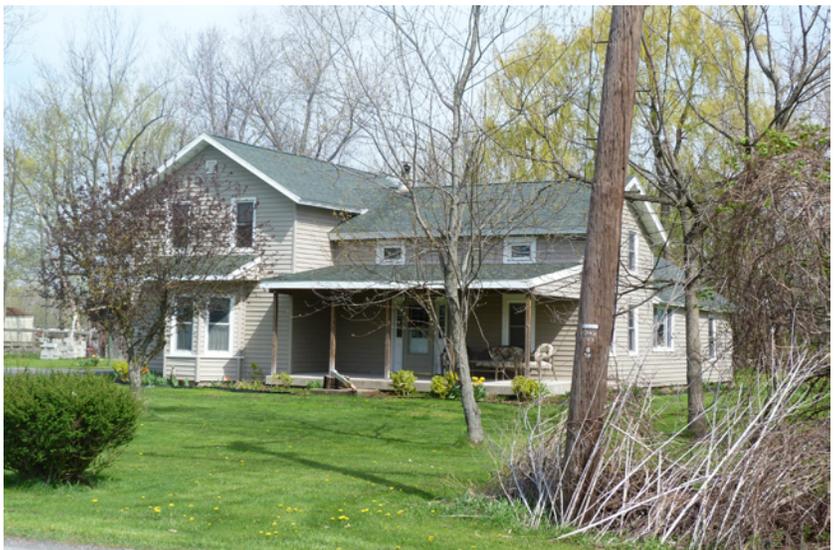
## 8730 Wolcott Rd.

Property includes a largely intact c. 1870 farmhouse with stone foundation, a contemporary metal garage, and an older structure that appears to be a small former barn with large shed roofed addition. that also extends behind the barn The barn portion is too small to be an agricultural structure and there is no evidence of barn doors on the side, so this is likely a former carriage barn and the door on the front was removed long ago and a window inserted instead (modification was likely c. 1935, based on the window style used.) The date and function of the shed roof addition is not known.

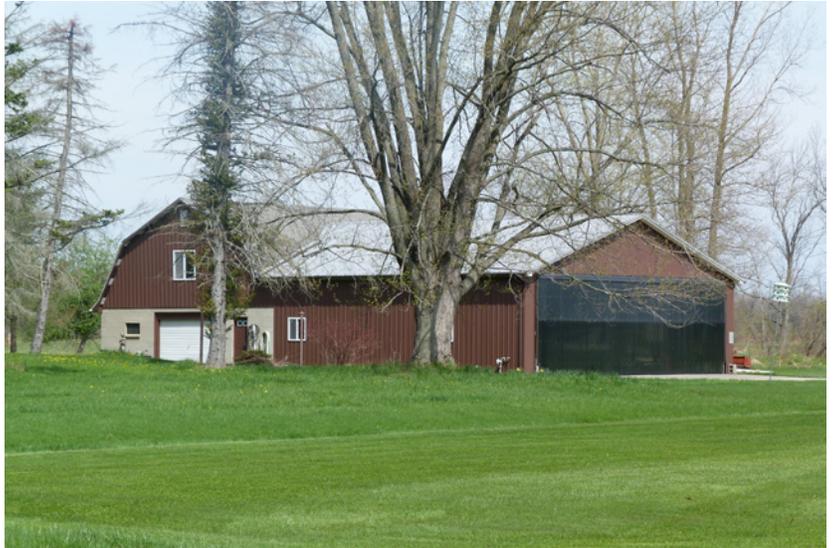
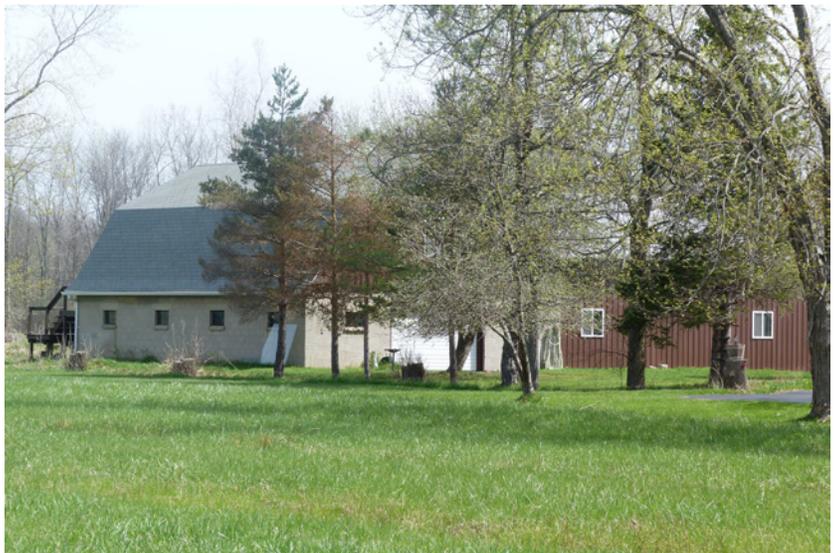
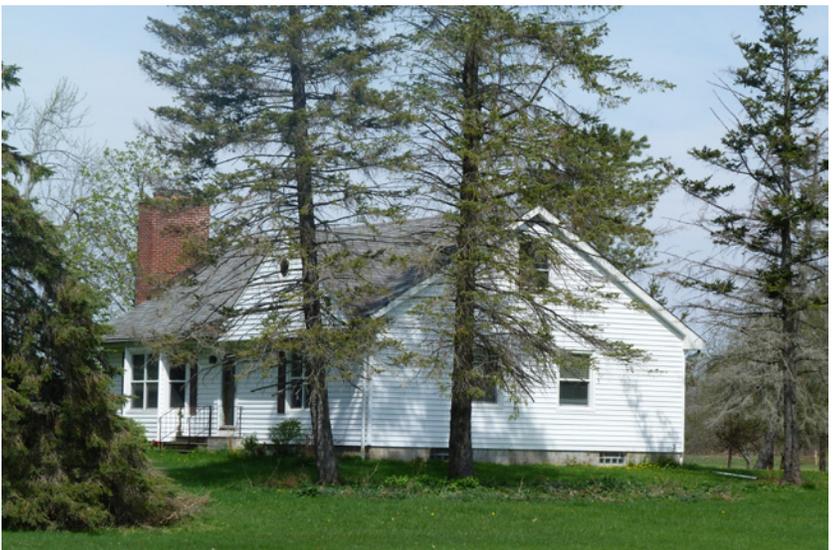
## 8890 Wolcott Rd.

Property contains a non-historic gambrel roofed structure with concrete block at first floor and metal siding above. It is possible that this was once an older barn, but if so it has been remodeled out of existence. Gable roofed addition to “barn” is an airplane hangar.

Property also contains a c. 1950s house with pedimented entry, bay window, and prominent brick chimney, as well as a frame garage.

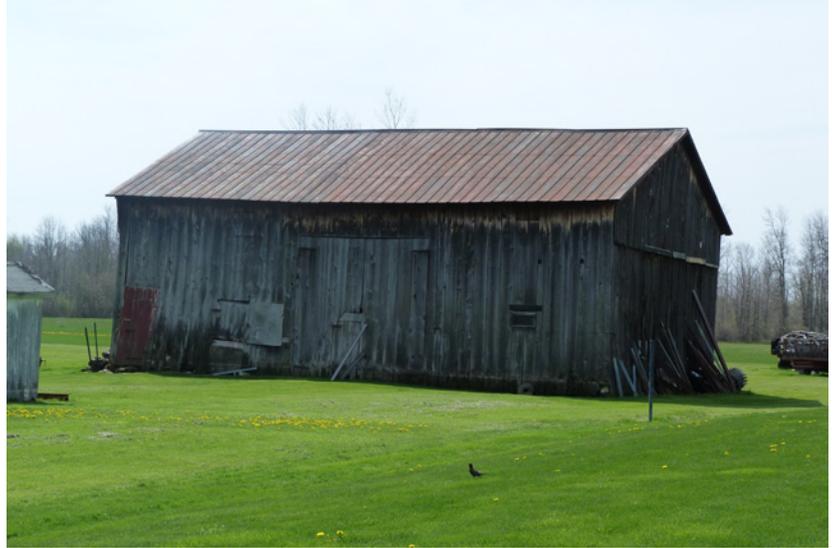
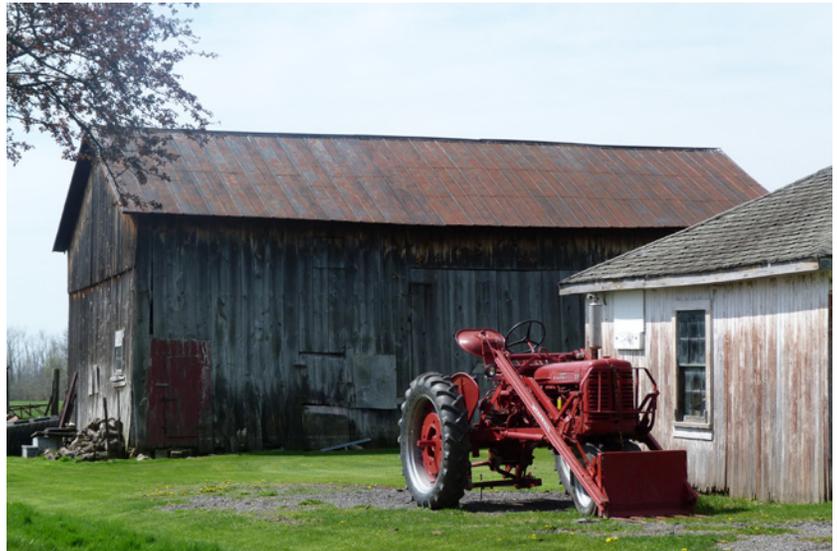
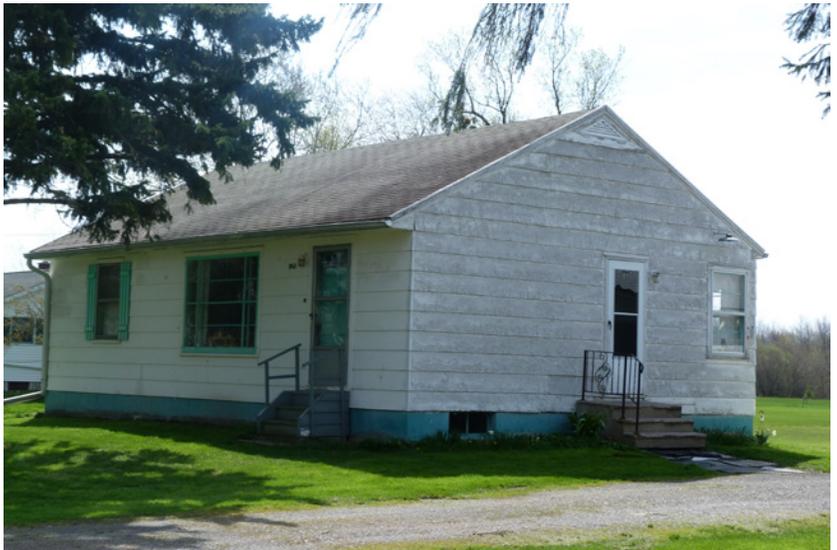
## 8965 Wolcott Rd.

Property contains a c. 1855 vertical wood plank gable-roofed English barn, small wood plank garage, and 1940s farmhouse. The barn appears to be one of the oldest in the North Country and likely was built soon after the Prussian immigrants arrived that settled this portion of Clarence. Both gable peaks feature martin holes, including a “barn cross” martin hole at the east gable peak. This barn is unique because it is one of the only ones in Clarence with hinged, not sliding, barn doors. Sliding barn doors were invented in the 1840s, but evidently the original owner did not adopt the new invention. The door hinges are quite ornate strapwork. Smaller doors on the barn also have strapwork hinges. The farmhouse is a very intact example of a 1940s tract house and may in itself contributing to the significance of the property because it is over 50 years old.

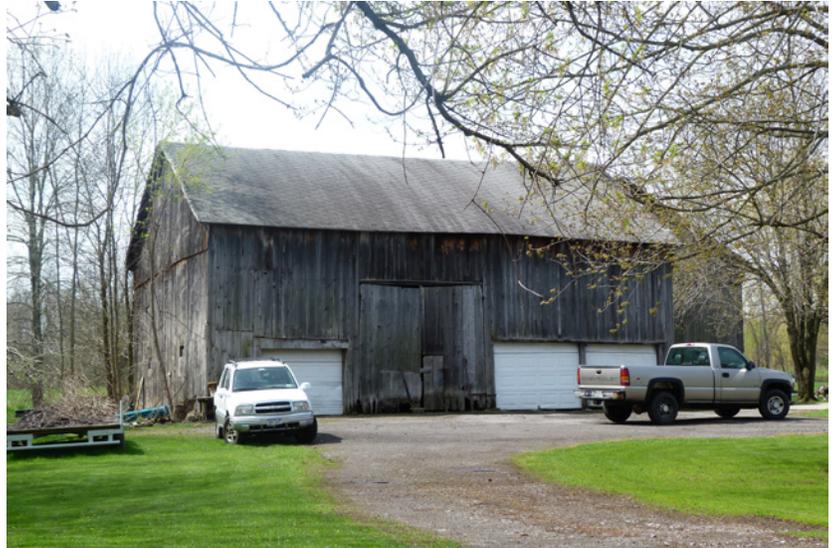
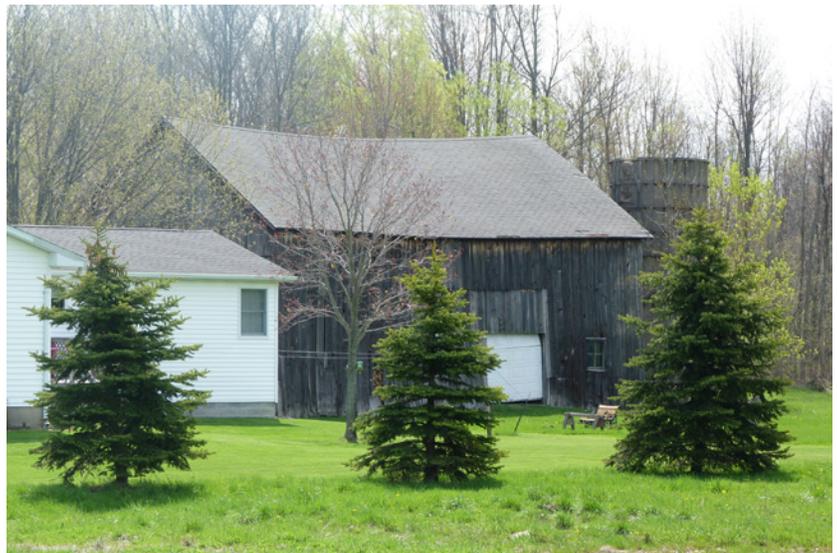
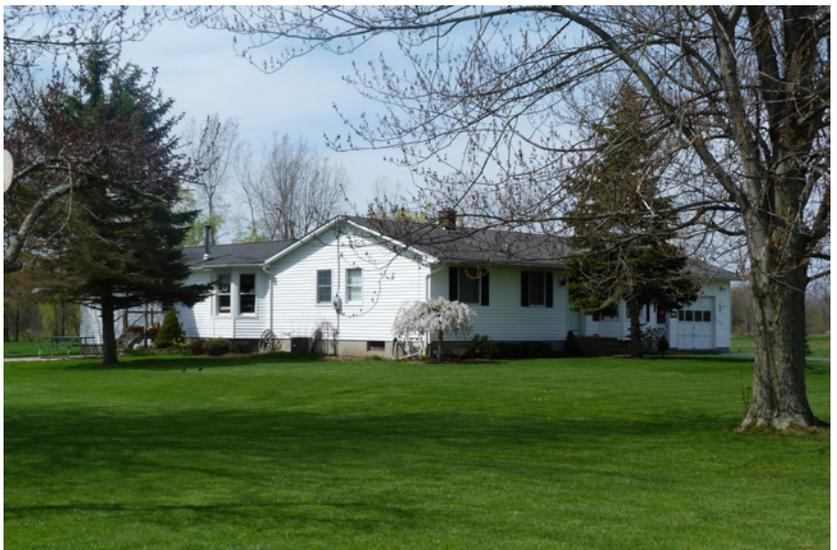
**Significance: Medium - possibly significant, further study needed**

Property contains two c. 1860 vertical wood plank gable roofed English barns, a concrete silo, and an intact c. 1965 ranch-style farmhouse. Multiple garage doors have been added to the side of both barns. Various strapwork hardware is present at the barn's smaller doors. The main doors of the front barn (top photo) may be hinged like those at 8965, but this is not confirmed. Front barn appears to have a "barn cross" martin hole on its west gable peak.

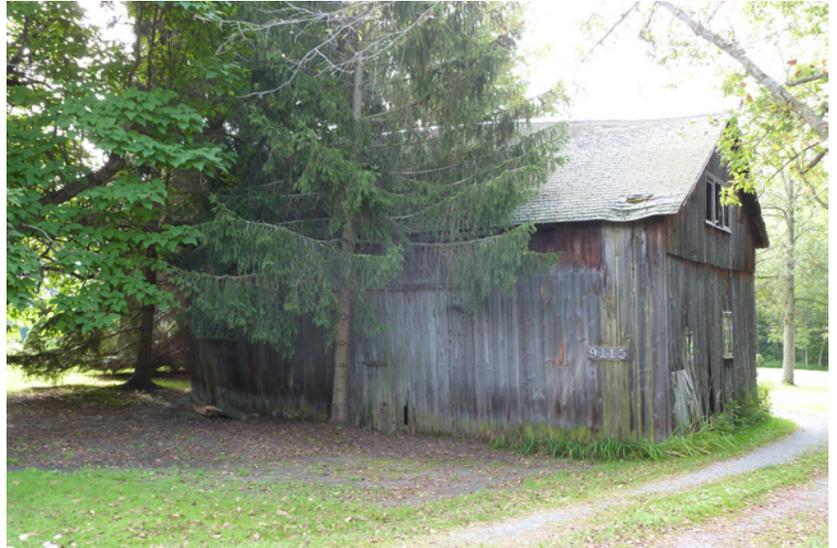
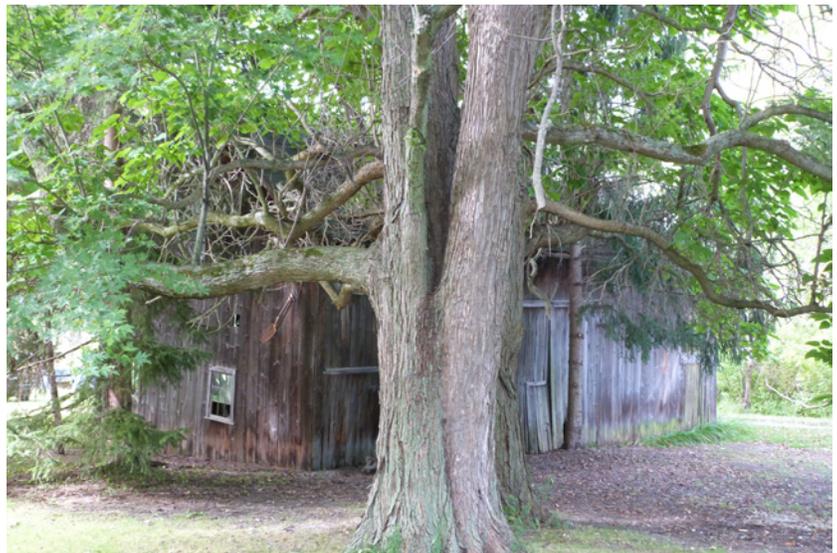
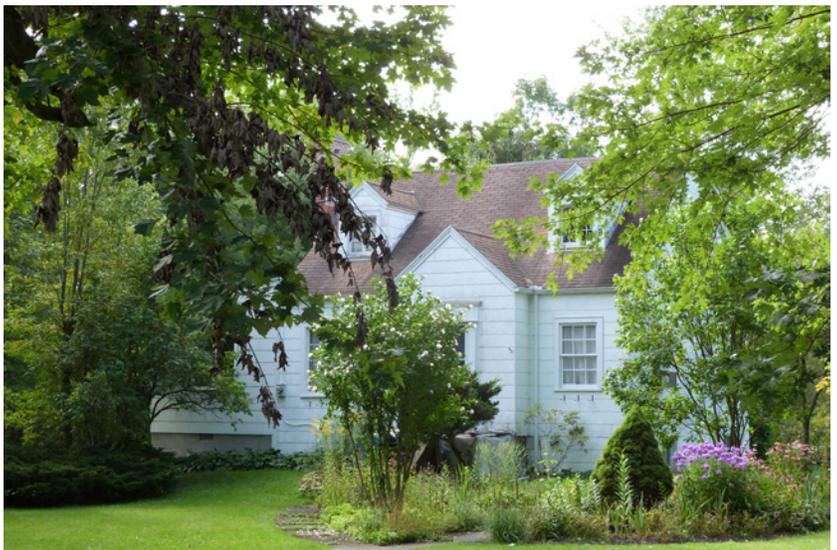
# 9115 Wolcott Rd.

## Significance: Low

Property contains three structures constructed c. 1925: a vertical wood plank English gable roofed barn, a Colonial Revival farmhouse, and a wood-framed workshop building. The workshop building was set far back from the street, so not visible at the time of survey. The barn has a set of three windows at the hay loft level and original wood windows at the first floor. Farmhouse has been sided with asbestos siding.

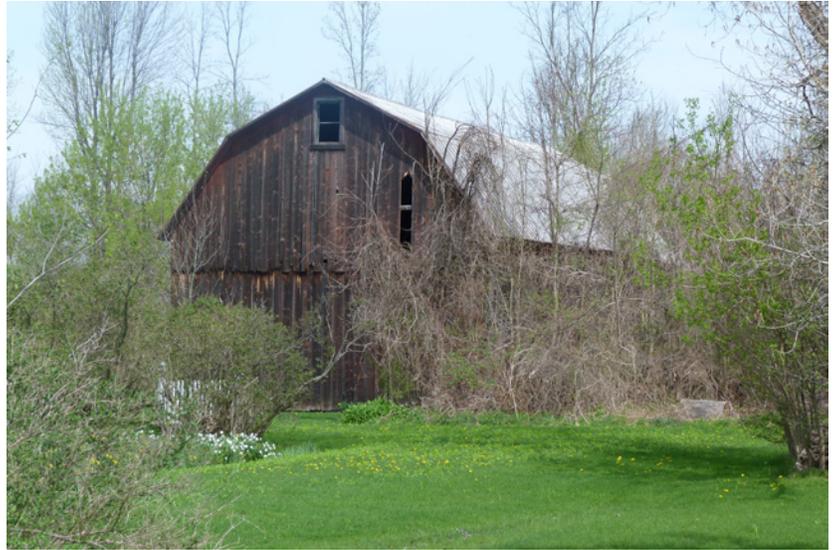
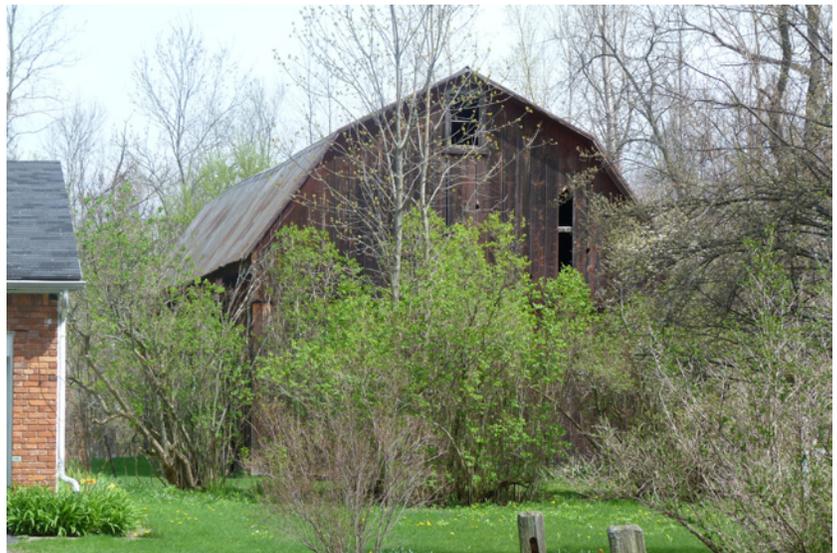
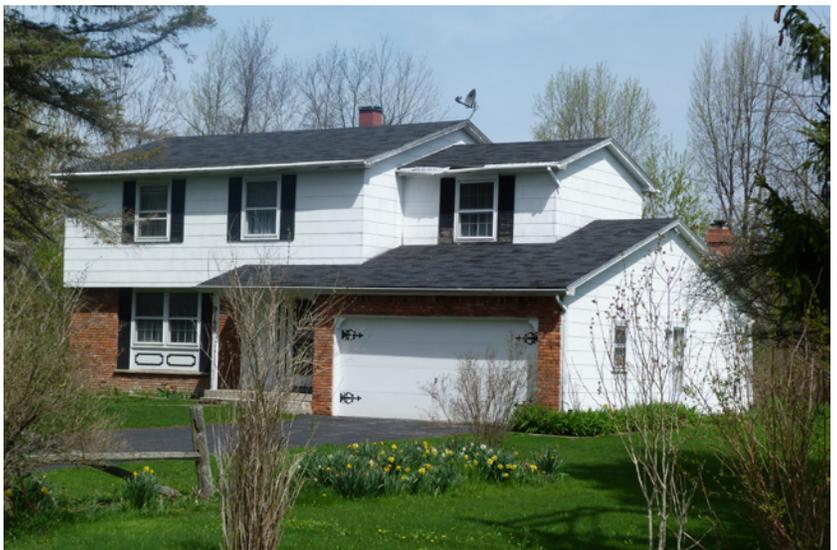
# 9160 Wolcott Rd.

## Significance: Low

Property contains a c. 1925 barn with vertical wood plank walls, metal gambrel roof, and double-hung window in its peak. Property also includes a c. 1965 ranch-style farmhouse.
