**RE: CONCEPT/SEQR REVIEW  
STRICKLER & GREINER SUBDIVISION**

This letter and the enclosed project documentation is being submitted to respond to the provided SEQR comments as part of the Coordinated Review process for the Strickler & Greiner subdivision project. Included with this submission are two (2) copies of the Traffic Impact Study for the subdivision.

The following report details the analysis performed to assess the traffic impacts of the proposed development on the adjacent roadway network within the study area. This report includes a summary of the assumptions and procedures used in the analysis, as well as the findings of the analysis and any recommended improvements necessary to mitigate the identified traffic impacts resulting from site traffic.

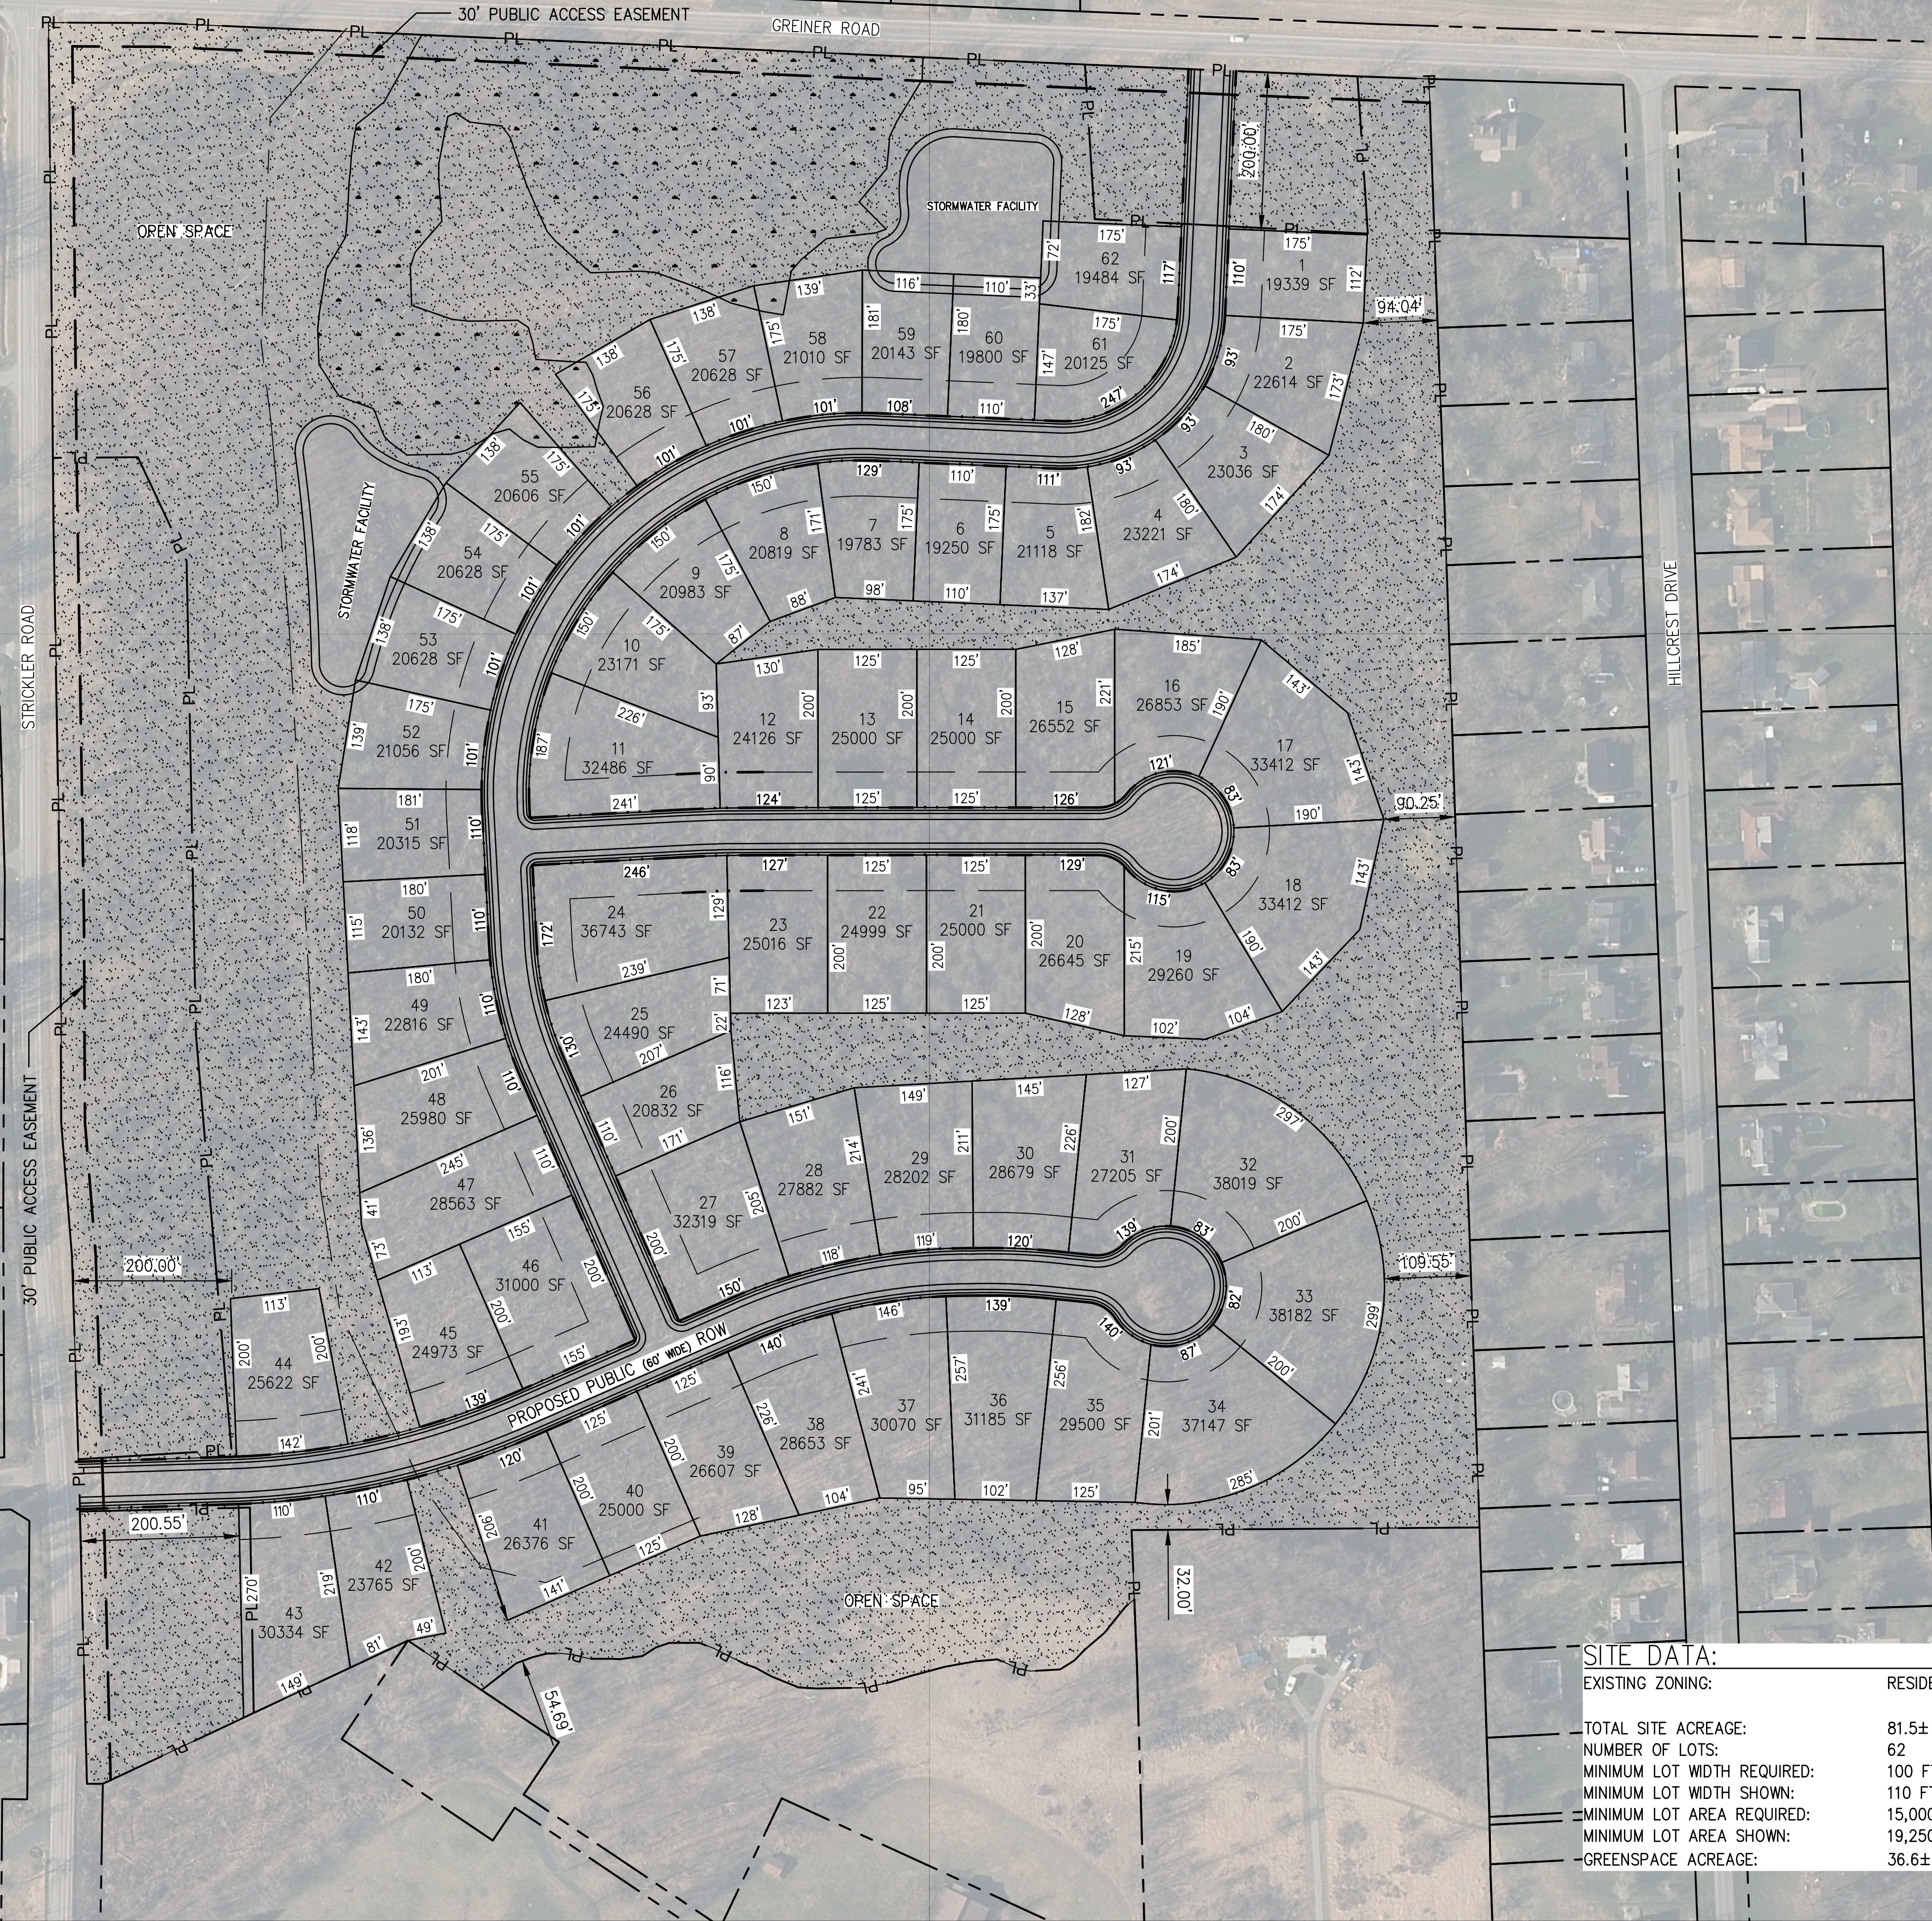
| SITE DATA: | |
|---|---|
| TOTAL SITE ACREAGE: | 81.5± Ac. |
| NUMBER OF LOTS: | 62 |
| MINIMUM LOT WIDTH REQUIRED: | 100 FT. |
| MINIMUM LOT WIDTH SHOWN: | 110 FT. |
| MINIMUM LOT AREA REQUIRED: | 15,000 SQ. FT. |
| MINIMUM LOT AREA SHOWN: | 19,250 SQ. FT. |
| GREENSPACE ACREAGE: | 36.6± Ac. (45%) |

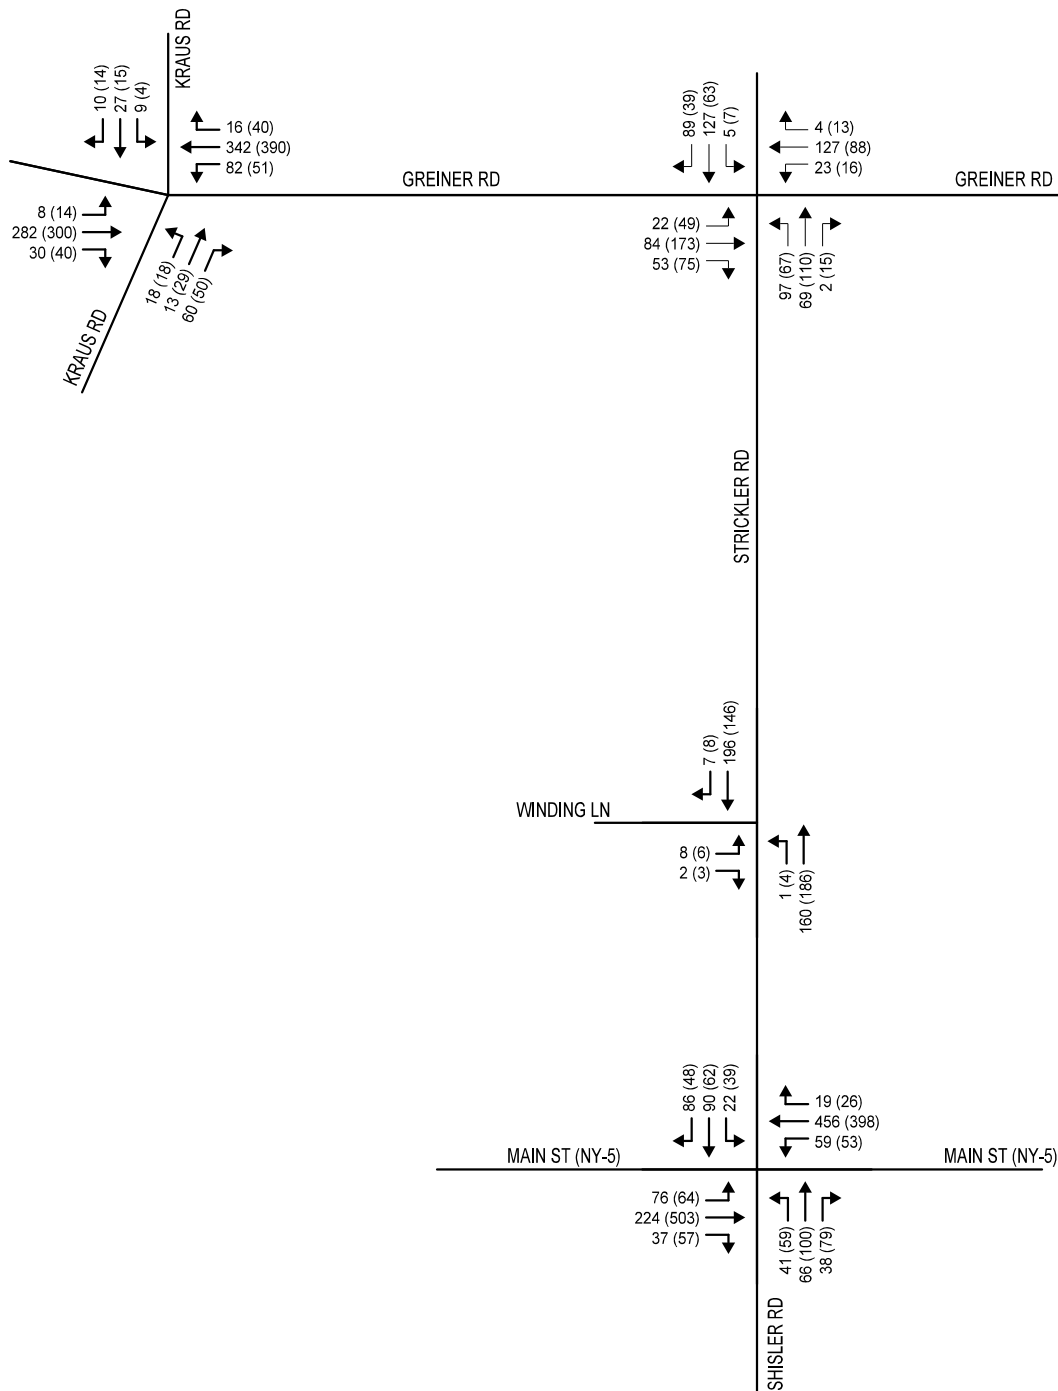
2024 EXISTING CONDITION  
PEAK HOUR VOLUMES

Based on the vehicle traffic data recorded it was determined that the weekday morning and afternoon peak hours for roadway traffic within the study area are 8:00 AM – 9:00 AM and 3:30 PM – 4:30 PM, respectively. Reviewing NYSDOT seasonal adjustment factors, it was determined that weekday December traffic is within about 1% of average annual conditions, so no seasonal adjustment was made to the count data. Traffic count data sheets for each of the intersections are included in Appendix B of this report. The 2024 Existing Peak Hour Traffic Volumes are shown in Figure 2 on the next page.

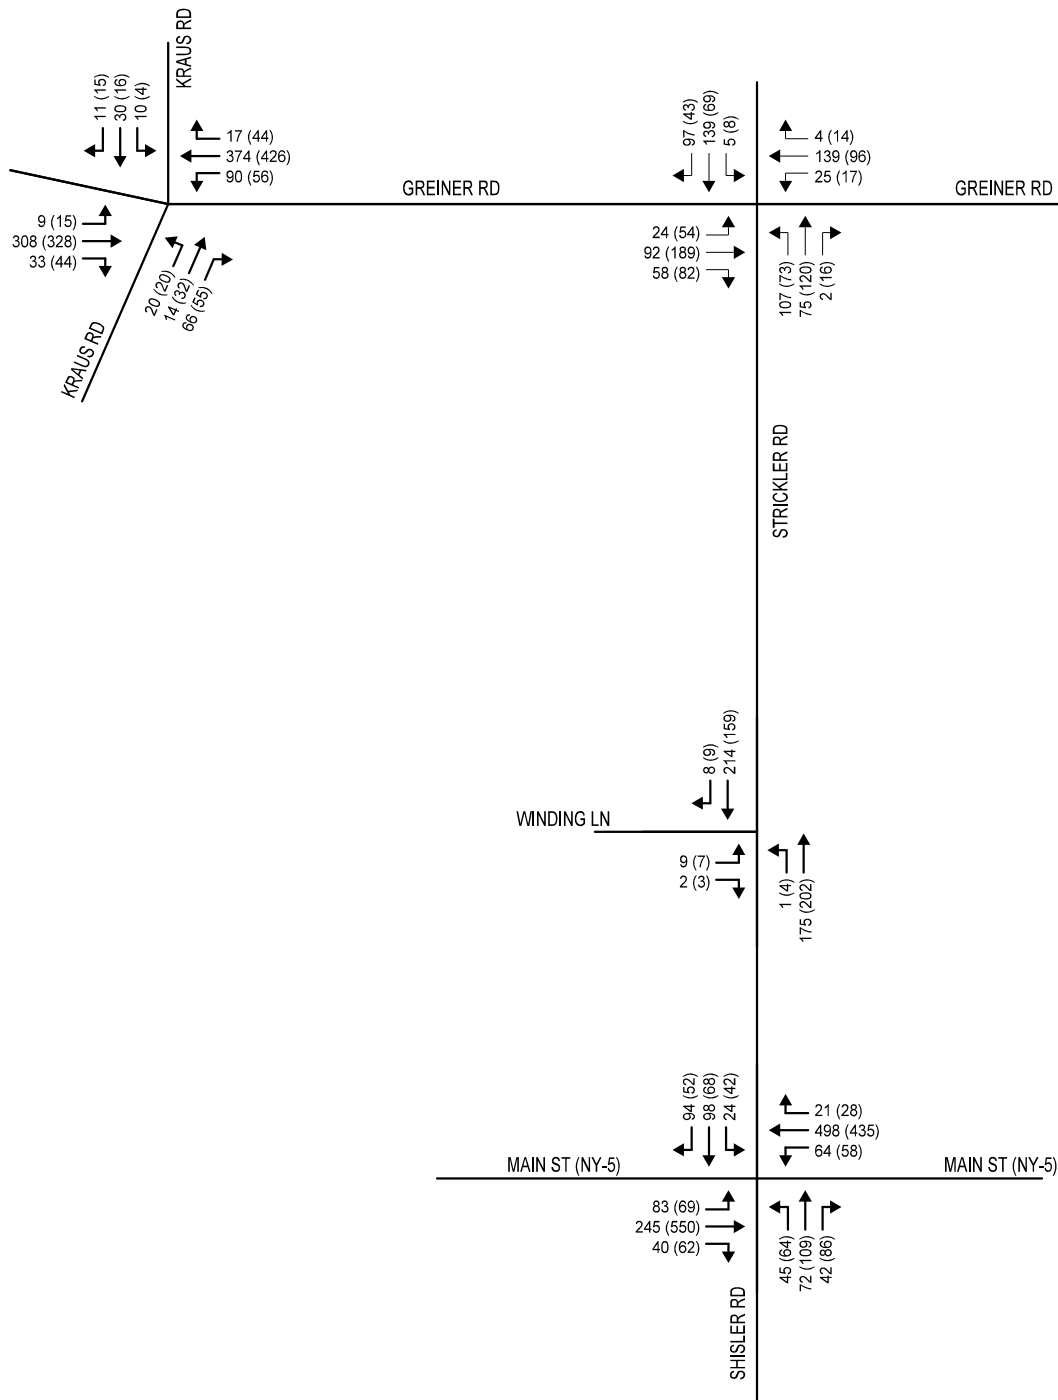
2030 NO-BUILD CONDITION  
PEAK HOUR VOLUMES

Using NYSDOT historical count station traffic data along the adjacent roadways, it was determined that up to 1.5% annual traffic growth could be expected as a result of regional development. Based on this data (see growth rate worksheet in Appendix B), existing traffic volumes were adjusted by a factor of 1.093 (1.5% for 6 years) to estimate the 2030 No-build (background) traffic volumes. These volumes are shown in Figure 3.

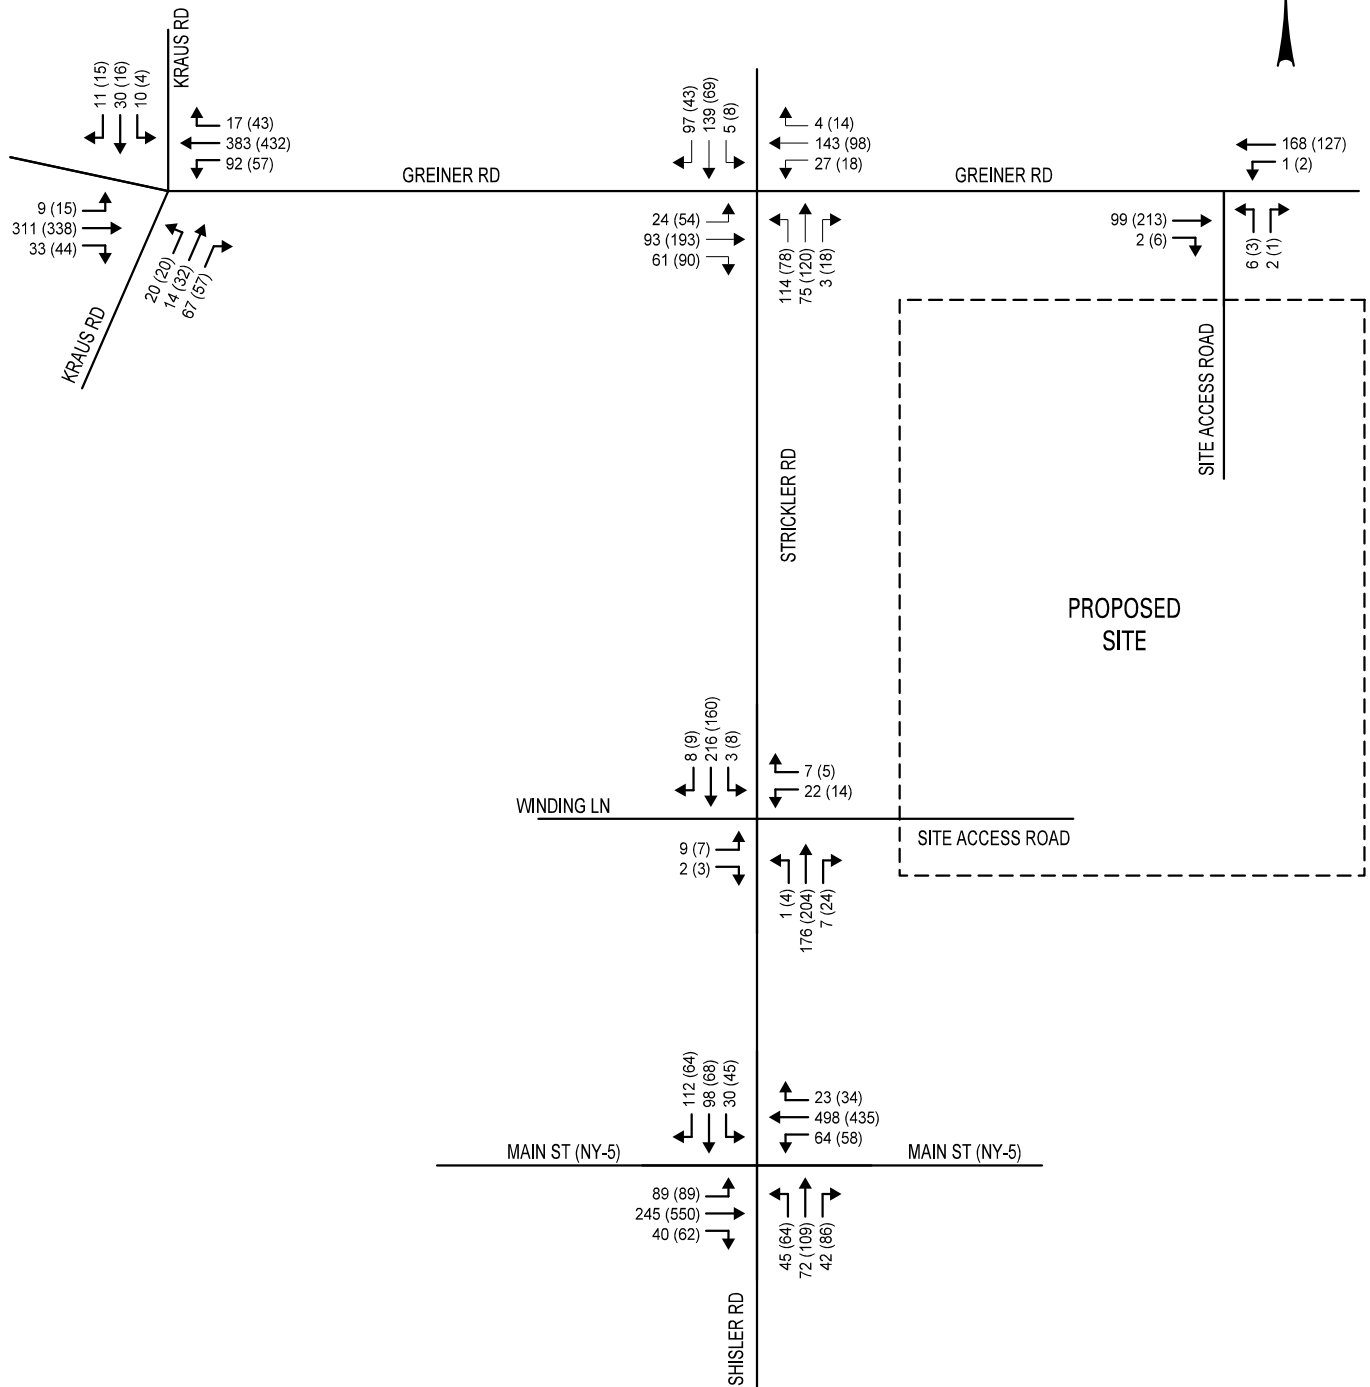
2030 BUILD CONDITION  
PEAK HOUR VOLUMES

The Build Condition peak hour traffic volumes were developed by combining the "2030 No-Build Condition Peak Hour Traffic Volumes" and the "Projected New Site Trips". These volumes are graphically depicted in Figure 6 – "2030 Build Condition Peak Hour Traffic Volumes".

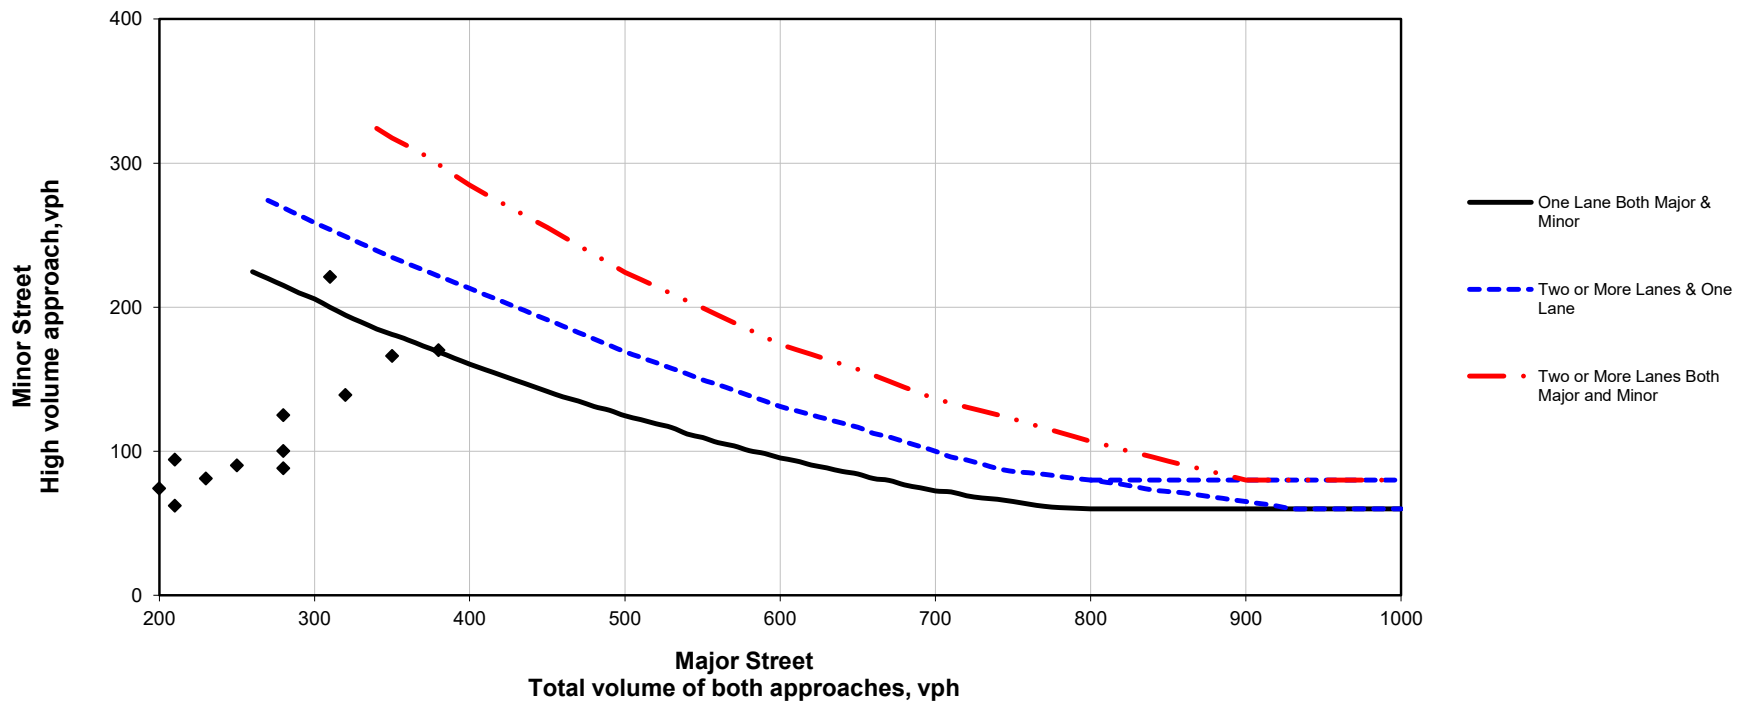
**Figure 4C-2. Warrant 2, Four-Hour Vehicular Volume (70% Factor)**  
 (COMMUNITY LESS THAN 10,000 POPULATION OR ABOVE 70 km/h (40 mph) ON MAJOR STREET)

Note: Points on graph represent hourly volumes. Points above the respective curve satisfy warrant, points below do not satisfy warrant.

This warrant has different warranting thresholds than the 8-hour warrant, and these thresholds must be satisfied for at least 4 hours during the day. The intersection volumes exceeded these thresholds only 2 hours of the day in the Existing condition and 3 hours of the day in the No-build and Build condition. ***This volume warrant is not met.***

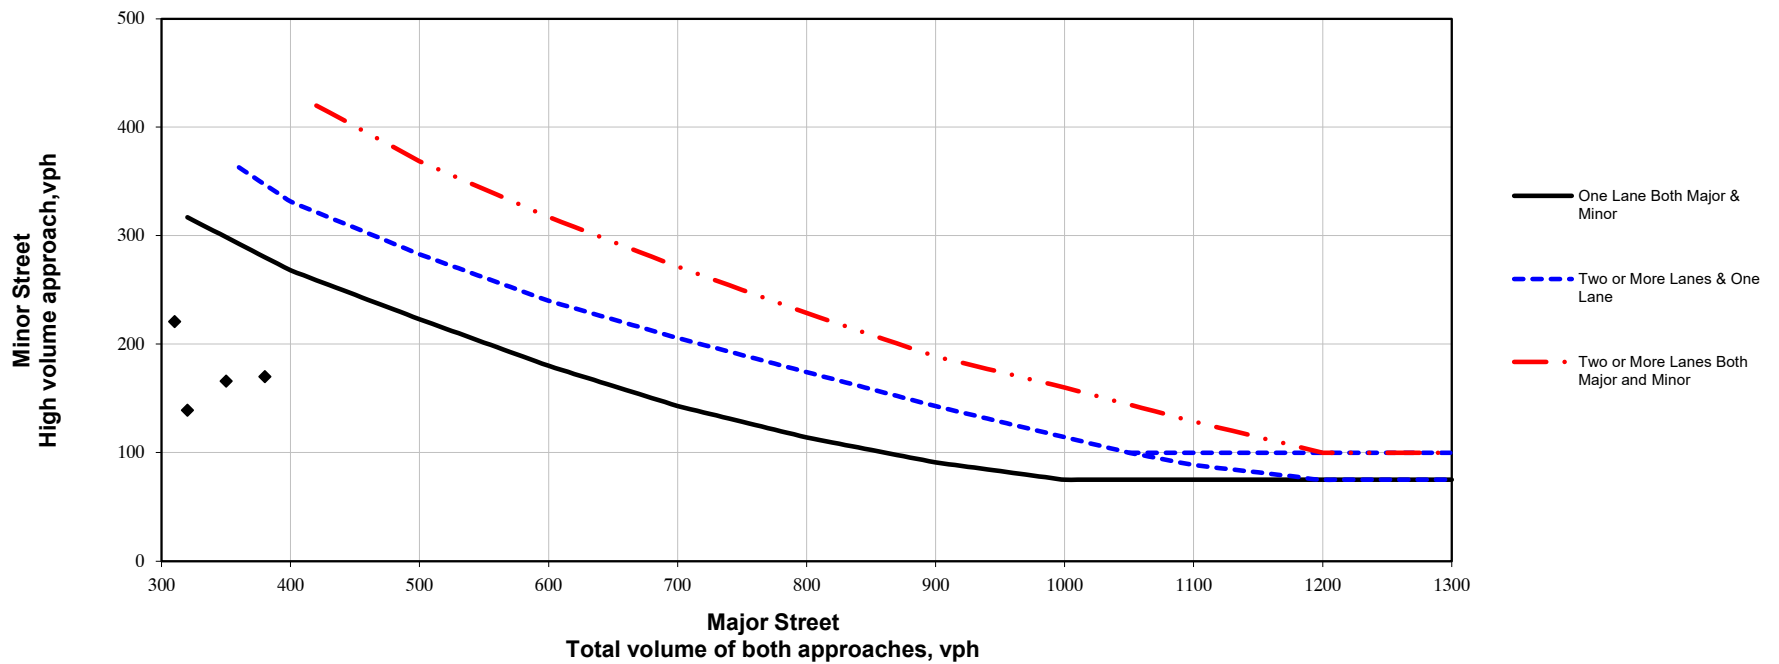
**Figure 4C-4. Warrant 3, Peak Hour (70% Factor)**  
 (COMMUNITY LESS THAN 10,000 POPULATION OR ABOVE 70 km/h (40 mph) ON MAJOR STREET)

Note: Points on graph represent hourly volumes. Points above the respective curve satisfy warrant, points below do not satisfy warrant.

In some cases peak roadway traffic hours are so extreme that a signal is warranted even if heavy traffic is not present during other hours of the day. For this warrant, the peak hour thresholds needs to be met for just a single hour of the day for signal justification. However, in this case, the peak hour threshold was not met for any hour of the day under the reviewed conditions. ***This volume warrant is not met.***

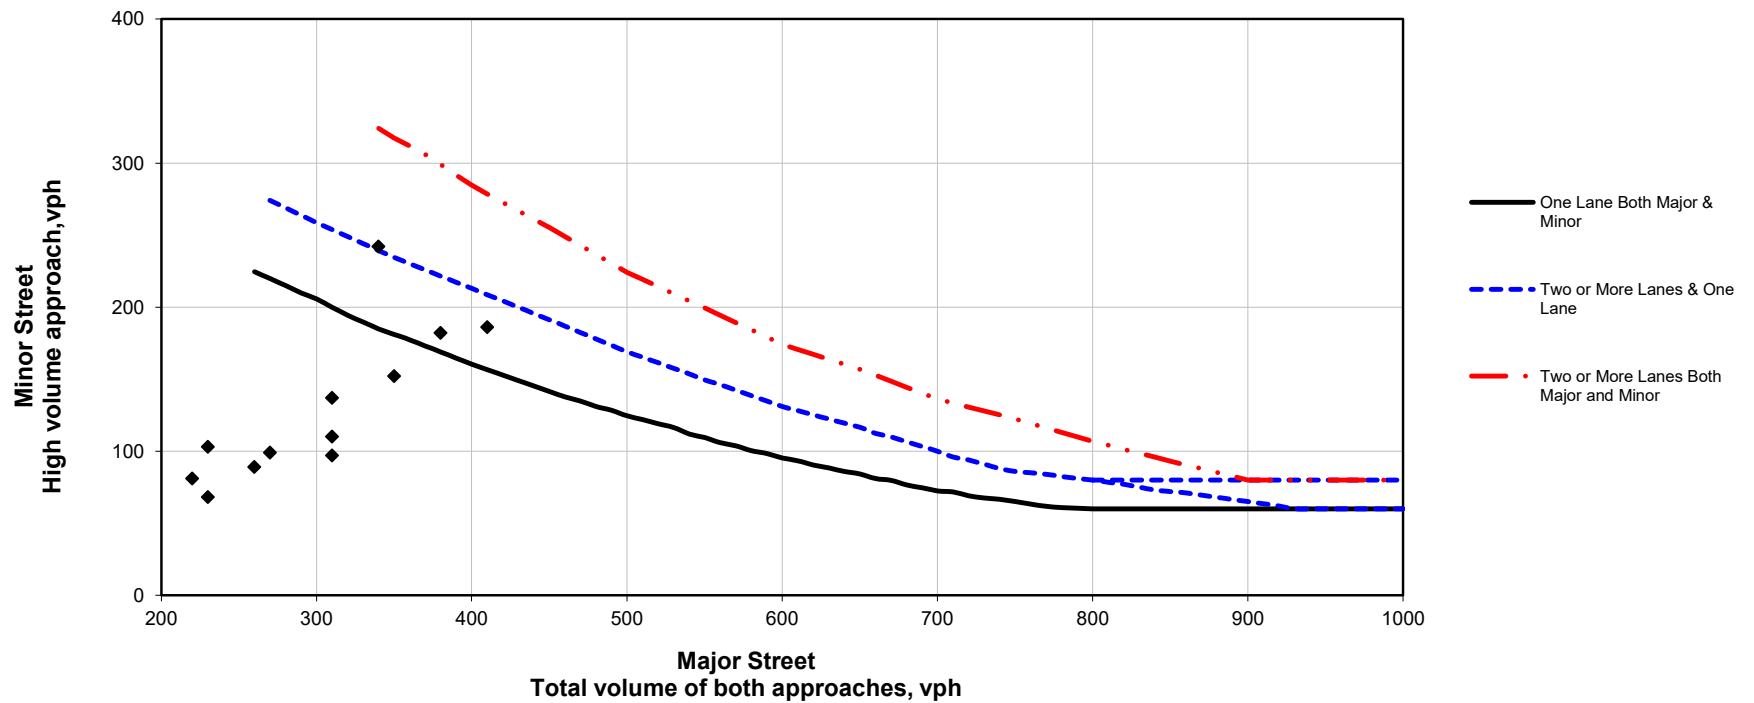
**Figure 4C-2. Warrant 2, Four-Hour Vehicular Volume (70% Factor)**  
 (COMMUNITY LESS THAN 10,000 POPULATION OR ABOVE 70 km/h (40 mph) ON MAJOR STREET)

Note: Points on graph represent hourly volumes. Points above the respective curve satisfy warrant, points below do not satisfy warrant.

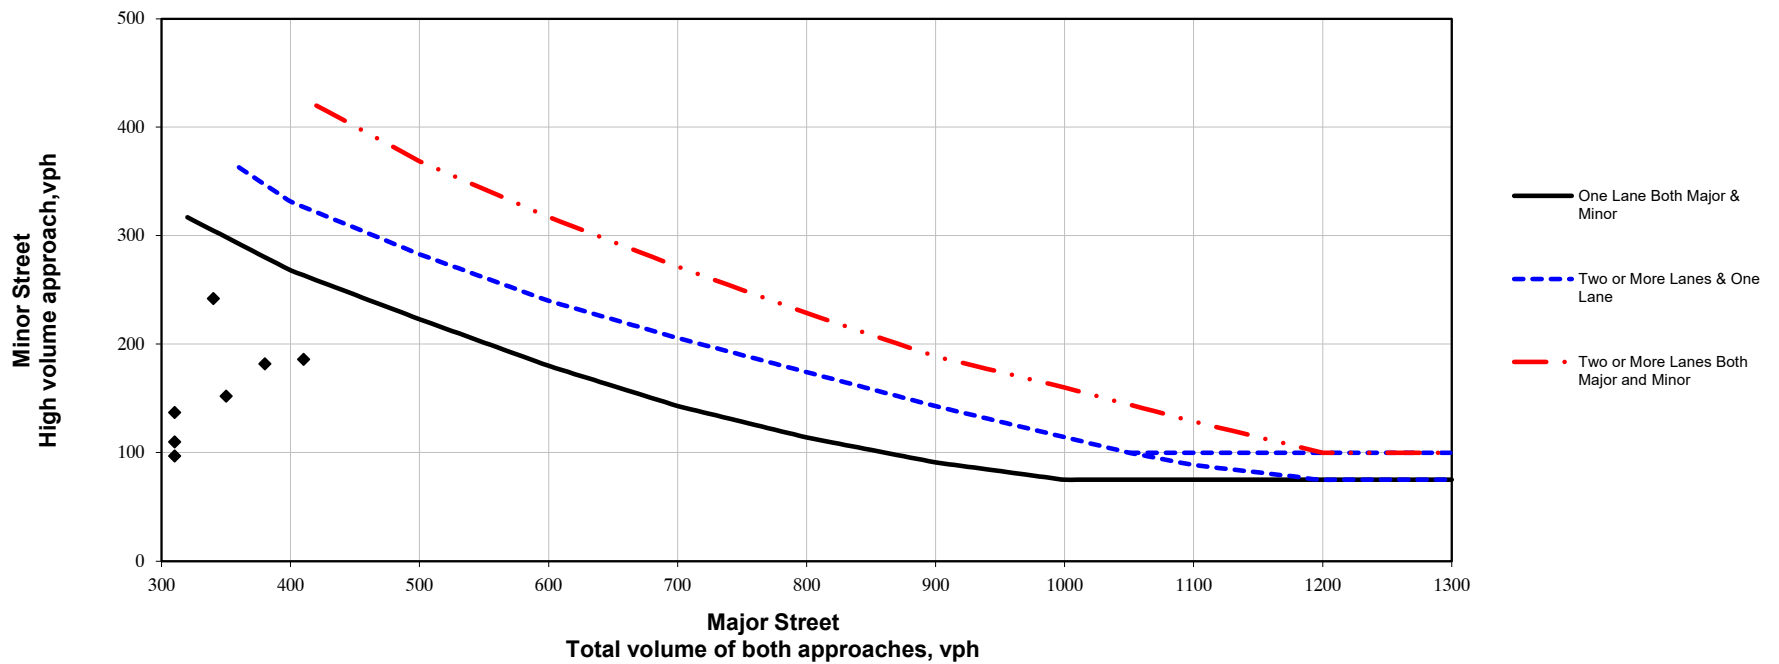
**Figure 4C-4. Warrant 3, Peak Hour (70% Factor)**  
 (COMMUNITY LESS THAN 10,000 POPULATION OR ABOVE 70 km/h (40 mph) ON MAJOR STREET)

Note: Points on graph represent hourly volumes. Points above the respective curve satisfy warrant, points below do not satisfy warrant.

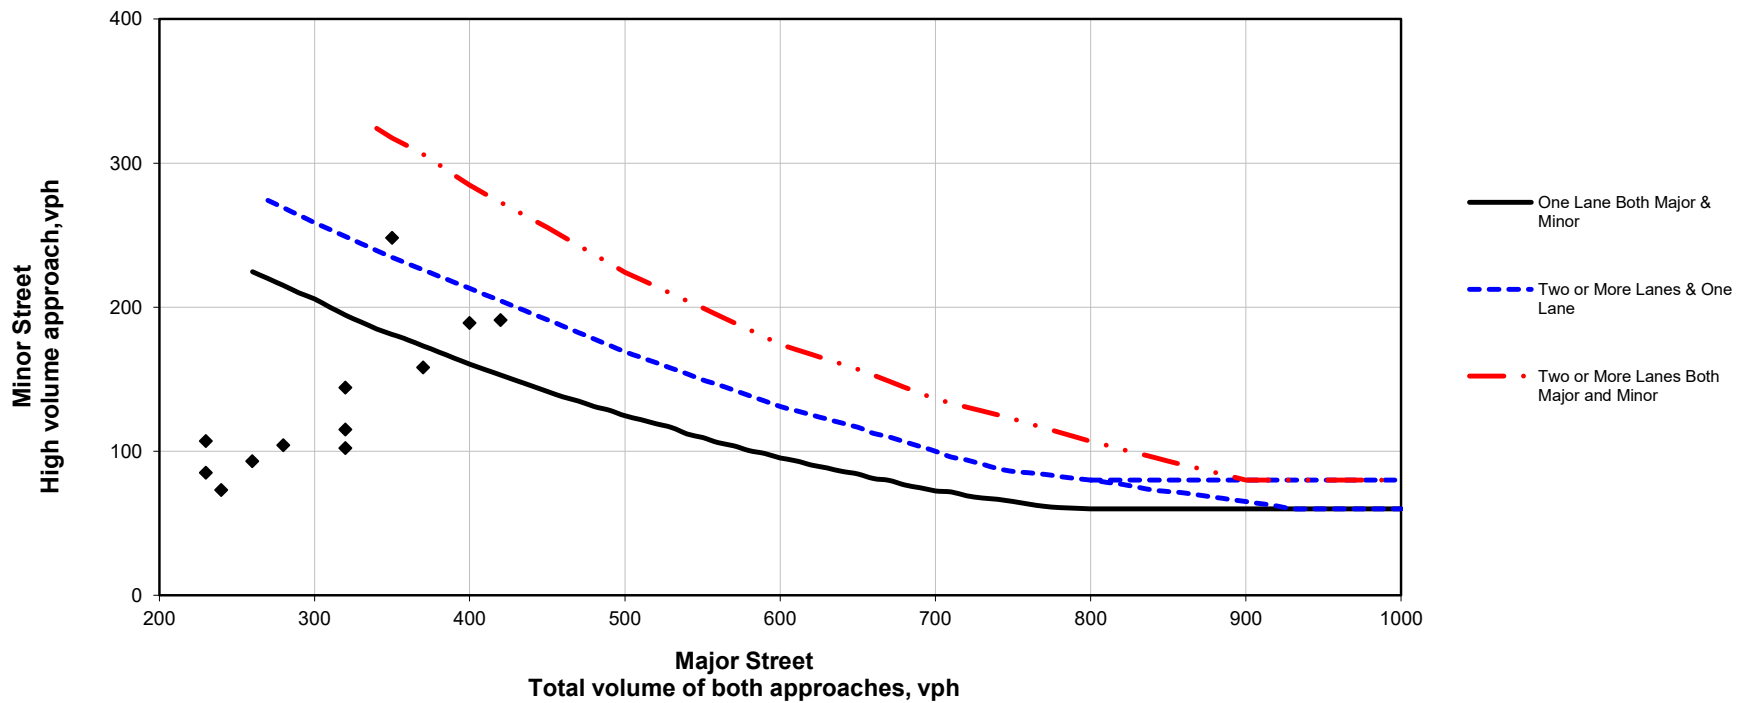
**Figure 4C-2. Warrant 2, Four-Hour Vehicular Volume (70% Factor)**  
 (COMMUNITY LESS THAN 10,000 POPULATION OR ABOVE 70 km/h (40 mph) ON MAJOR STREET)

Note: Points on graph represent hourly volumes. Points above the respective curve satisfy warrant, points below do not satisfy warrant.

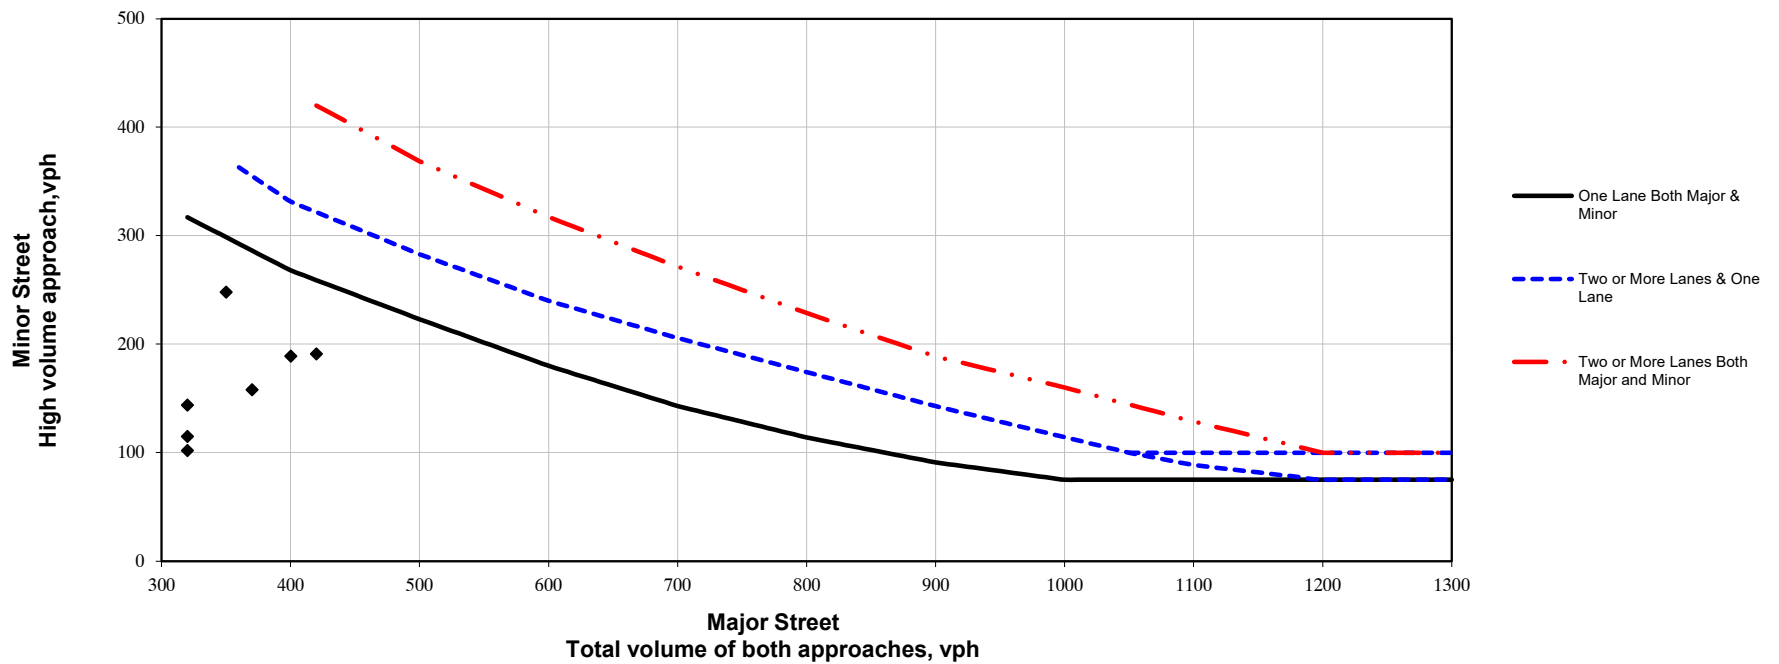
**Figure 4C-4. Warrant 3, Peak Hour (70% Factor)**  
 (COMMUNITY LESS THAN 10,000 POPULATION OR ABOVE 70 km/h (40 mph) ON MAJOR STREET)

Note: Points on graph represent hourly volumes. Points above the respective curve satisfy warrant, points below do not satisfy warrant.
